TIREY & ASSOCIATES, P.C.

CONSULTING STRUCTURAL ENGINEERS

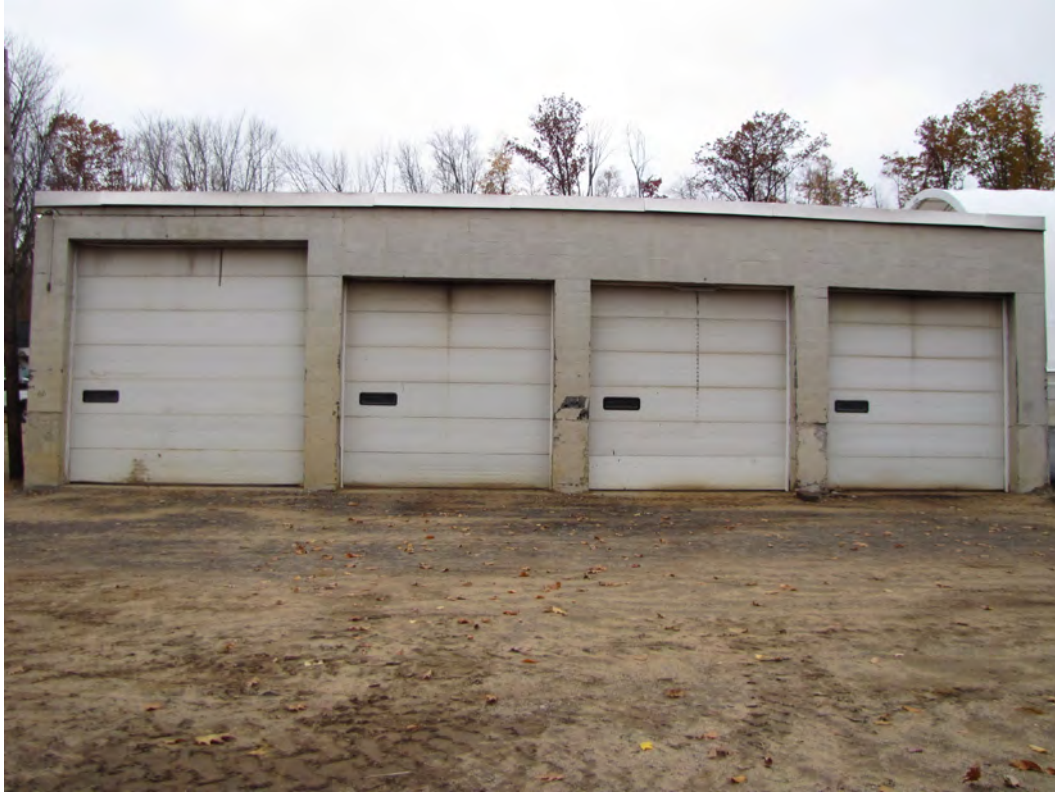
Photo 036: South face of garage building with 4 overhead doors. There is extensive structural damage to the concrete and masonry block pier between the two center doors and between the two right, or easterly, doors.

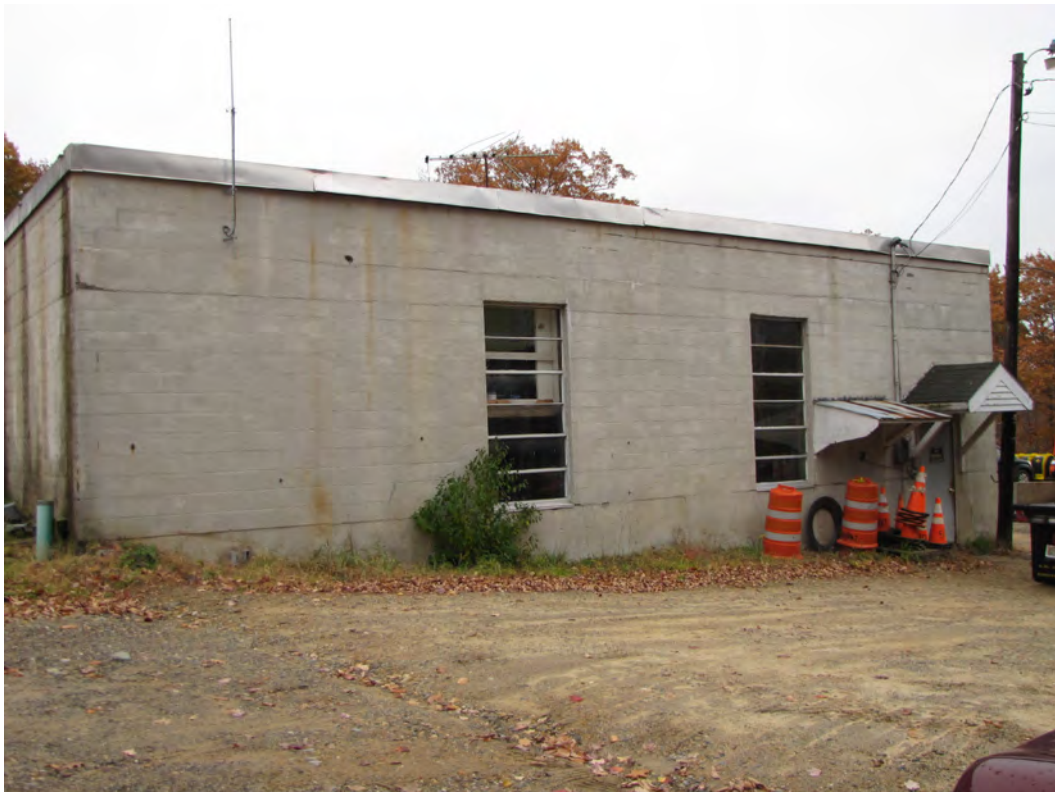
Photo 001: West wall of building. Note crack at bottom of top course of block, just below metal fascia, at southern half of wall. See detail photos 003 and 006.

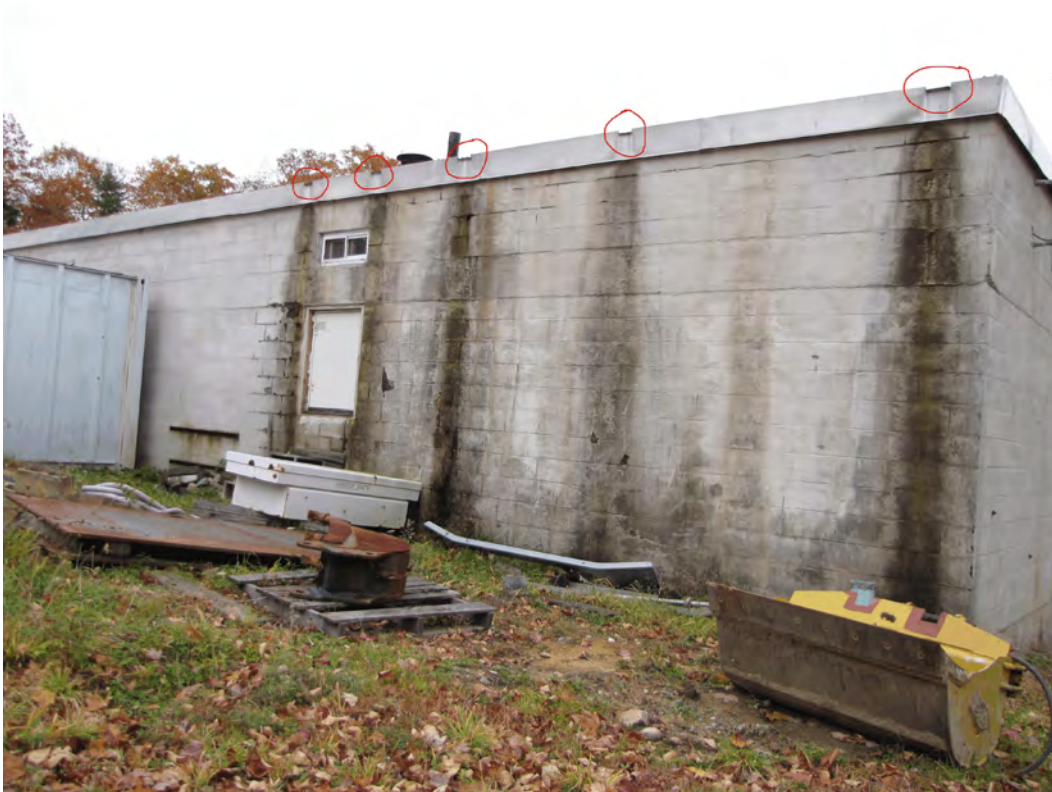
Photo 007A: North wall of building, showing effects of water runoff from roof. See detail Photos 009, 010, 011, 012, 013 and 015. Note that the metal fascia has been cut and folded down at 5 locations (in red circles) to form scuppers for roof drainage.

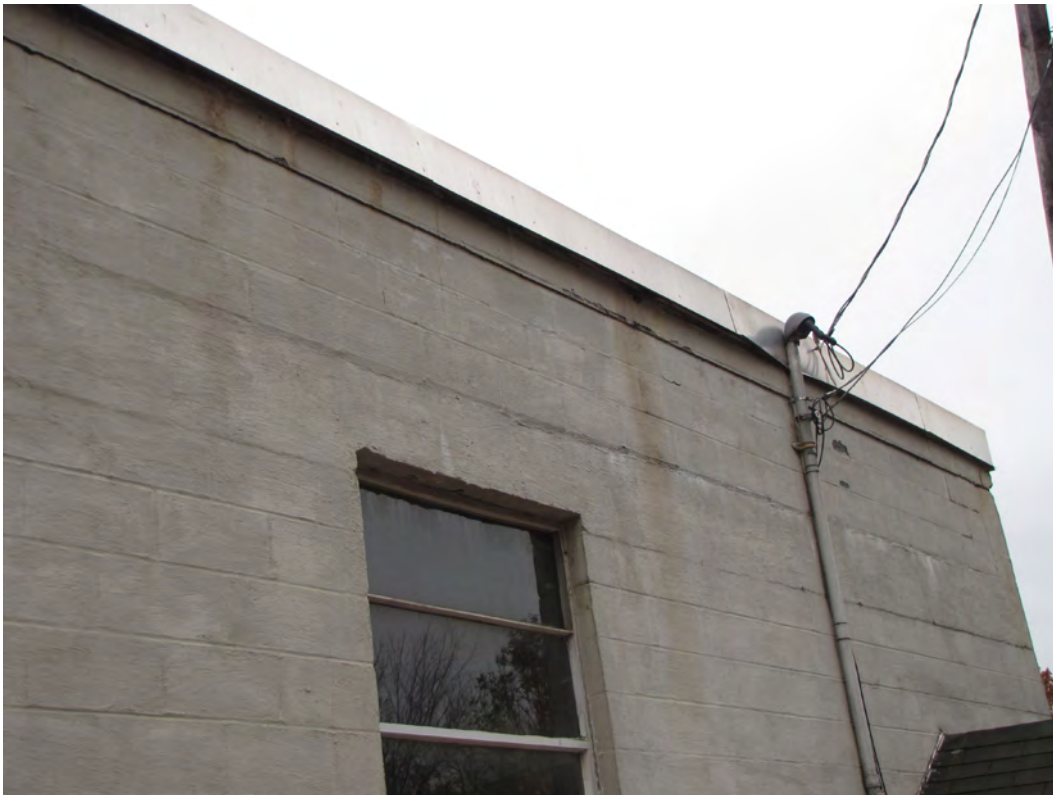
Photo 003: Closer view of south half of west wall showing top, 4th course of masonry above concrete band beam, cracked and laterally displaced to the outside from the wall below.

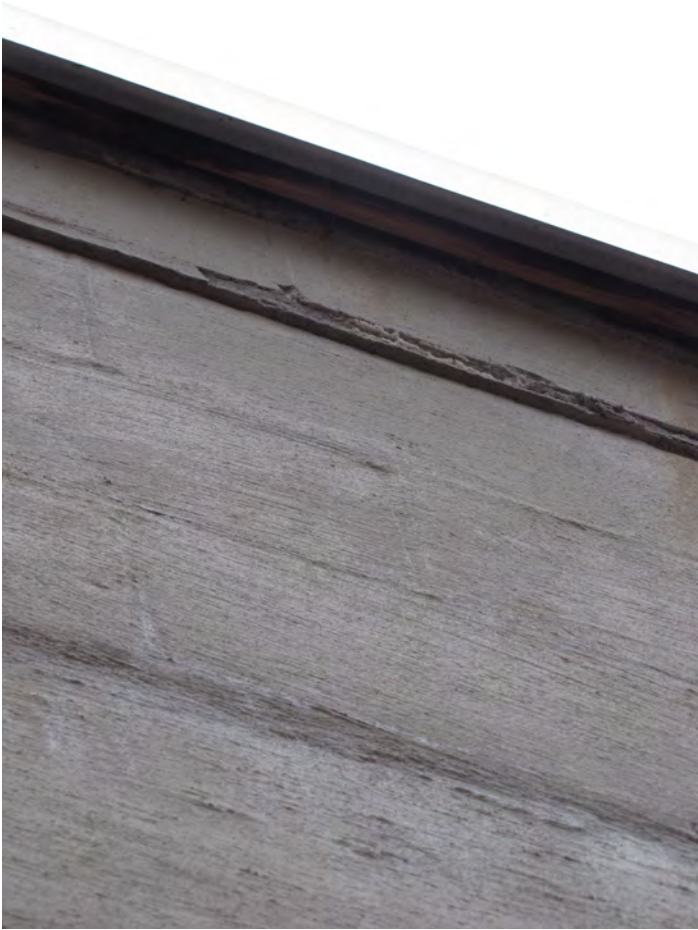
Photo 006: Close up of the west wall in Photo 003 showing about ½" of lateral displacement of the top course of masonry block. This course is located mostly at the thickness of the precast concrete plank roof inside.

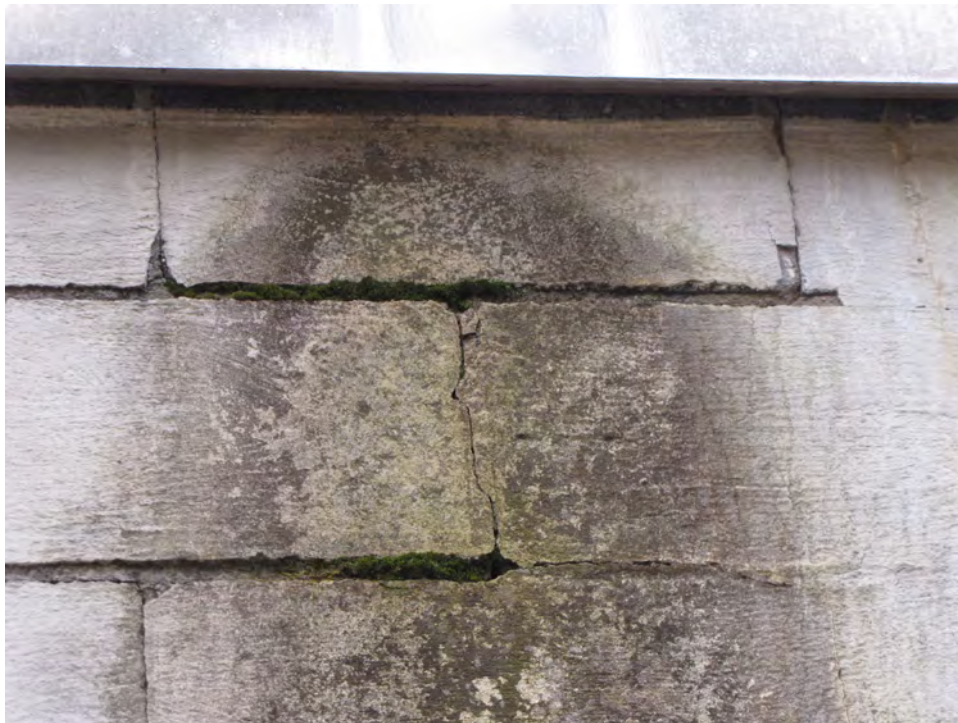
Photo 009: Water damage to north wall of building where water is overflowing roof through "scupper" created through the metal fascia. Moss is growing in mortar joints which are cracked and permit water infiltration.

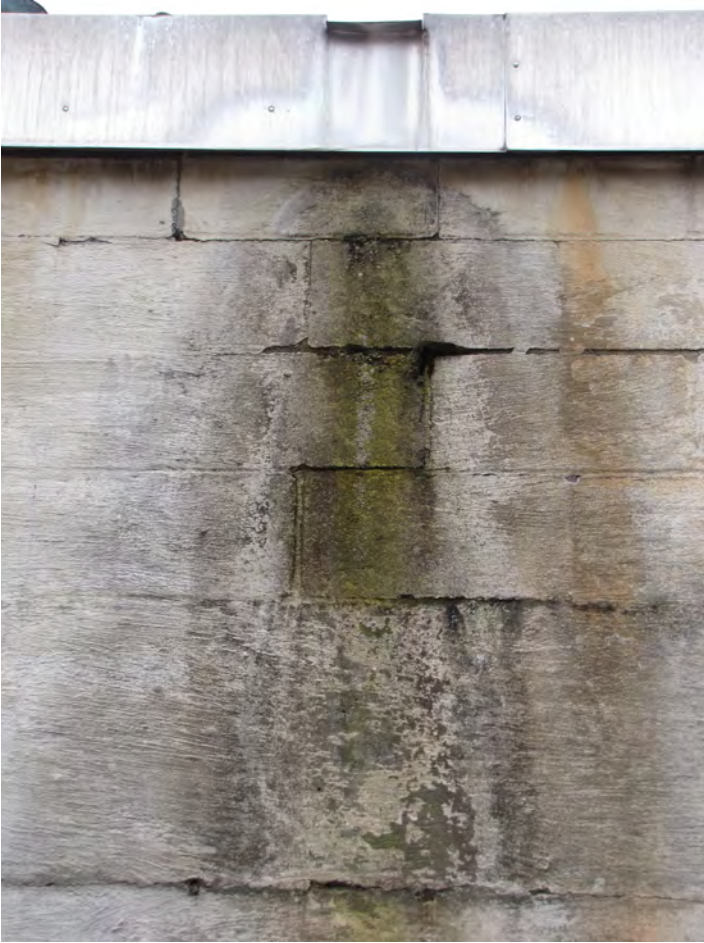
Photo 010: Water damage on north wall below “scupper” created through metal fascia. Algae and moss are growing on wall and mortar joints, respectively. Cracks in mortar joints permit water infiltration.

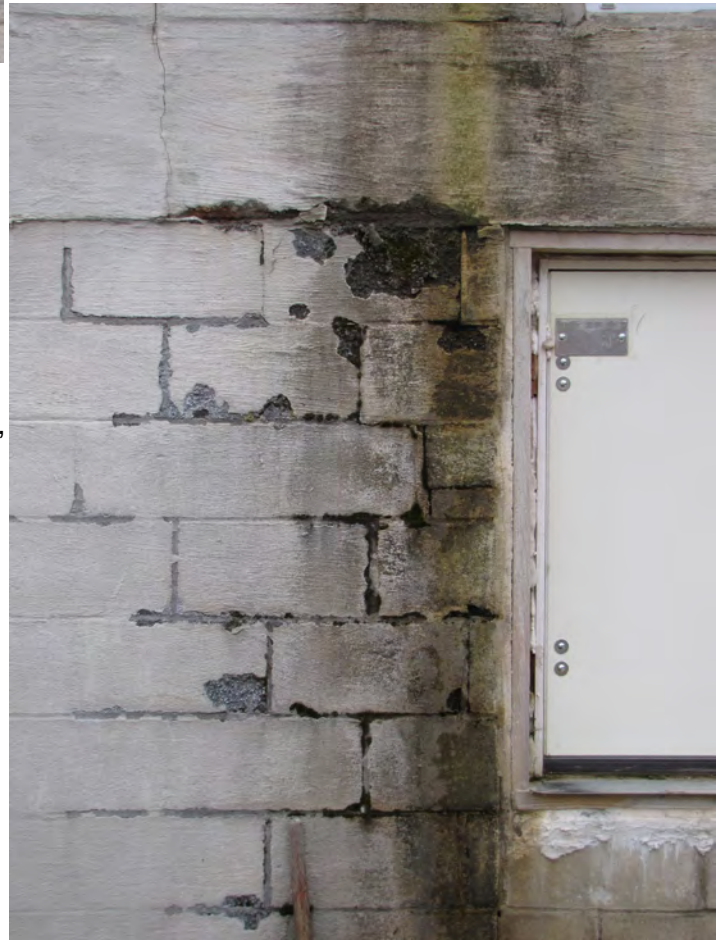
Photo 011: Significant water damage of north wall, on east side of emergency egress hatch door. Masonry is spalled and joints cracked. Note crack through concrete band beam.

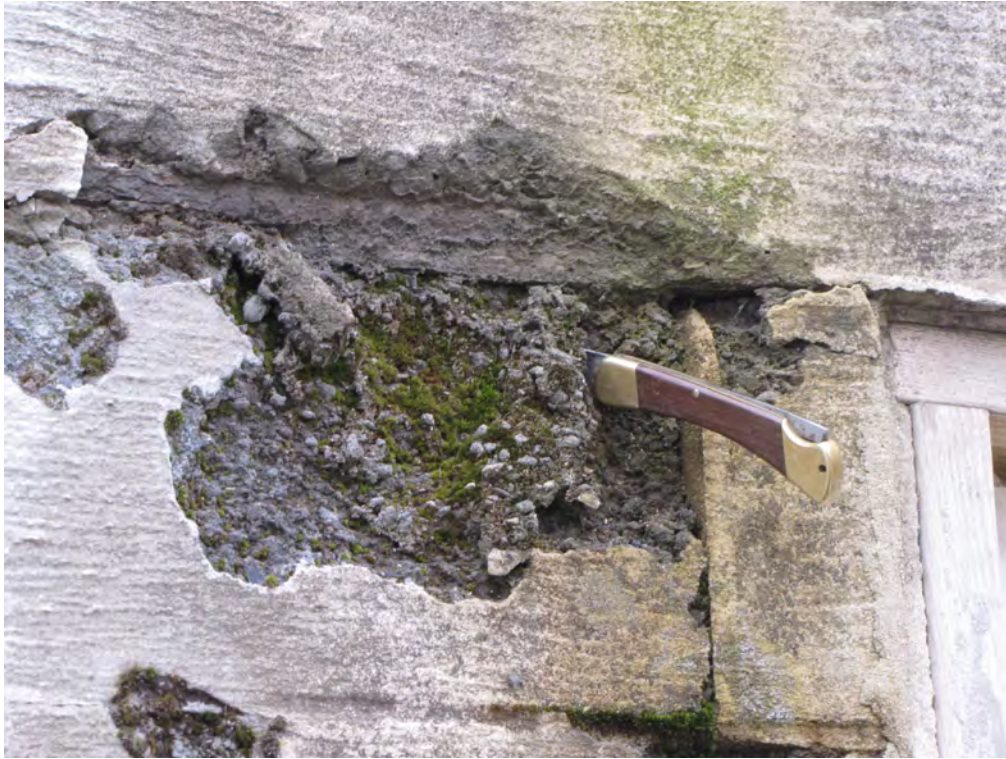
Photo 012: Close up of Photo 011 at upper corner of hatch door. Masonry is so deteriorated a dull knife blade can push right through face shell. Note the bottom outside corner of the concrete band beam is spalled off (cracked and fallen off).

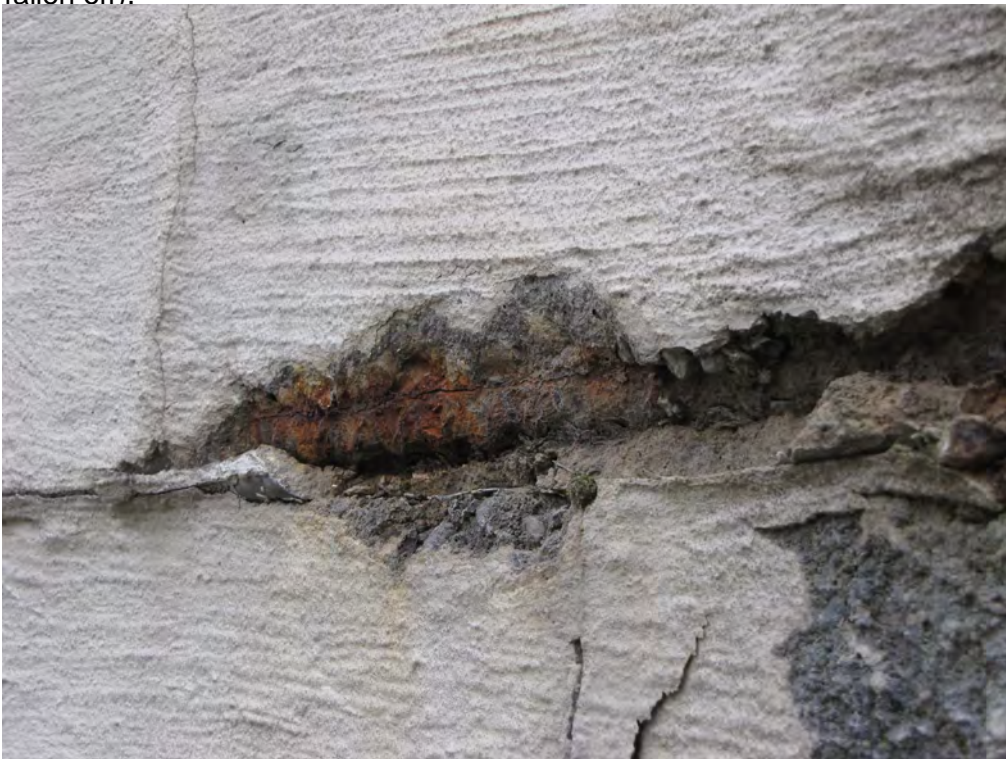
Photo 013: Close up of Photo 011 at the bottom of the crack in the concrete band beam. Reinforcing bar is visible where concrete has spalled off. There is insufficient concrete cover around the bar. Corrosion will cause continued cracking and concrete deterioration.

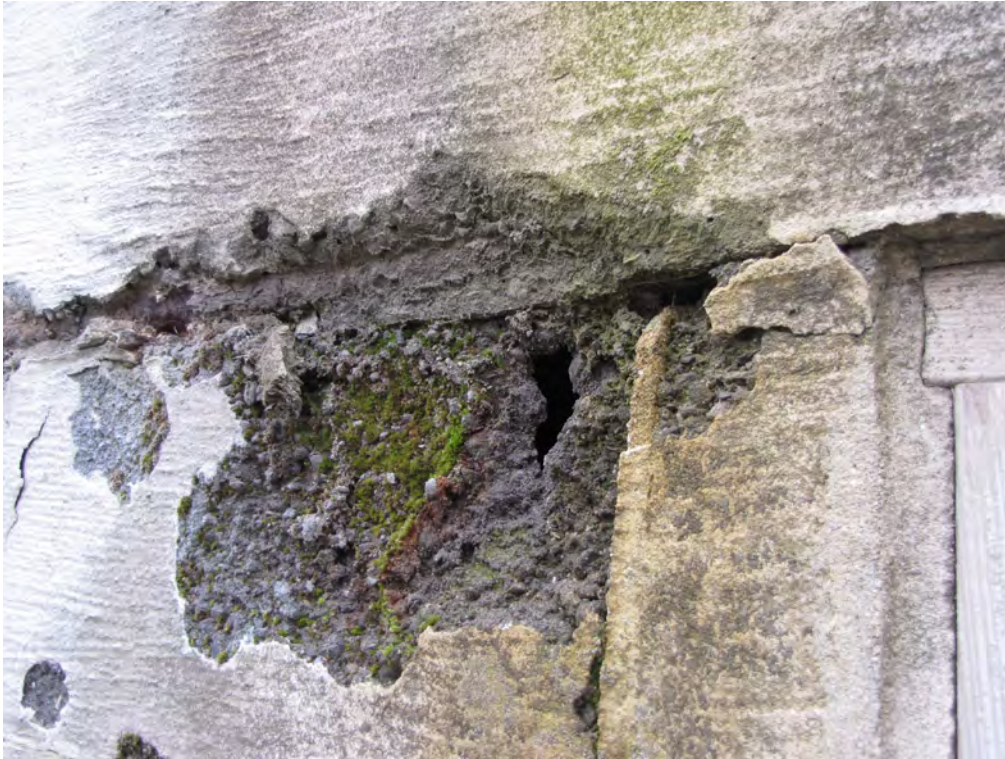
Photo 015: View of Photo 012 with knife removed. The masonry around the hole in the face shell crumbles in your hands.

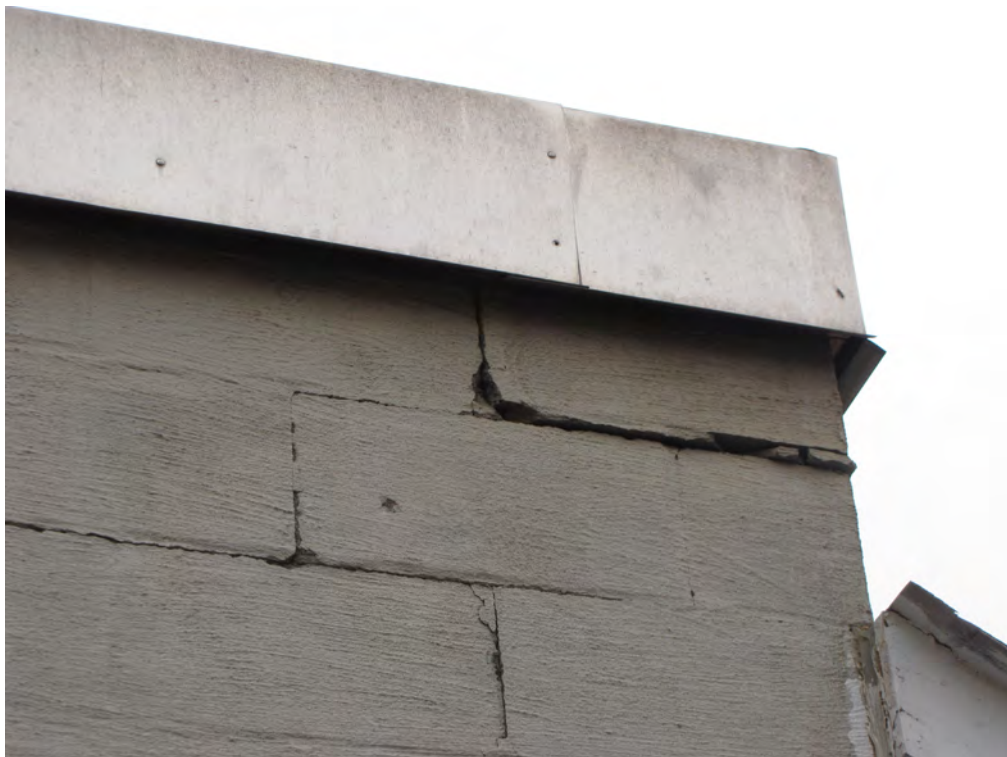
Photo 018: North end of east wall showing cracked and loose block at corner.

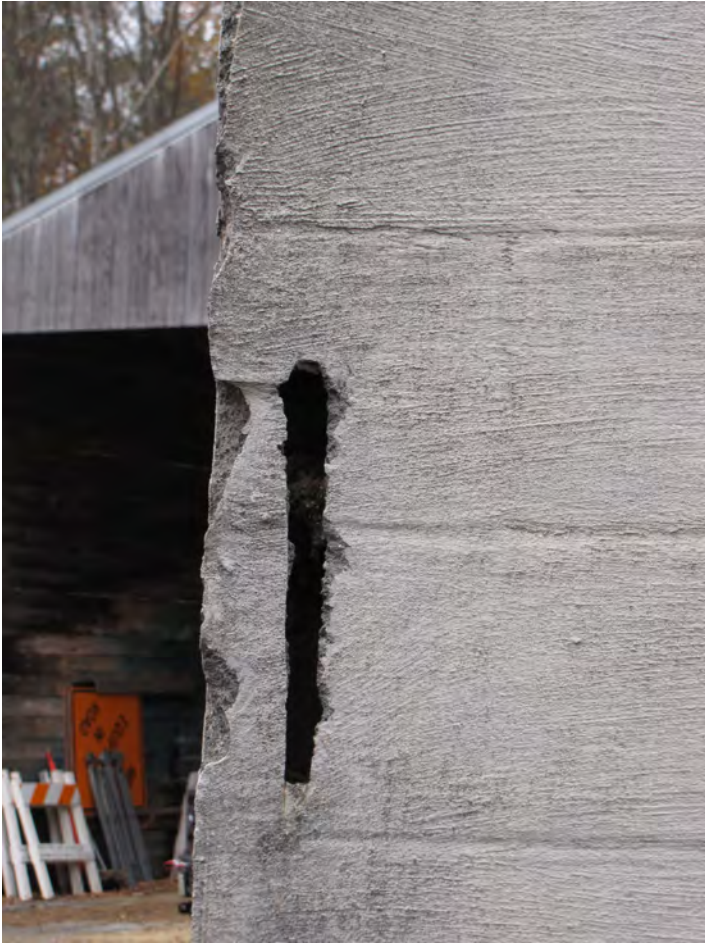
Photo 021: Deteriorated masonry with hole in face shell of south end of east wall.

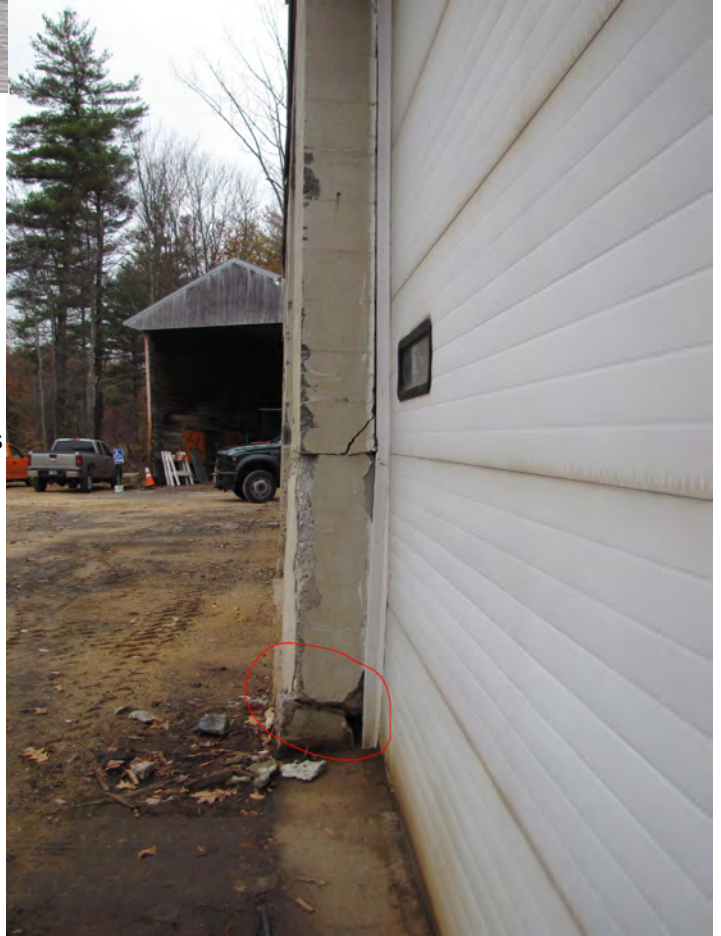
Photo 022A: South wall of building, looking west at pier between first two overhead doors. This pier was hit by a vehicle, cracking and dislodging the pier towards the inside of the building. Area in red circle has about 2" of movement.

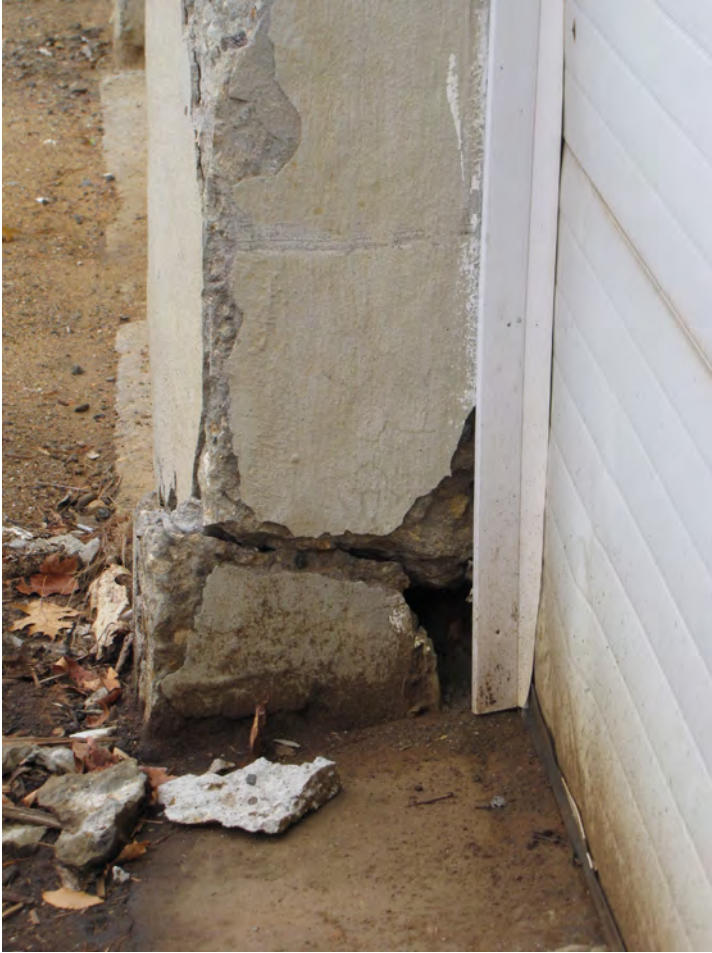
Photo 023: Close up of Photo 022A showing extreme movement of concrete pier. This structure is unreinforced concrete. The pier is unstable and not safe.

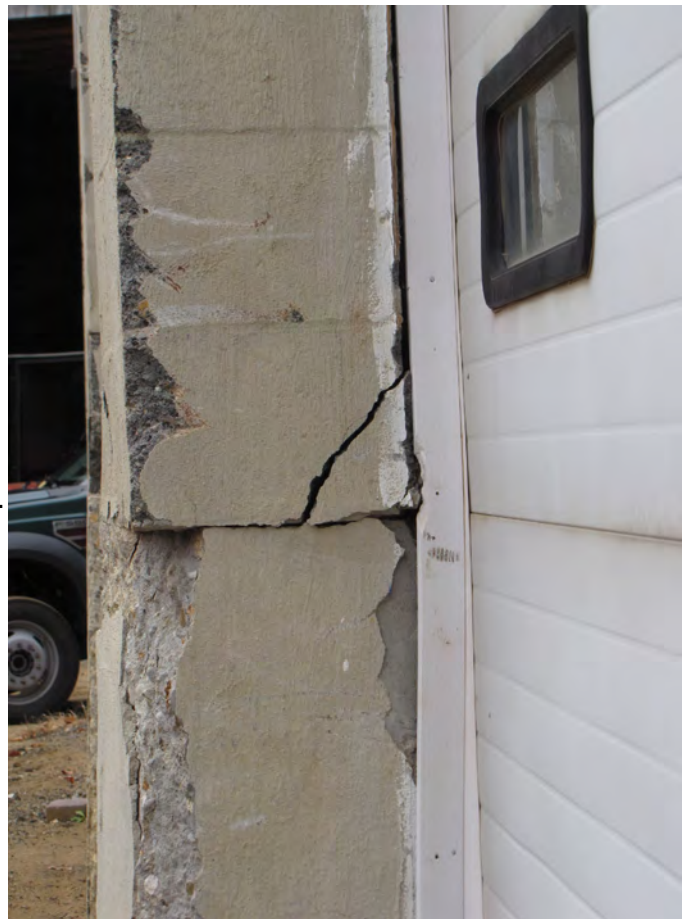
Photo 024: Joint interface closeup of concrete to block, from Photo 022A. Note position of outside face of block of this pier relative to the pier beyond.

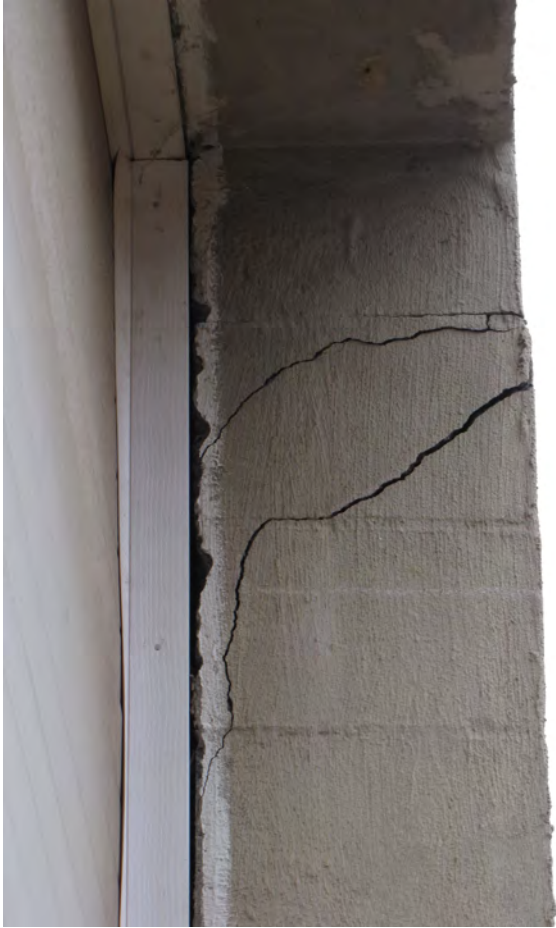
Photo 026: Top of masonry portion of pier between two eastern doors, as viewed from west side of pier. Cracking is severe, is not repairable, and must be replaced.

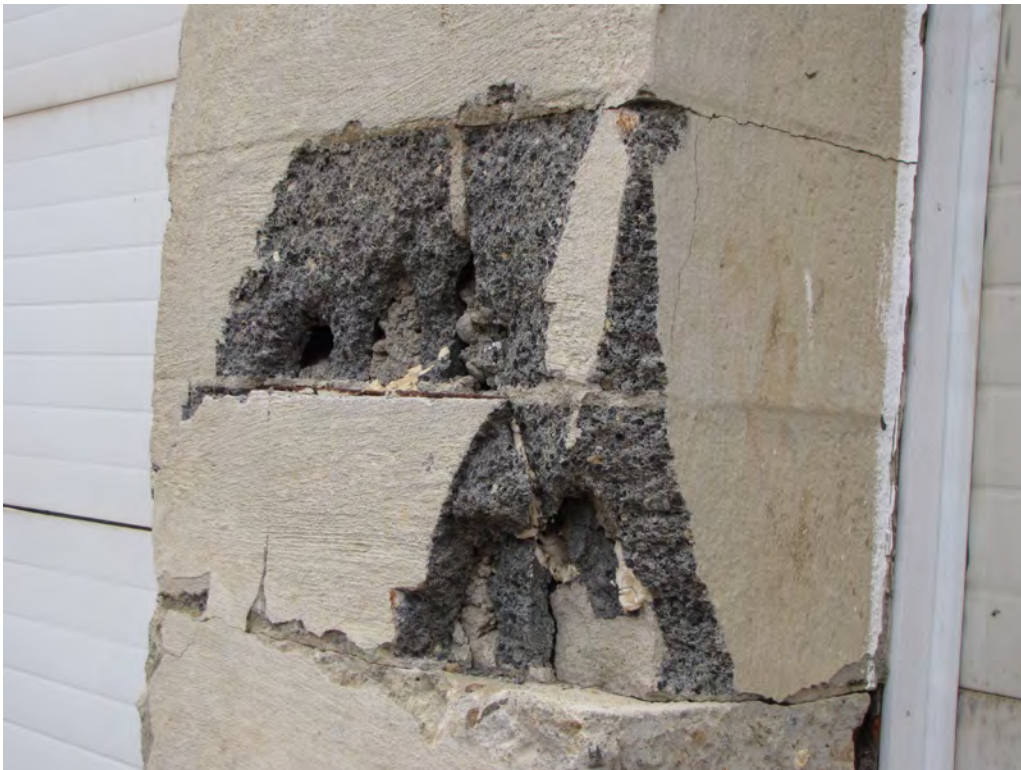
Photo 028: View of pier between two center overhead doors at top of concrete. Damage to masonry is likely due to impact by vehicles or equipment. Masonry has translated towards the inside of the building.

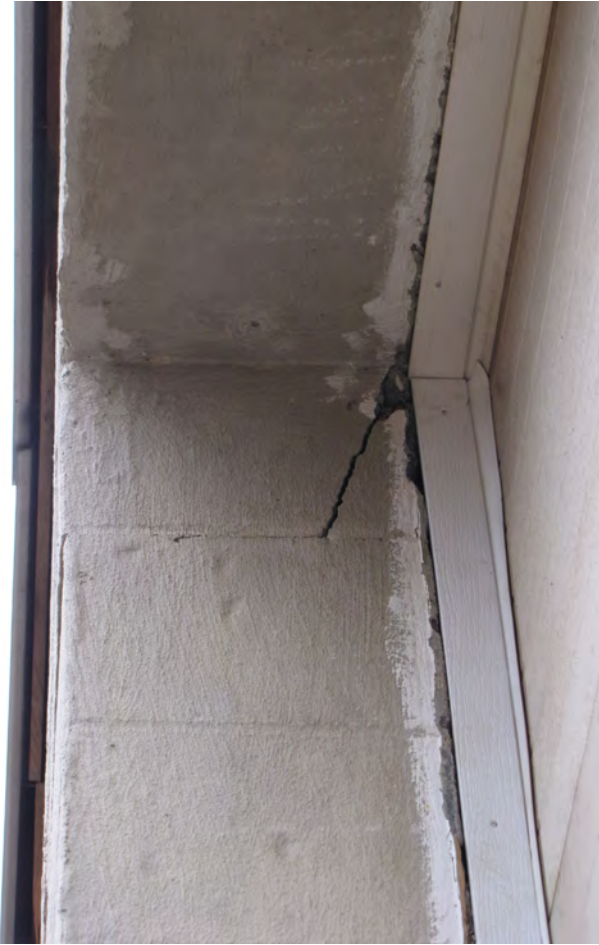
Photo 029: Crack in top of center pier between overhead doors, showing translation of block below top course.

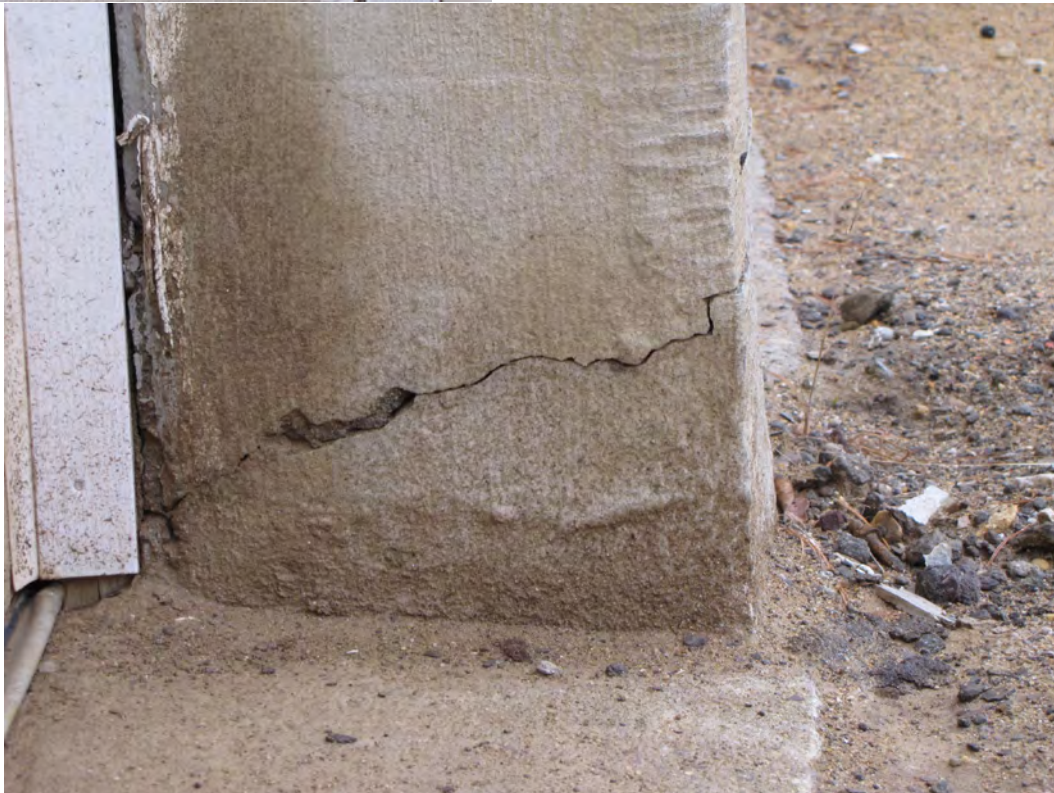
Photo 033: Crack at bottom of concrete center pier at overhead doors. Shear crack results from lateral impact force on exterior face of pier.

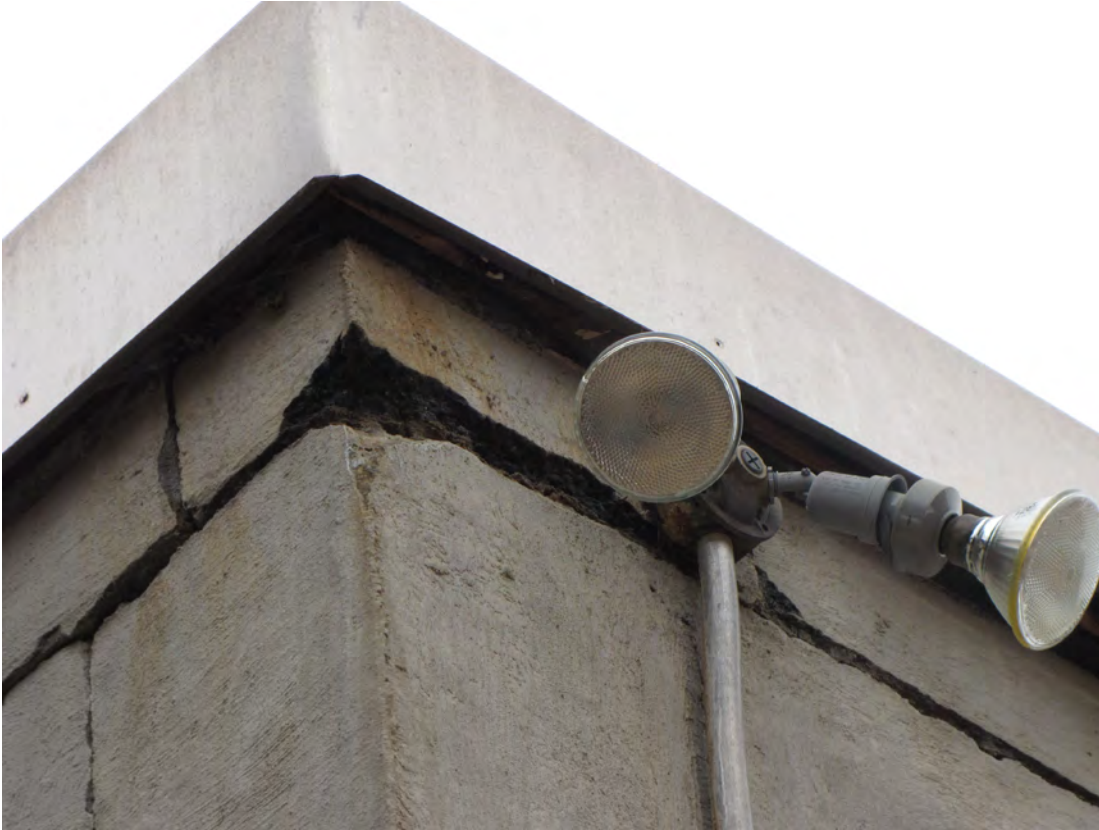
Photo 038: SW corner of building showing deterioration of block and mortar joint at top course of block.
