# FINAL REPORT

## EVALUATION AND ASSESSMENT SANBORNTON TOWN OFFICE & PUBLIC SAFETY BUILDINGS SANBORNTON, NEW HAMPSHIRE

FEBRUARY 1, 2017

The H.L. Turner Group Inc.

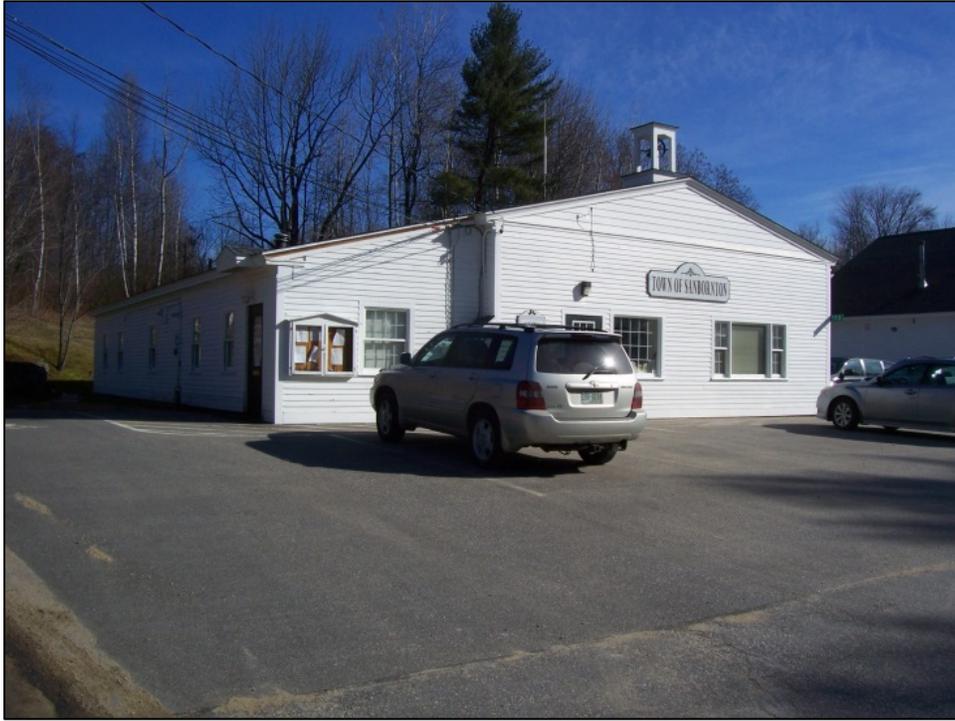
Potential to restripe spaces and relocate the accessible space.

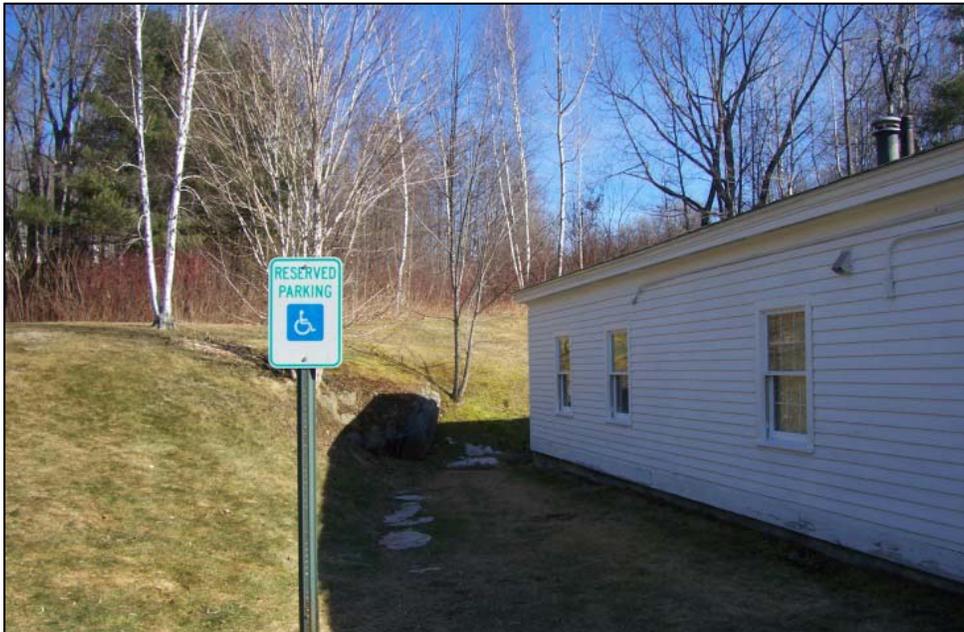
Add 'Van Accessible' sign to existing sign. Swale that ponds water seen behind.

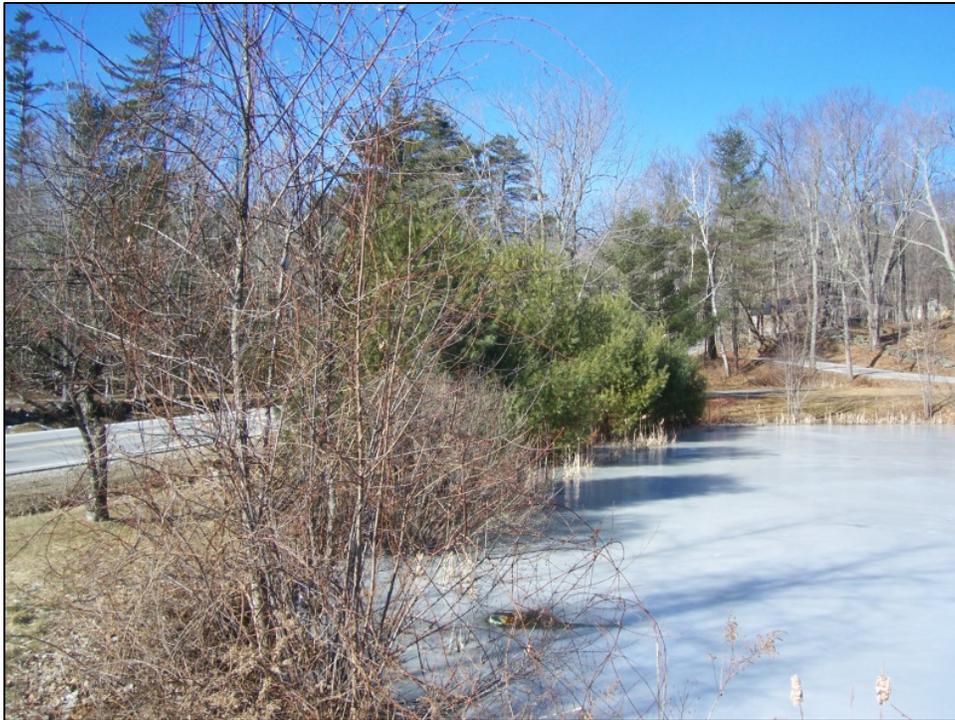
The constructed pond embankment paralleling Route 132 has several coniferous trees, shrubs, and other woody vegetation growing along the south and east sides of the pond. Although this pond does not appear to meet the NHDES criteria for dam classification, this vegetation is a concern as it can weaken the integrity of the earth detaining the water in the pond by providing conduits for water to seep through, potentially leading to an embankment failure.

Excessive growth along embankment of fire pond.

- Remove the trees, shrubs, and other overgrowth from the south embankment, between the pond and Route 132. Maintain the embankment as a grass-covered surface. Vegetation on the north, east, and west sides of the pond, where it is cut into the existing grade, can remain because there is no danger of an embankment failure in these areas.

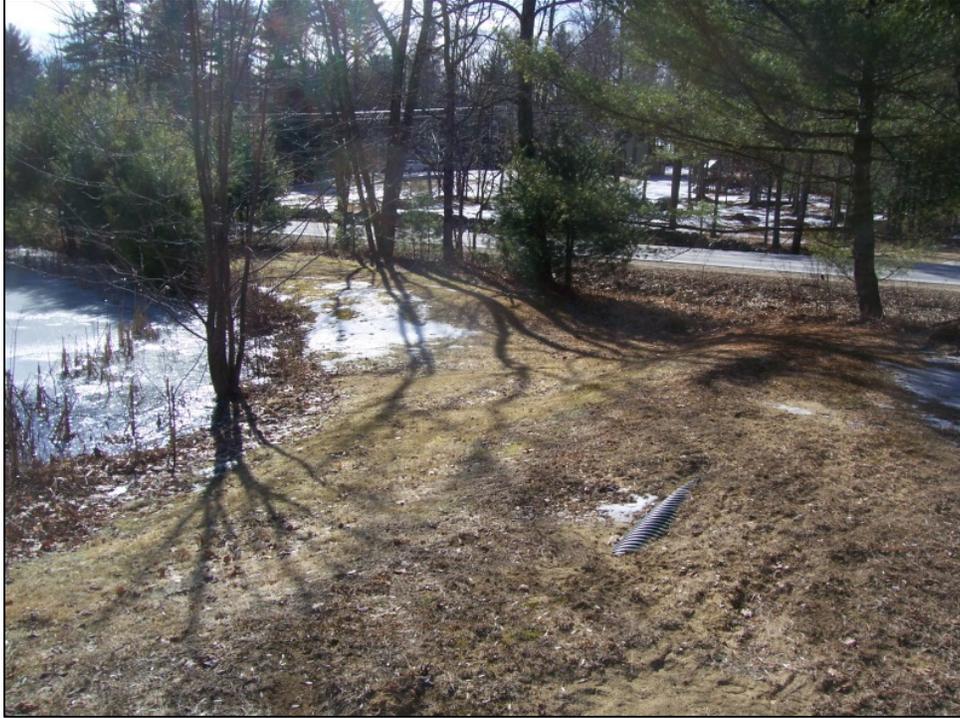
Fire pond emergency spillway and exposed HDPE pipe.

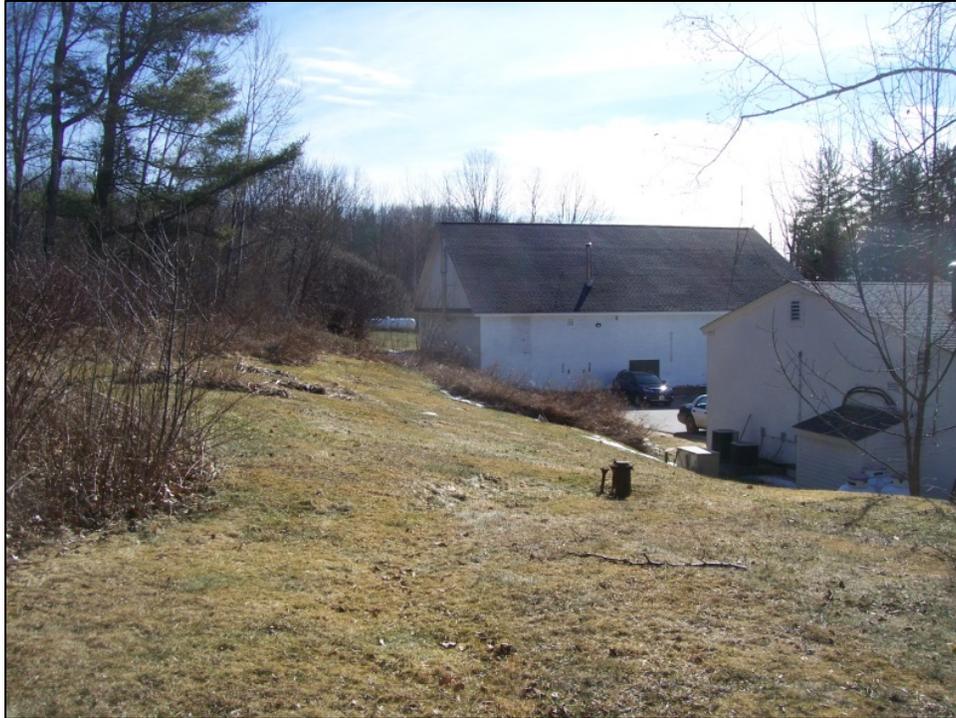
On the north side of the building there is a grassed and wooded slope of some significance that slopes toward the building. It is important that the Town maintain adequate drainage on the north side of the building to move any stormwater runoff and snowmelt away from the foundation. During spring thaw and after rainfall events groundwater seepage ponds on the north side of the office building. There is some evidence of the ground settlement at the foundation, particularly where the addition with the oil storage tank meets the original building. Water drains back toward the building in this area. Two catch basins (one with a square inlet and one with a round inlet) at the northwest corner of the building help drain some of this runoff, but the ground has settled around them, leaving the inlets higher than surrounding grade. Water ponds around the perimeter of the grates until it evaporates or seeps into the ground. The structure with the round inlet grate consists of stacked masonry blocks and the water pooling around the inlet grate seeps through the joints between the blocks and into the basin. Over time, this leakage can create sinkholes and lead to structure failure, as well as increase the sediment loading in the discharge water. The basin has a 4-inch diameter PVC pipe exiting eastward, toward the fire station. We suspect it ties into the foundation drains, which discharge into a catch basin along the edge of Route 132 in front of the Town Office building, but there are no existing utility plans to confirm this.

Slope on north side. Construct swale between exposed wellhead and generator.

- Create a vegetated swale running perpendicular to the slope on the north side of the building to intercept runoff and channel it around the building, to reduce the amount of standing water and saturated soils against the foundation on the north side of the offices. Position the swale approximately a third of the way up from the toe of the slope so it can also protect the generator by intercepting runoff immediately upstream of this unit, helping to protect it from water and ice damage.

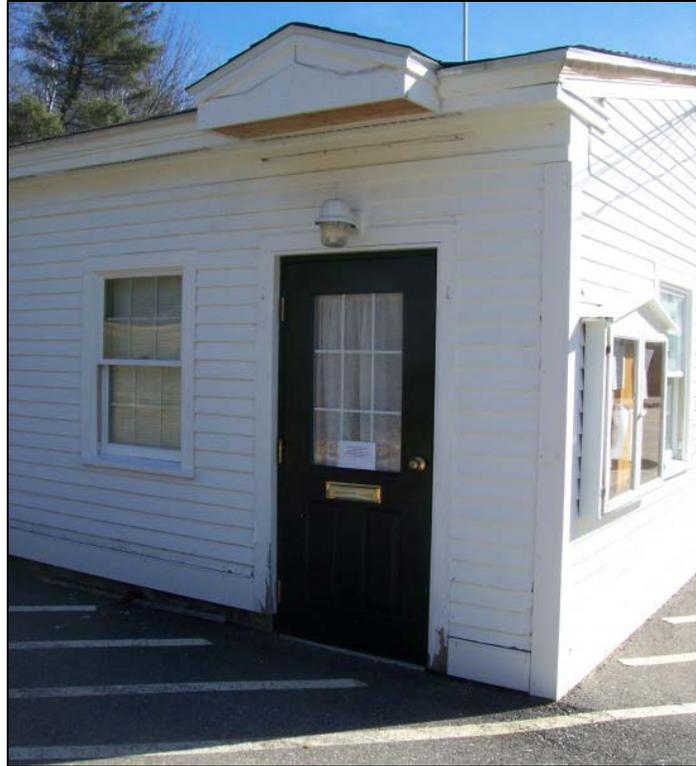
Door at southwest corner with infiltration problems at sill.

- Install a trench drain or similar inlet to capture runoff in front of the exterior door at the southwest corner of the building.
- Regrade the non-paved areas abutting the foundation to ensure the ground slopes away from the building. Consider installing a stone lined drip edge with a perforated pipe around the perimeter of the building where there is no pavement, to collect stormwater and snowmelt and pipe it away from the structure.

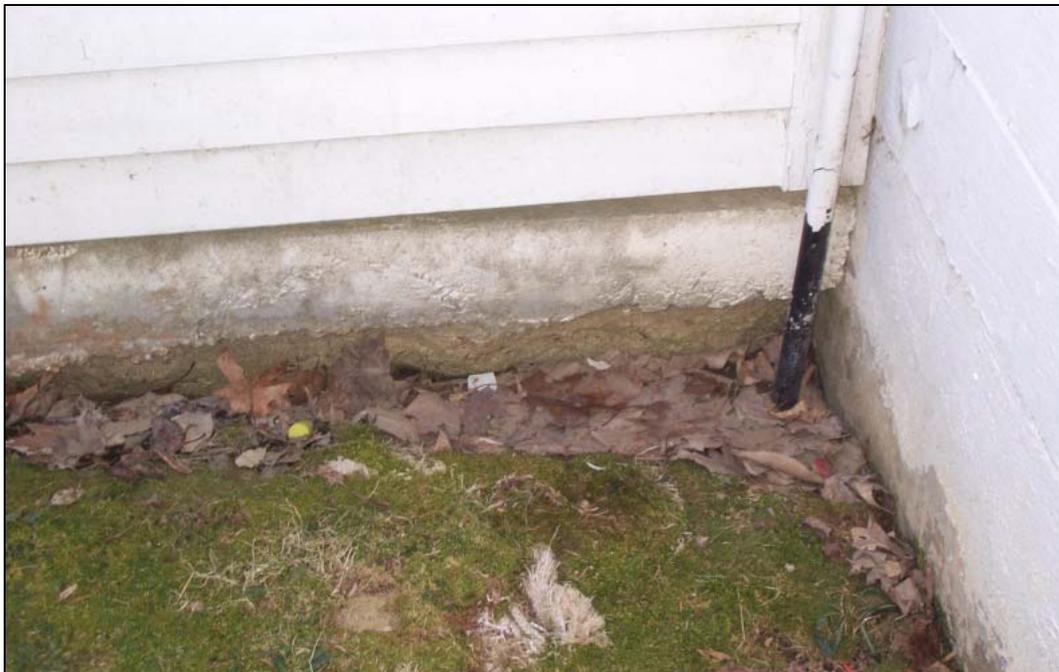
Ground sloping back toward building.

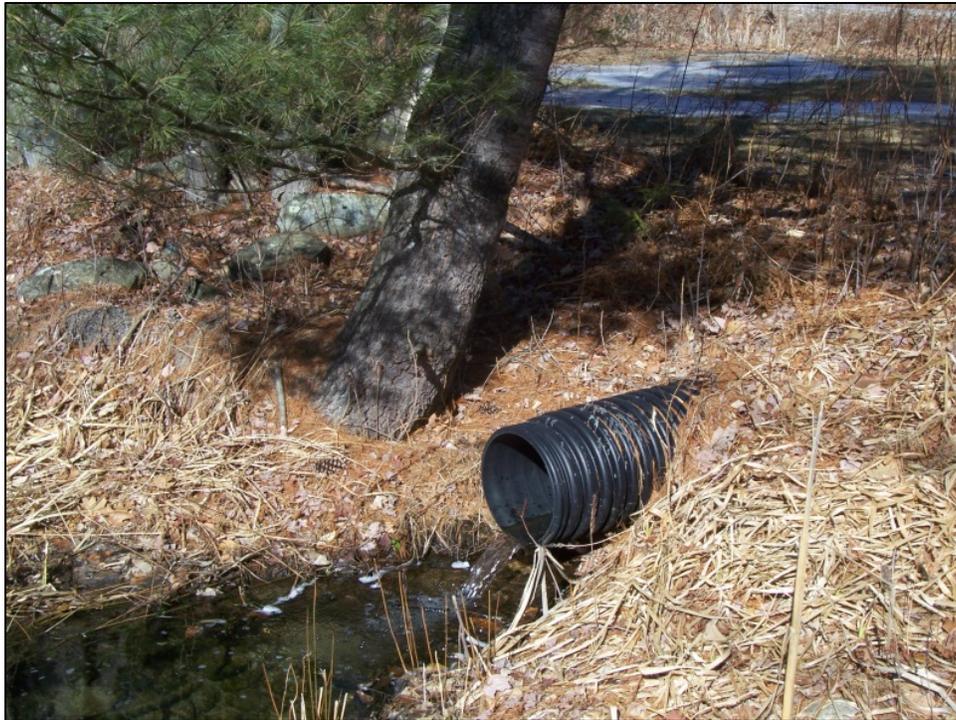
HDPE outlet and scoured outfall.

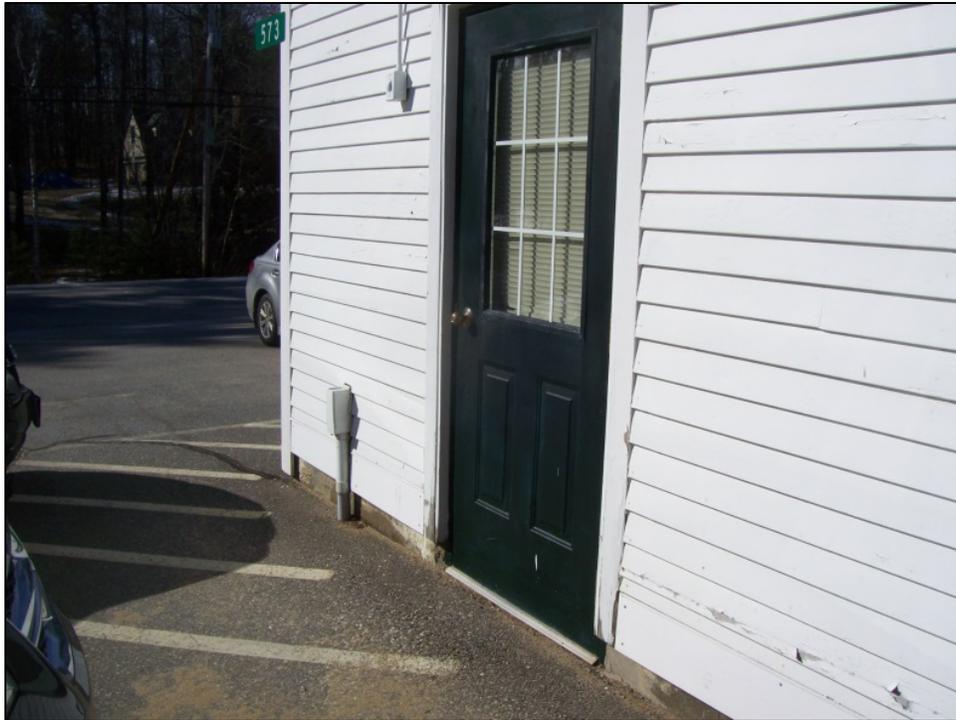
Non-ADA compliant exterior door.

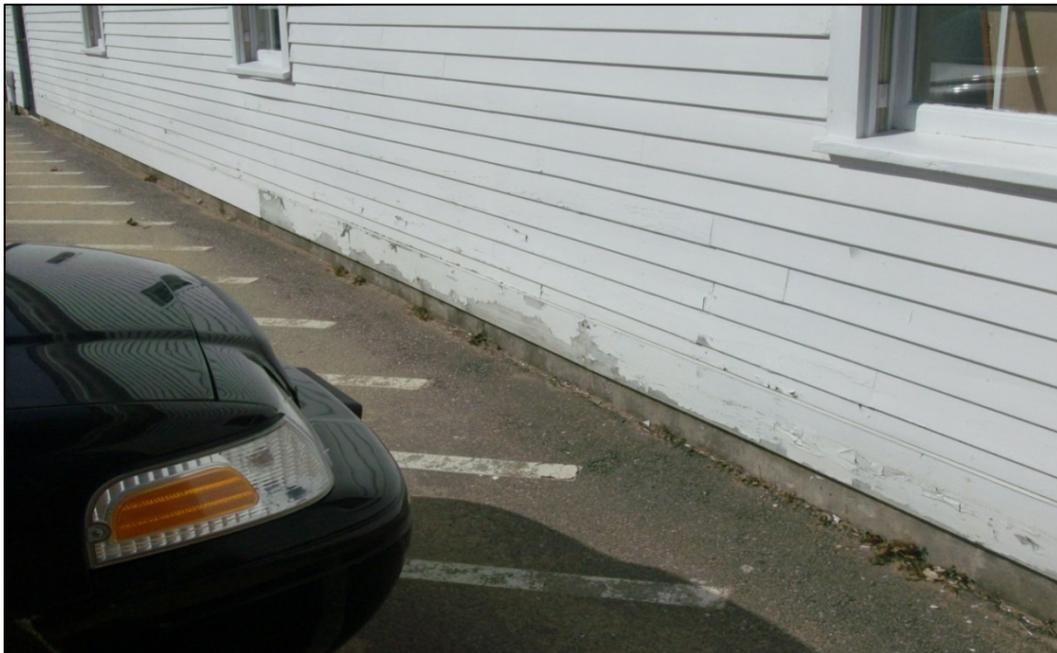
The roof is covered with a traditional 3-tab asphalt shingle. The shingles appear to be in very good condition. The front (south side) as well as the east and west sides of the building have been clad with wood clapboards. There are wood trim boards at the eaves, soffit, corners and along the water table at the base of the walls. In some areas the paint is cracked and is starting to peel. The wood trim is more in need of scraping and painting than the clapboards, but the walls will need painting within the next 2 to 3 years. The same applies to the wood cupola straddling the ridge near the front section of the roof as it shows signs of peeling and flaking paint.

East Side of Town Office Building. Note peeling paint.

- Monitor the condition of the exterior coatings on the wood trim, clapboards and CMU wall and sometime within the next 2 to 3 years, make plans to scrape and re-paint the building.

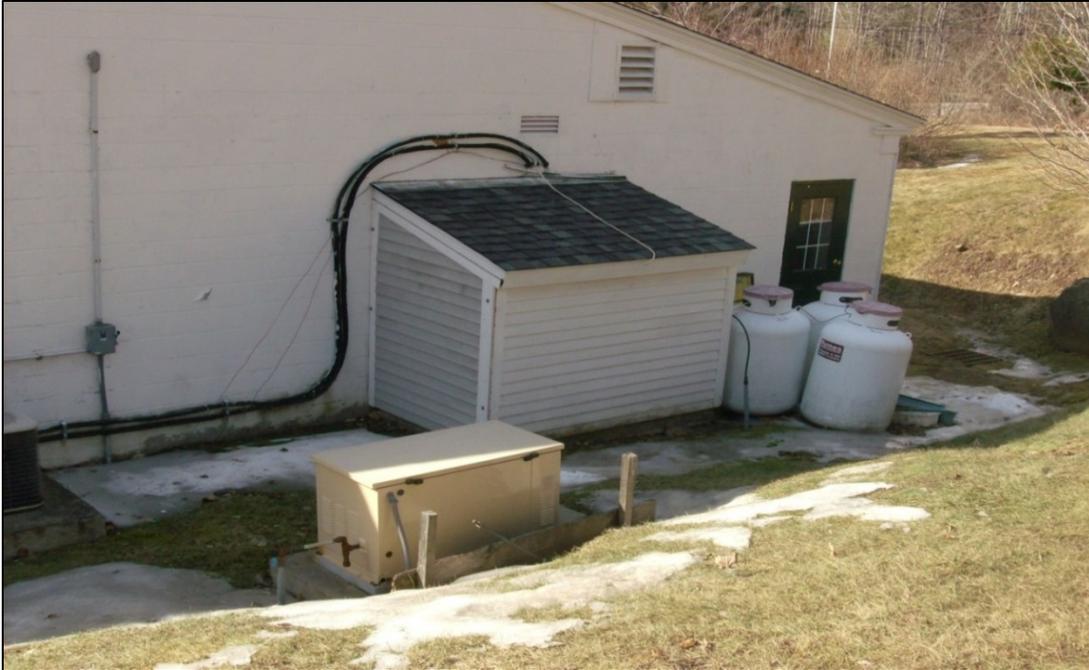
The north or rear of the building is the exposed CMU masonry block. The block has been painted but there are a few spots where the paint is blistered and starting to peel. The peeling and blistering paint is indicative of excessive moisture trying to make it's through the wall.

Rear of Town Office Building.

Note: CMU construction, propane fired generator, and storage area for oil storage tank.

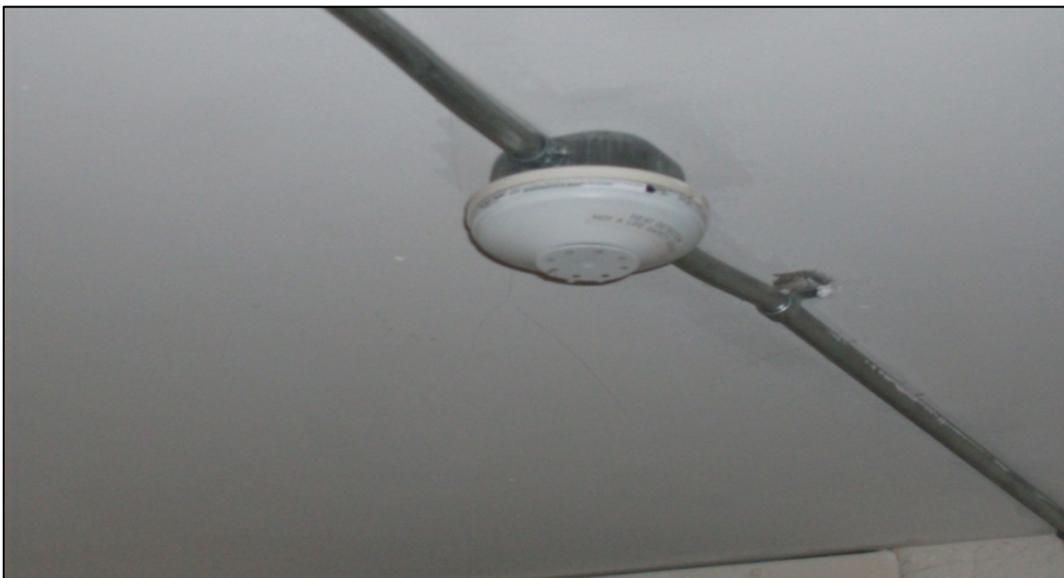
Typical smoke alarm located throughout the building.  
There are two pull stations; however there are no horns or strobes.

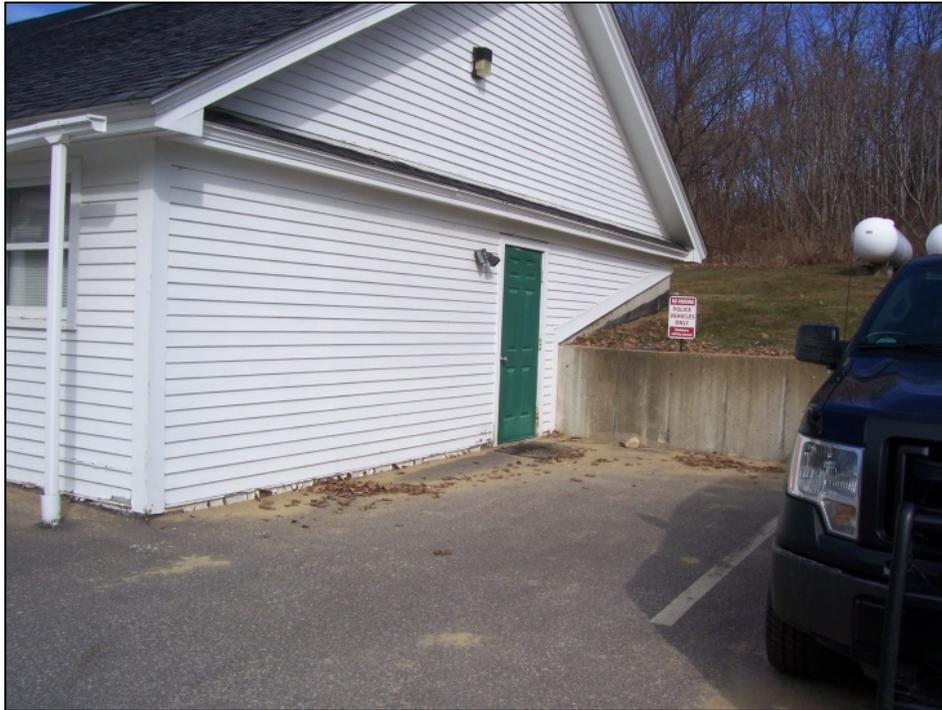
At the east end of the building there are four spaces reserved for police department vehicles. One of the spaces is adjacent to an exterior door, which may be partially blocked if a vehicle is in the space. The parking spaces and access driveway slope toward Route 132, and may become icy and hazardous conditions during cold weather.

Conflict between parking space and exterior door.

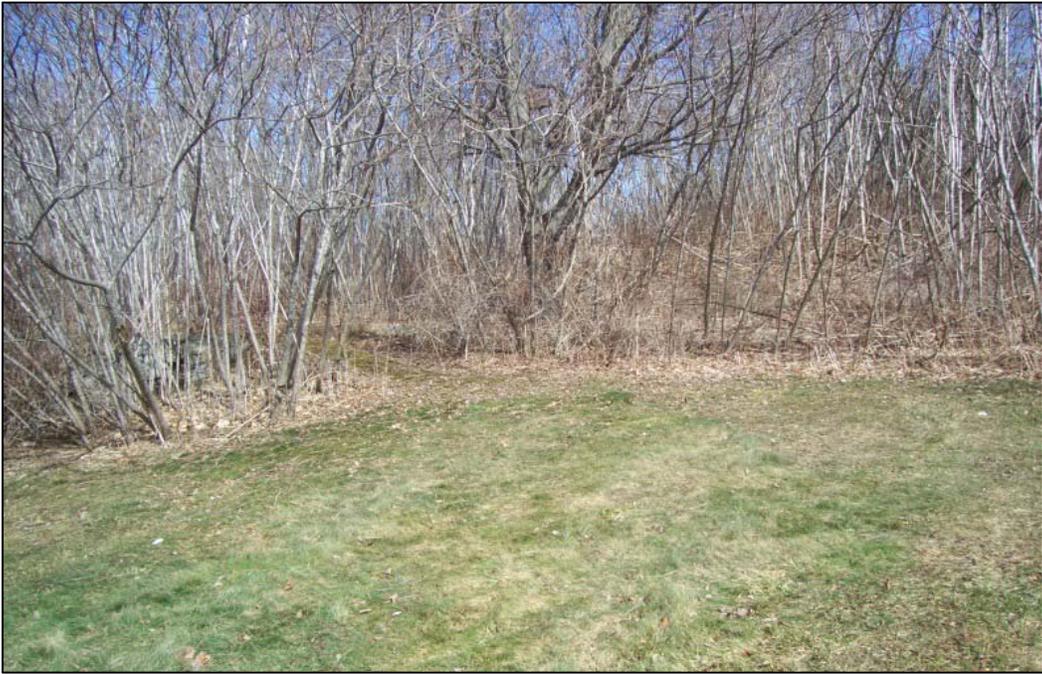
The EDA is on a slope, approximately 20 vertical feet higher than the grade at the rear of the PSB. According to record design drawings located by TTG, the EDA is a pressure distribution system and consists of 1 ¼" perforated PVC pipes that disperse the pressurized effluent into a stone bed, from which it infiltrates into the ground. The terrain above the EDA is overgrown with trees and dense shrubs, and there are animal burrows in the side slopes.

Dense woody growth over effluent disposal area.

- Completely remove the vegetation from atop the EDA and fill in any animal burrows. Reseed to ensure a dense stand of grass will cover the EDA. Assess its condition, looking for any signs of system failure, such as liquid seeping out through the side slopes or breaching the surface. As noted in the Town Office Building section of this report, TTG suspects that in addition to the wastewater from these two facilities, some groundwater and runoff from behind the Town Office Building drains into a septic tank and is eventually pumped into the EDA. This creates an additional hydraulic load on the system, for which it was not designed, which increases the risk of premature system failure.

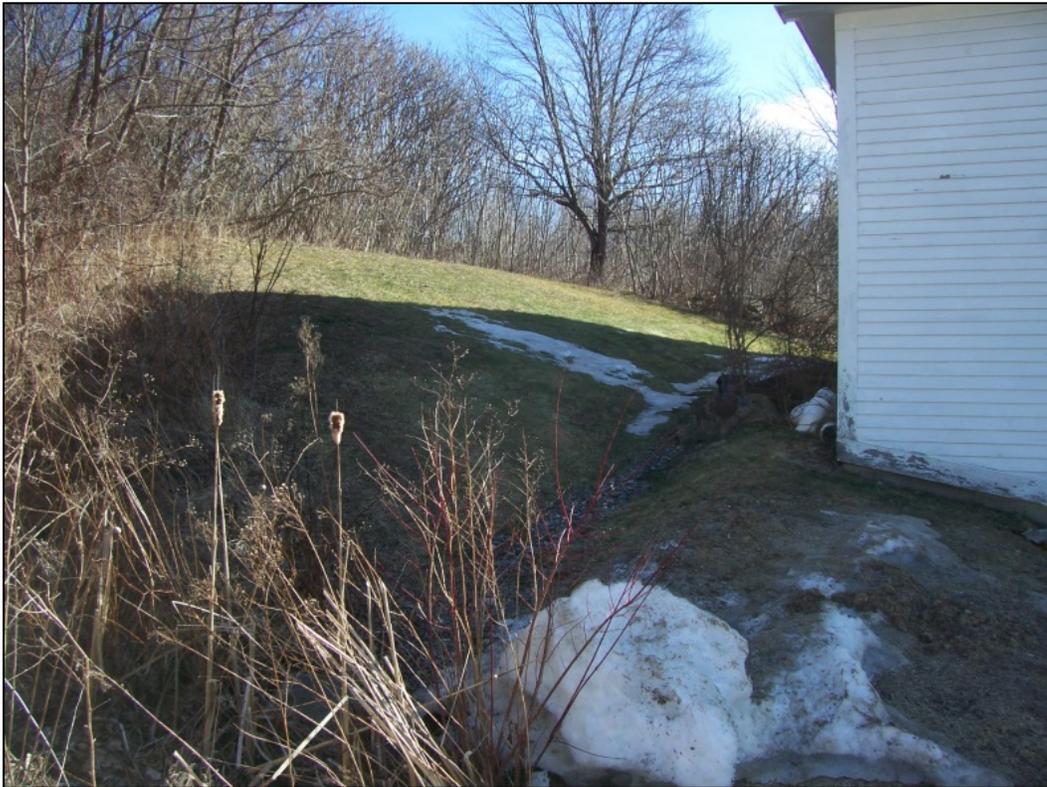
On the north side of the building, similar to the condition at the Town Office building, the ground slopes upward for several hundred feet. The terrain is grass-covered and densely wooded. Behind the apparatus bay, a shallow swale intercepts runoff from this slope. It is inadequate to manage runoff significant rainfall or snowmelt events.

Shallow swale behind apparatus bay.

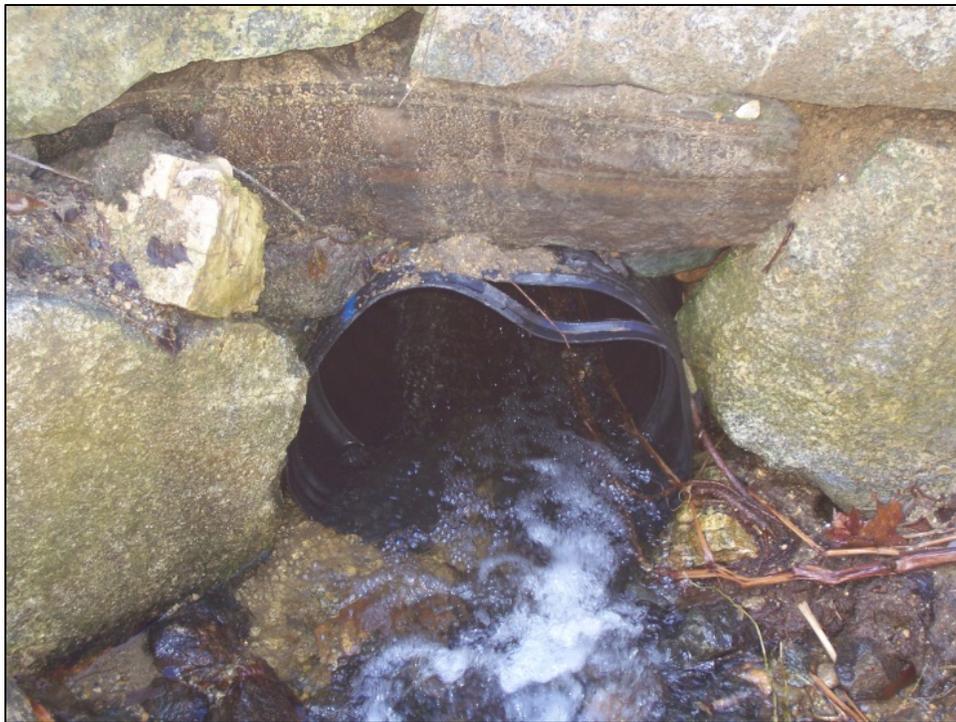
Deformation at culvert inlet.

- Video-inspect the culvert beneath the pavement to verify it is functioning properly, that it has not deflected, and that it is not leaking water through its joints. If there are any signs of distress or leakage, additional measures may be warranted, such as relining or replacing the culvert. The Town should ensure the integrity of this pipe with regular annual inspections. Reconstruct or replace the headwall at the upstream end to prevent water from seeping through the joints.

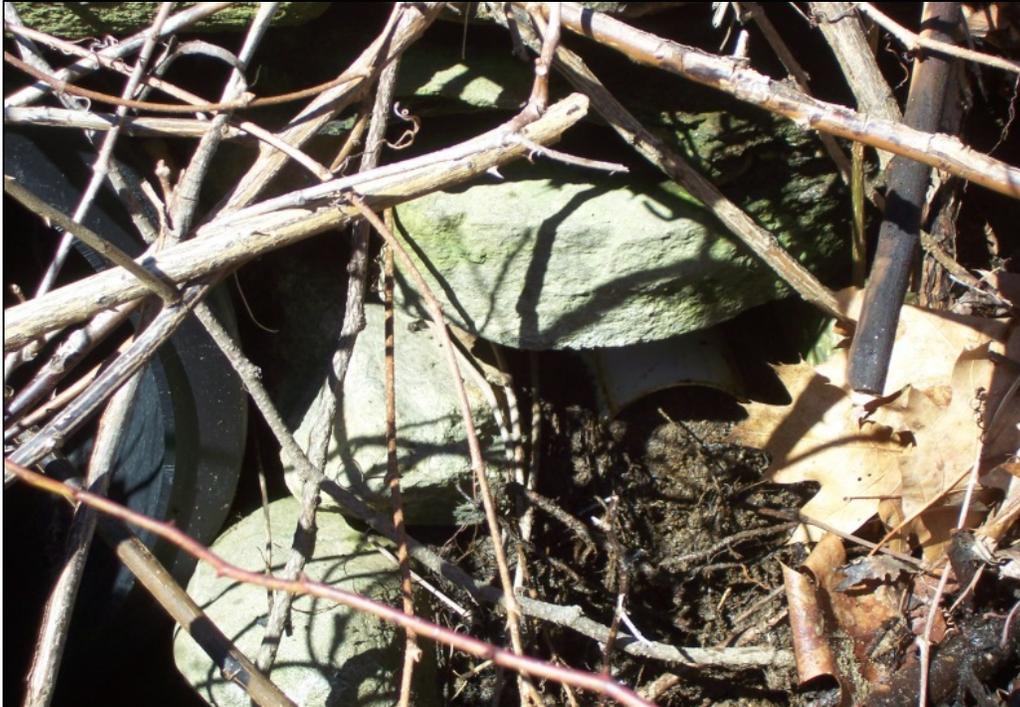
Clogged 4-inch PVC pipe at headwall.

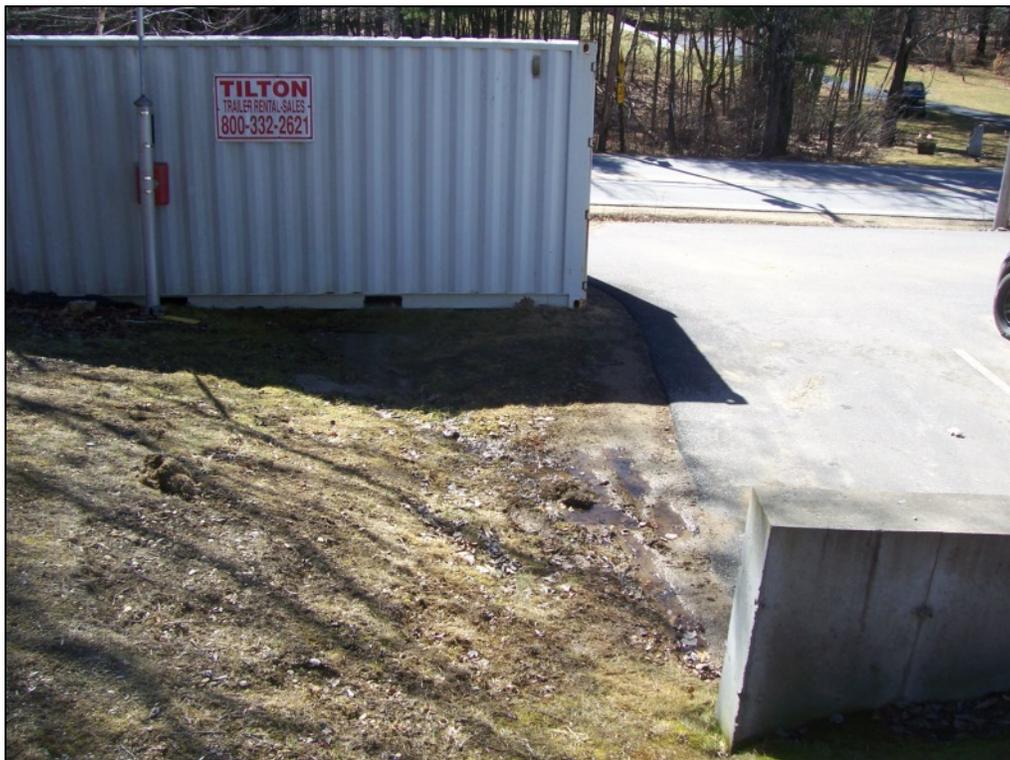
Concentrated runoff flowing past retaining wall.

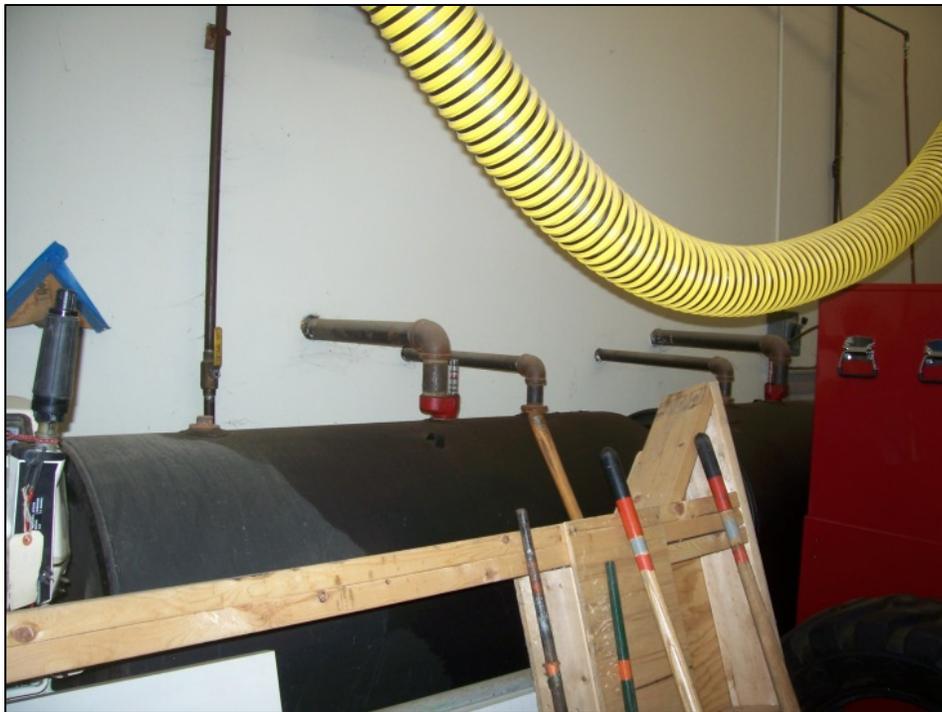
Apparent leakage on oil tank surface.

- Install a spill kit adjacent to the oil storage tanks inside the apparatus bay. Inspect the tanks regularly for leaks, signs of distress, or other problems.

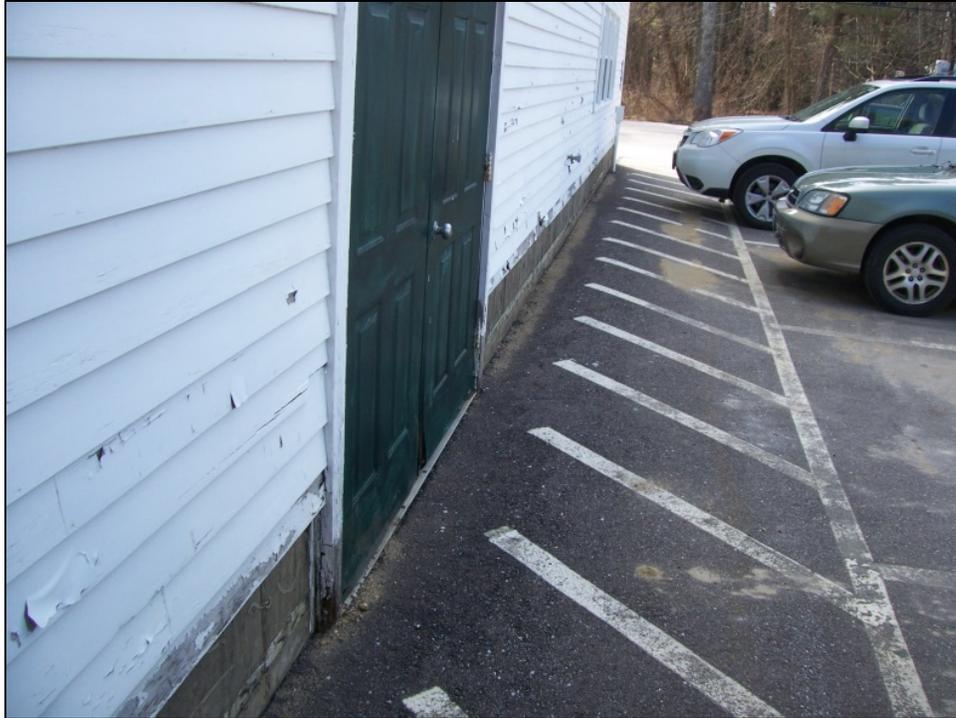
The steel double doors on the west side of the apparatus bay are corroding near the sill because the parking lot allows runoff to drain back toward the building. This is also a possible source of water intrusion into the apparatus bay.

Slope back toward foundation and corrosion at exterior doors.

- Consider installing a trench drain or similar stormwater inlet structure, such as a catch basin, in front of the double doors on the west side of the PSB to prevent water from sitting against and leaking under the doors.

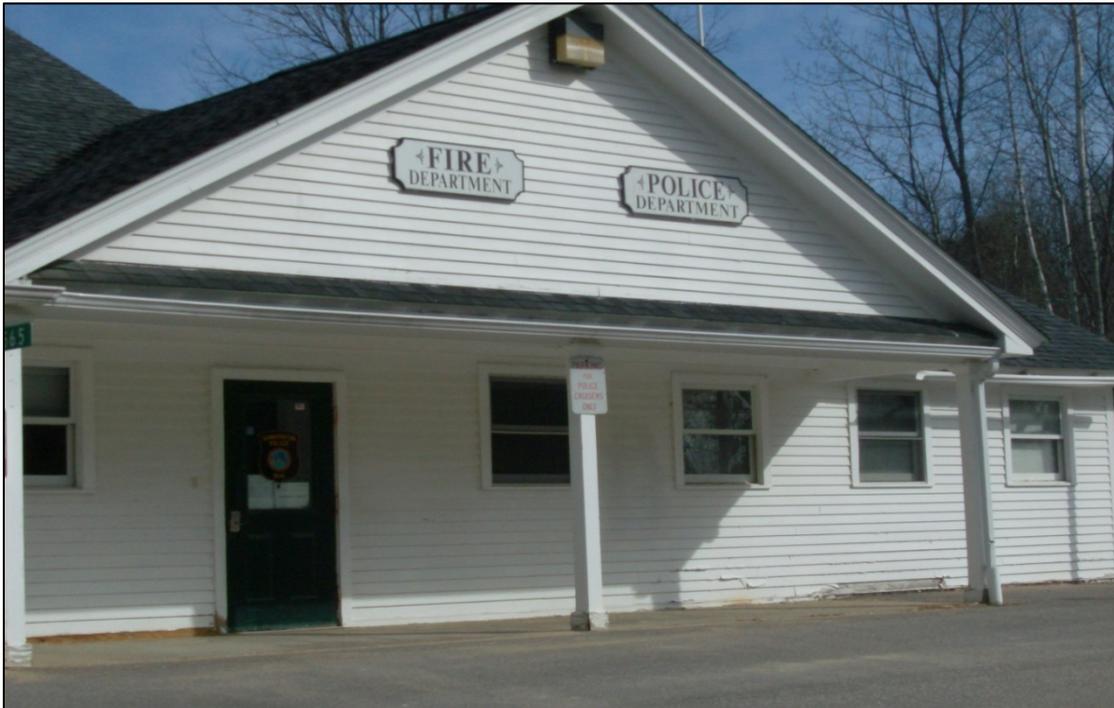
Main Entrance for the public. Note peeling paint along the lower section of the wall.

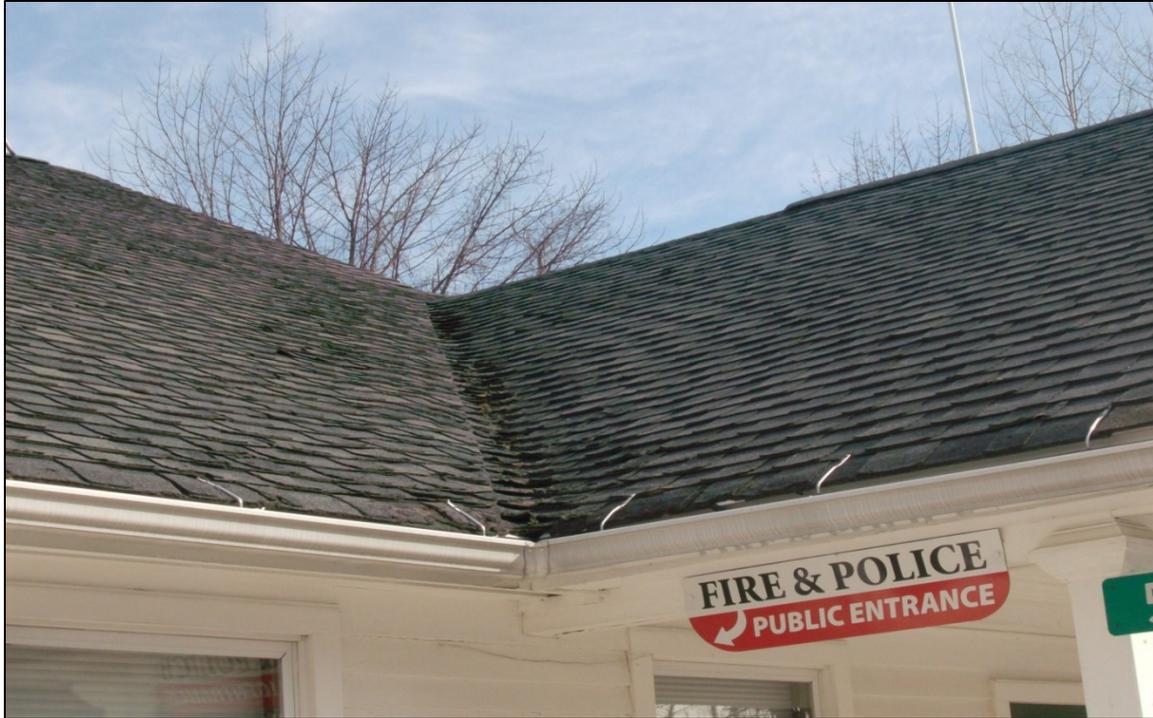
Roof valley with worn and deteriorated shingles.

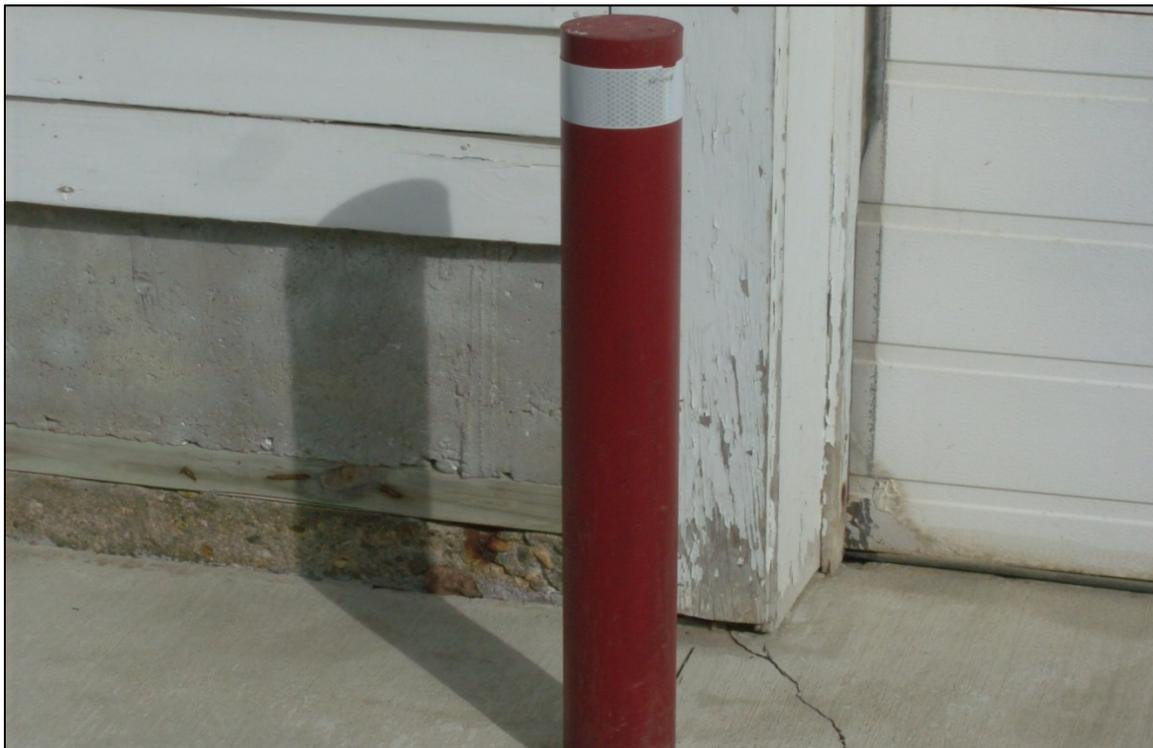
Bollard by overhead door. Note peeling paint and cracked concrete apron.

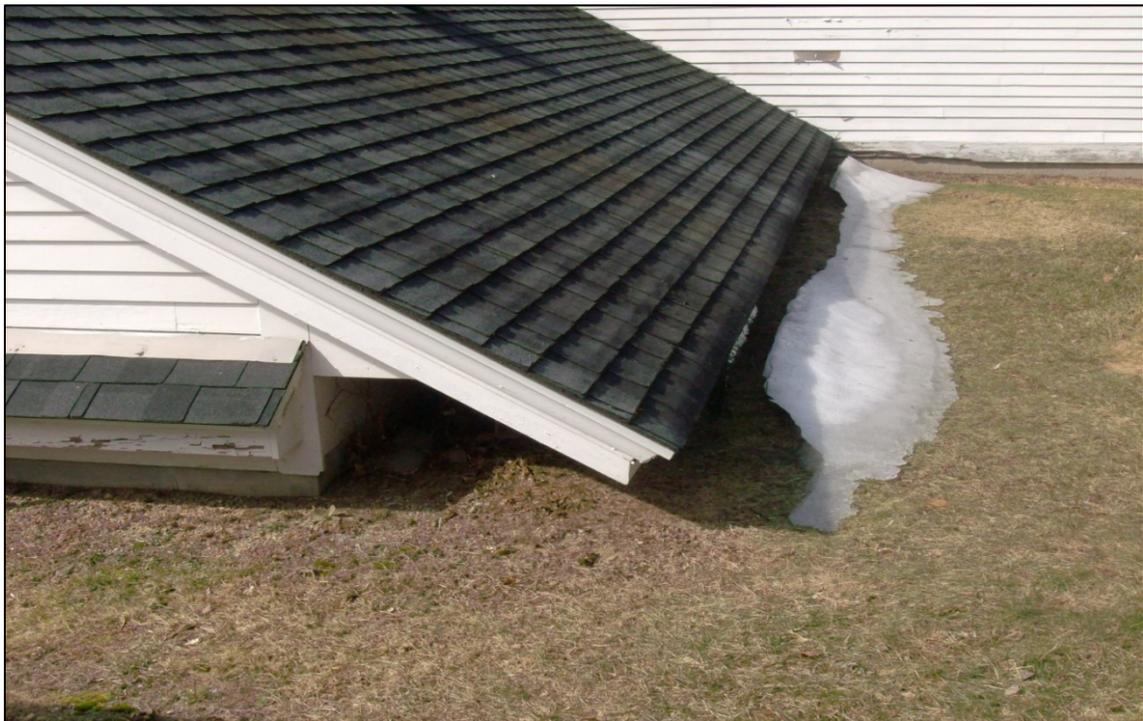
North roof only about 12-inches above grade.

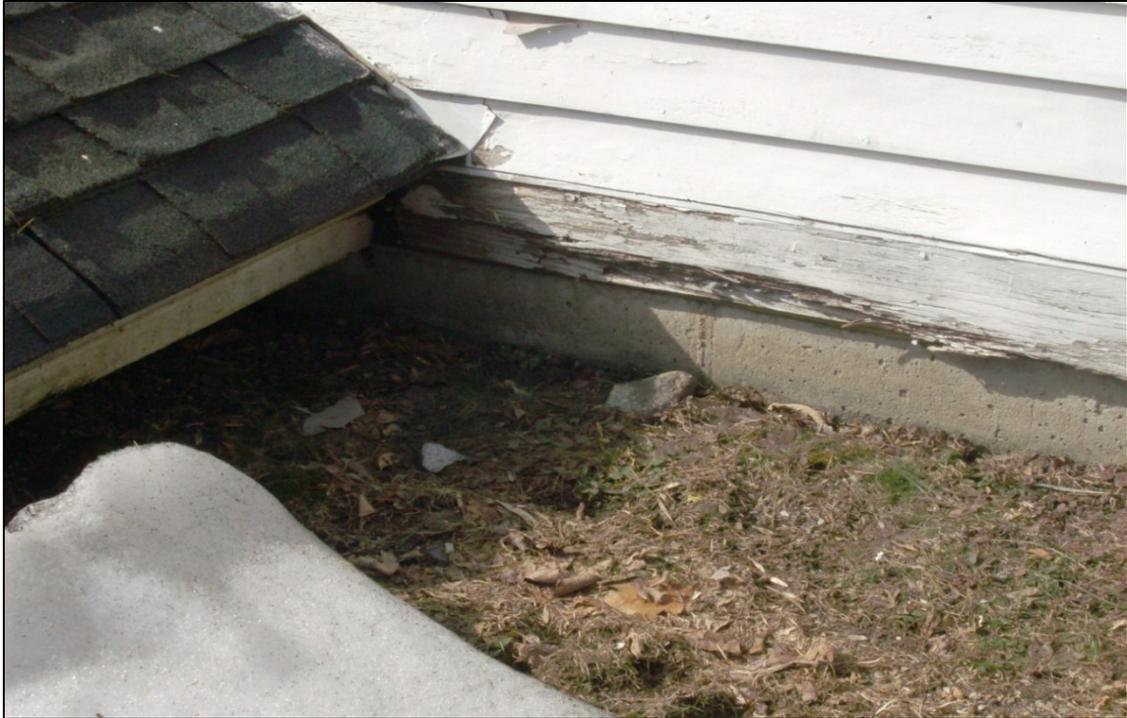
Peeling paint and rotted trim at intersection of roof and sidewall.

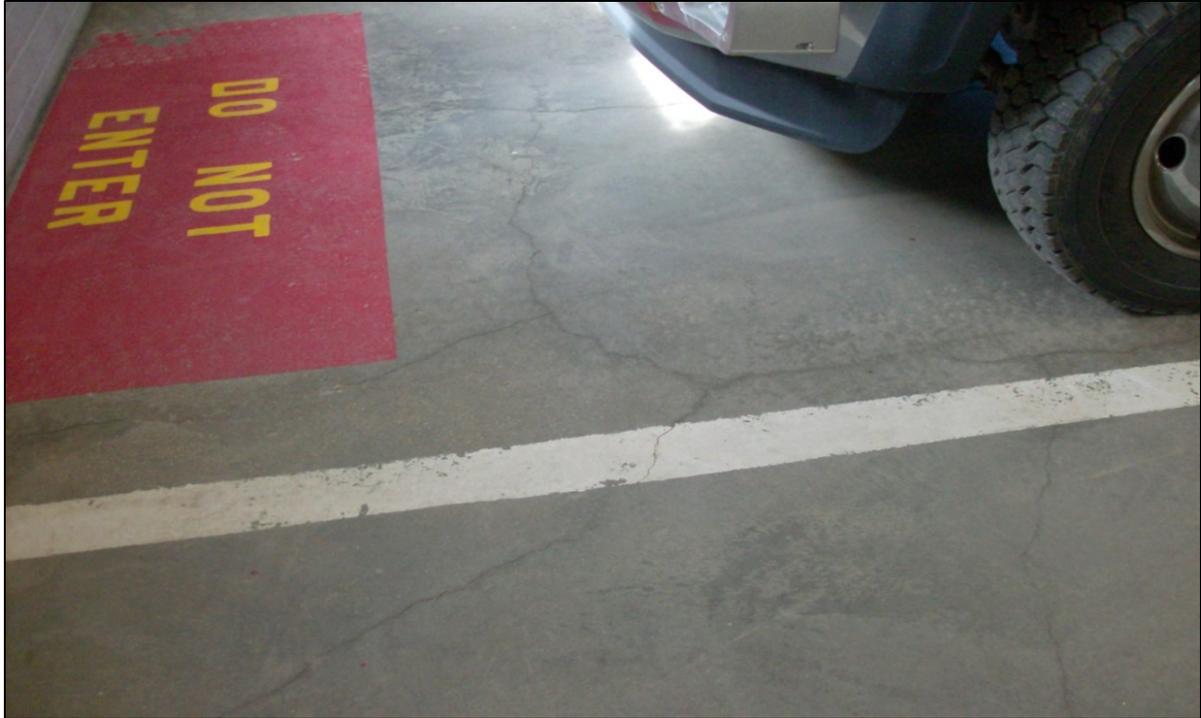
Hairline cracking in the floor of the apparatus bay.

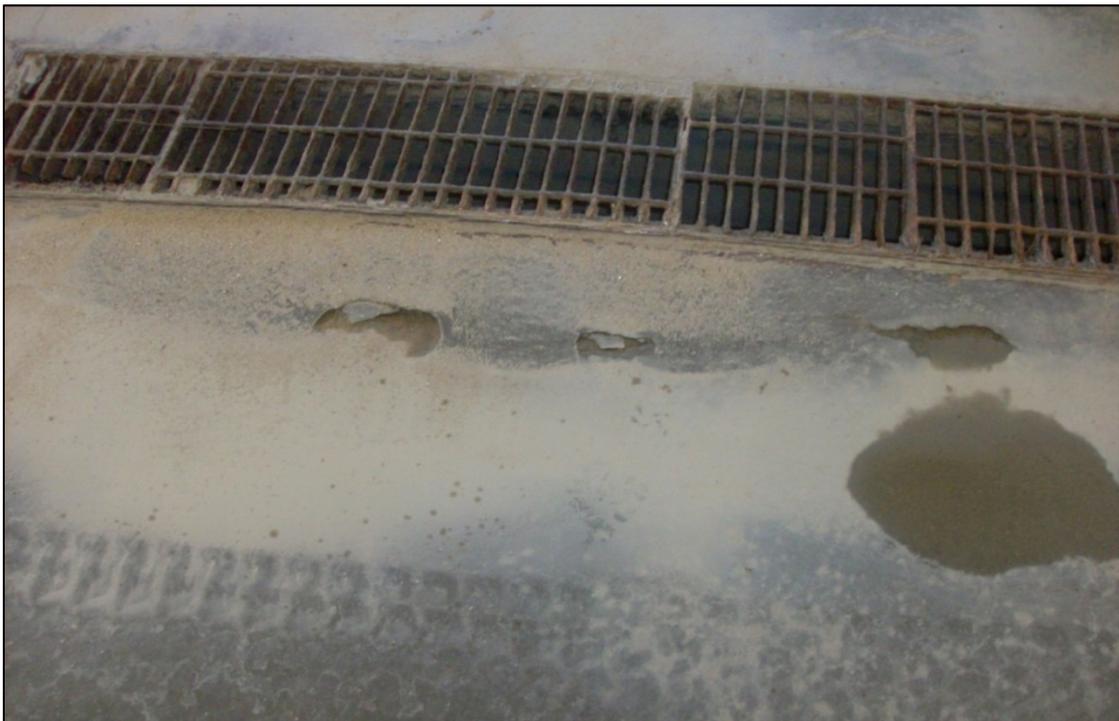
Spalled and depressed concrete around floor drain in apparatus bay.

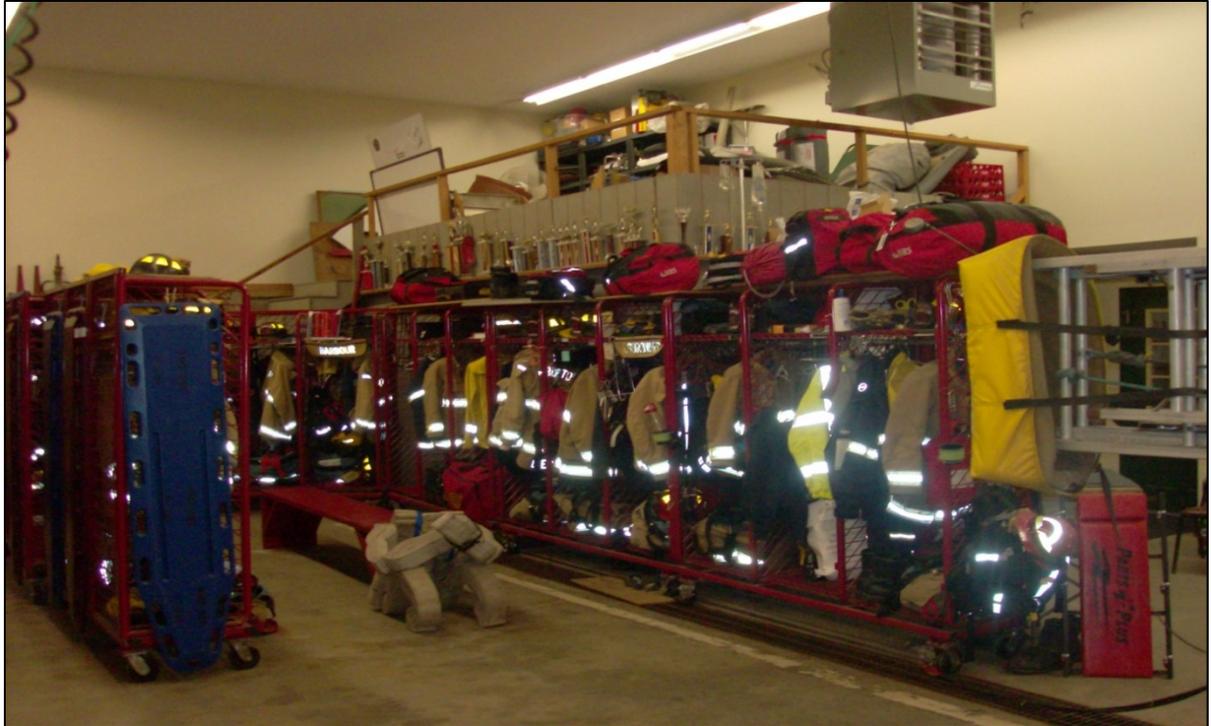
Limited space available for equipment storage.
