Re: Dr. True Road – Gravel Roadway Evaluation Study
Sanbornton, NH
Gale 719100

FIELD OBSERVATION REPORT

PROJECT:	Dr. True Road
PROJECT No.:	719100
DATE:	March 22, 2023
CONTRACTOR:	None
LOCATION:	Sanbornton, NH
FIELD ENGINEER:	Scott Bourcier

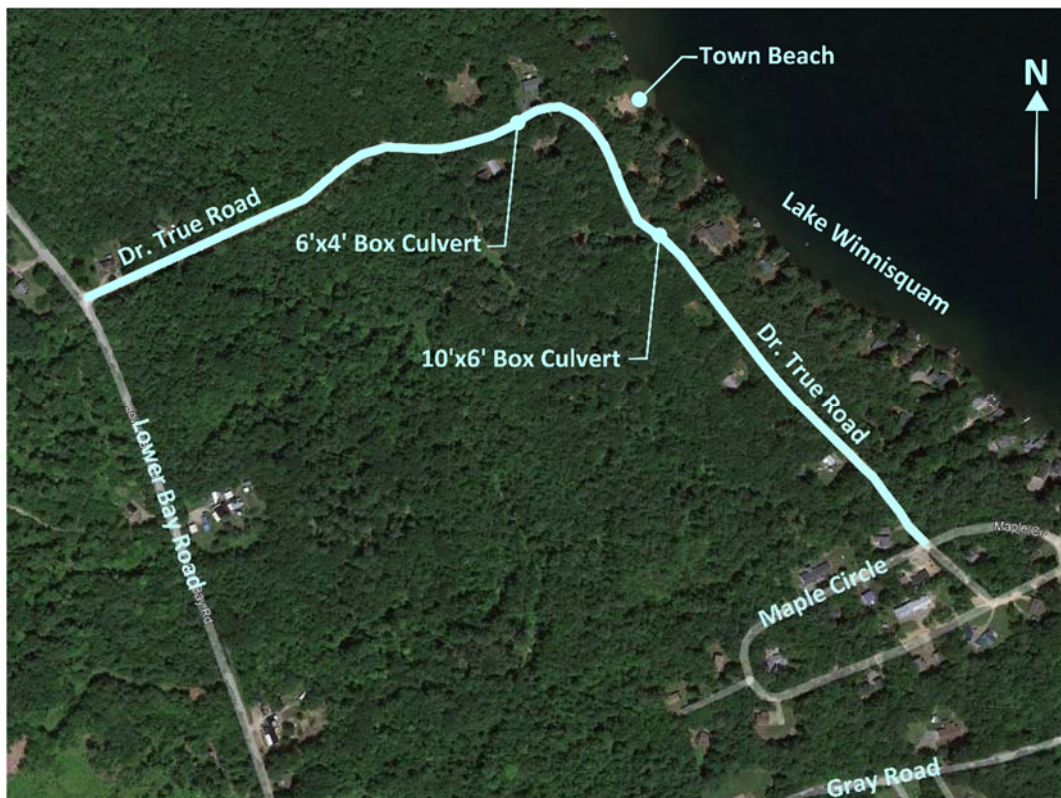
Figure 1 – Project Limits

Dr. True Road is an approximately 3,400 linear-foot long unpaved roadway located along the east side of Town, off Lower Bay Road, and adjacent to Lake Winnisquam; please see Figure 1. Based on the Town’s tax map, Dr. True Road services 70 residential parcels along the roadway and Maple Circle located at the end of Dr. True Road. In-line with other unpaved roadways within the Town, Dr. True Road is annually susceptible to moisture conditions associated with spring thaw. Residents, emergency vehicles, and the Highway Department have endured saturated gravel surface, compressible roadway materials, and surface rutting. Similar to other unpaved roadways within the Town, the Highway Department has attempted to stabilize the gravel surface with the placement of clean 3/4-inch crushed stone over the roadway surface. According to the Highway Department, while the corrective measure does stabilize the unpaved surface, the longevity of the improvement has not met expectations.

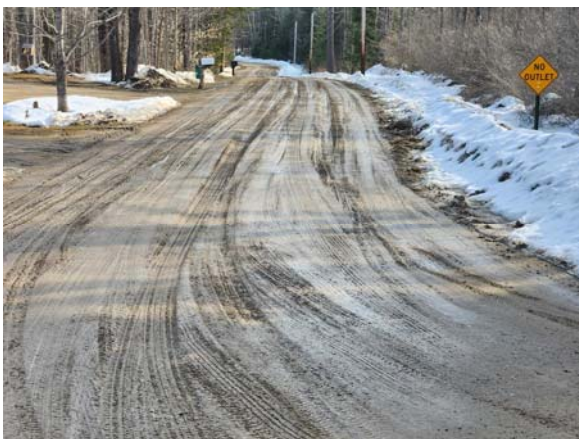
5. The following brief existing conditions inventory was performed.
 - a. Sta. 0+00: Intersection of Dr. True Road and Lower Bay Road, aerial utility located on right side (utility crosses both sides of roadway), drainage swale along on right side only.

- g. Sta. 34+20: Intersection of Dr. True Road and Maple Circle no drainage swale.
6. The following evaluation was performed.
- a. Gravel roadway: From approximate Sta. 0+00 to 4+00 the surface appeared to be saturated with evidence of approximate 2 to 3-inch deep rutting. The remaining length of roadway appeared to be compressible and saturated, with no evidence of rutting.

Figure 1 – Sta. 0+00 gravel roadway surface condition.

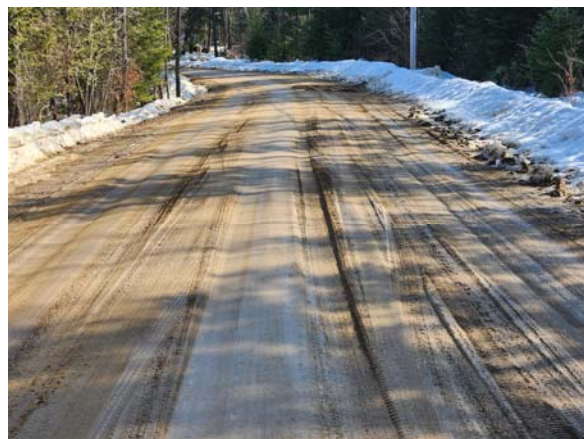
Figure 2 – Sta. 5+40 gravel roadway surface condition.

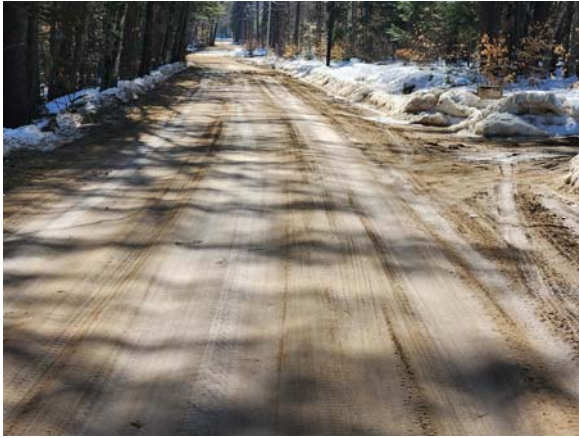
- e. Sta. 17+11: Town Beach, closed drainage infrastructure consisting of two (2) catch basin structures and associated pipe, no drainage swale.
 - f. Sta. 21+05: No drainage swale, 10' wide by 6' high pre-cast concrete box culvert.

Figure 3 – Sta. 21+05 gravel roadway surface condition.

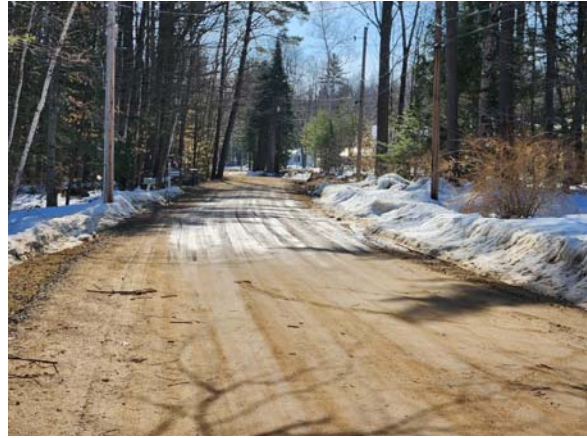
Figure 4 – Sta. 30+60 gravel roadway surface condition.

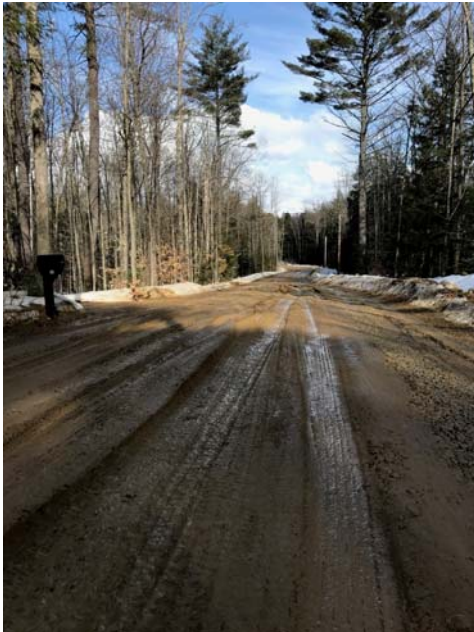
3. During the excavation of the test pits, resident Jeffrey Caira of 89 Dr. True Road inquired about the activities being conducted. I reported test pits were being performed, noted roadway material samples were being collected for analysis, and explained the Town’s goals. Jeff showed existing roadway conditions he has recorded, and (per my request) shared the photographs; see Figures 5 through 8. The date and location of the photographs are unknown.

Figure 5 – Photograph shared by Jeffrey Caira, unknown location and date.

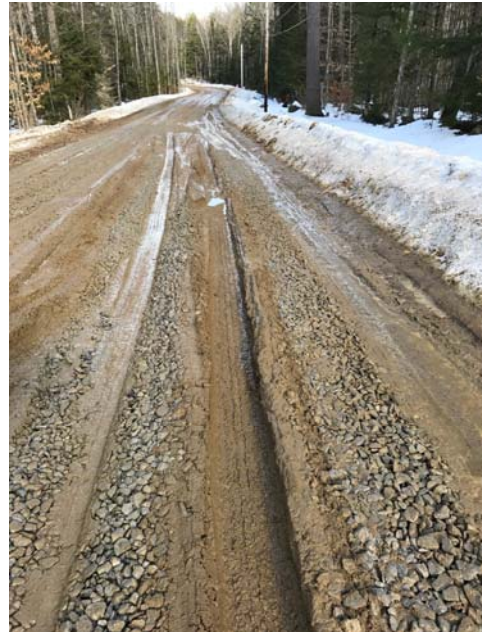
Figure 6 – Photograph shared by Jeffrey Caira, unknown location and date.

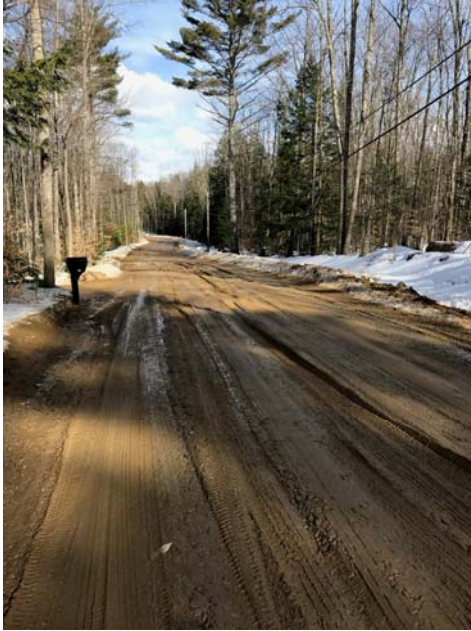
Figure 7 – Photograph shared by Jeffrey Caira, unknown location and date.

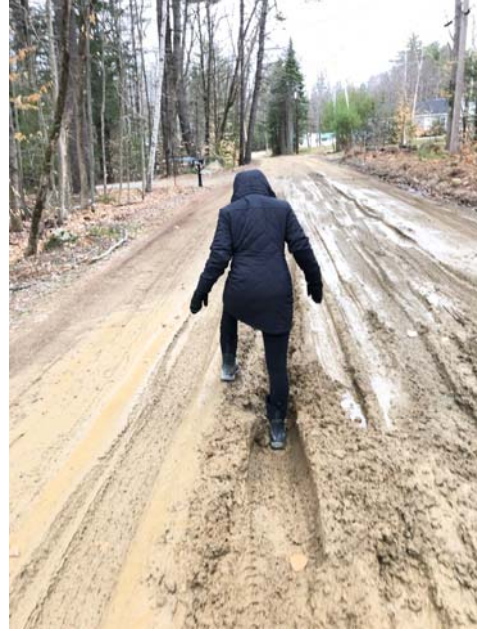
Figure 8 – Photograph shared by Jeffrey Caira, unknown location and date.

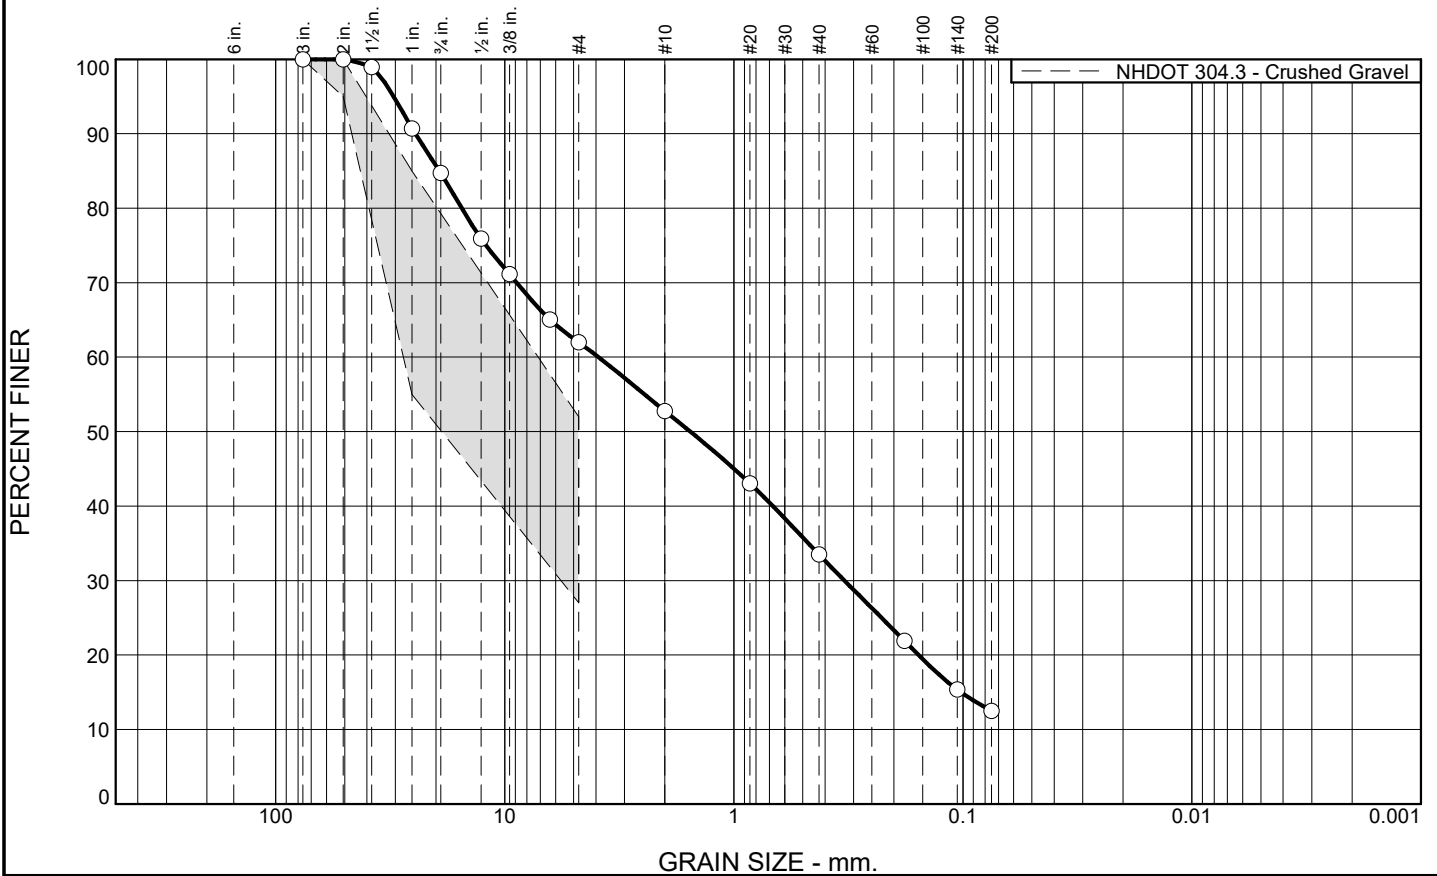
Location: TP-1
 Sample Number: Bulk

% +3"	% Gravel		% Sand			% Fines	
	Coarse	Fine	Coarse	Medium	Fine	Silt	Clay
0.0	15.3	22.7	9.2	19.3	21.0	12.5

SIEVE SIZE	PERCENT FINER	SPEC.* PERCENT	PASS? (X=NO)
3"	100.0	100.0	
2"	100.0	95.0 - 100.0	
1 1/2"	98.9		
1"	90.7	55.0 - 85.0	X
3/4"	84.7		
1/2"	75.9		
3/8"	71.1		
1/4"	65.0		
#4	62.0	27.0 - 52.0	X
#10	52.8		
#20	43.0		
#40	33.5		
#80	21.9		
#140	15.4		
#200	12.5

Soil Description
silty sand with gravel

Classification
 USCS= SM AASHTO= A-1-b

Remarks
 Natural Moisture Content: 6.3%
 20.2% passing the #200 sieve based on the portion the #4 sieve.
 Specification requires 0-12%.

The seven (7) gradation test results do not meet the NHDOT Section 304.3 specification. Copies of the sieve/gradation test results are included herein this letter.

The gradation analysis indicates the existing surface, base, and subbase roadway materials of Dr. True Road have a low content of aggregate (material larger than the No. 4 sieve), a high content of sand (material between the No. 4 and No. 200 sieves), and a high content of silt (material passing the No. 200 sieve). The issue with an unbalanced blend of aggregate and sand base materials is it can impact the roadway structure's ability to support vehicular loads. This issue can be corrected by the addition of specified size and quantity aggregate materials to the base course. The issue with high silt content is that it can retain a high moisture content. While moisture can help to bond/stabilize the aggregate and fines, too high of a moisture content can impact the structural stability of a roadway.

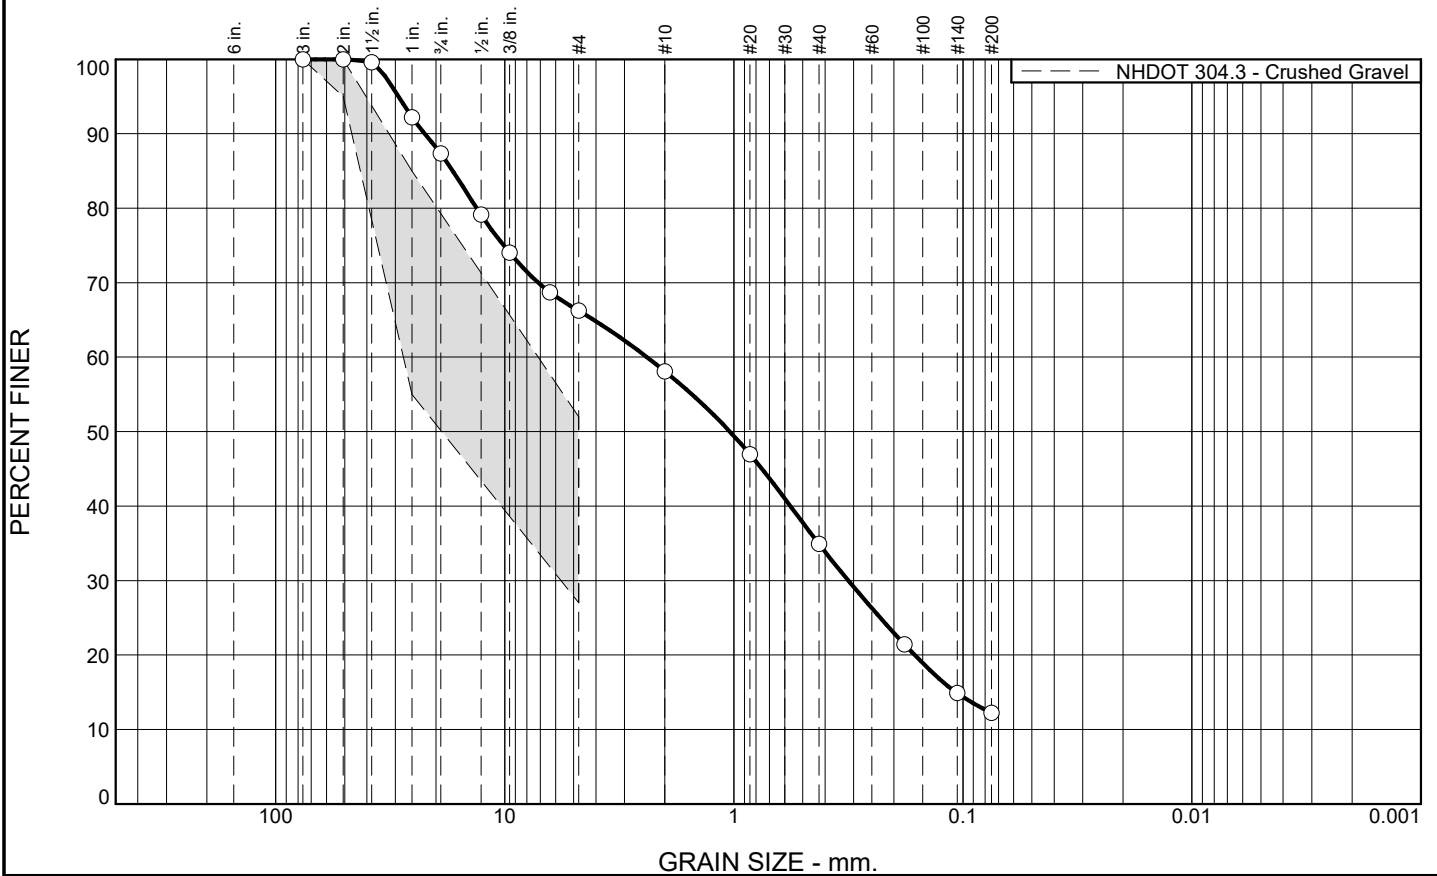
Location: TP-2
Sample Number: Bulk

% +3"	% Gravel		% Sand			% Fines	
	Coarse	Fine	Coarse	Medium	Fine	Silt	Clay
0.0	12.7	21.1	8.1	23.2	22.7	12.2

SIEVE SIZE	PERCENT FINER	SPEC.* PERCENT	PASS? (X=NO)
3"	100.0	100.0	
2"	100.0	95.0 - 100.0	
1 1/2"	99.6		
1"	92.2	55.0 - 85.0	X
3/4"	87.3		
1/2"	79.1		
3/8"	74.0		
1/4"	68.7		
#4	66.2	27.0 - 52.0	X
#10	58.1		
#20	46.9		
#40	34.9		
#80	21.5		
#140	14.9		
#200	12.2

silty sand with gravel

USCS= SM AASHTO= A-1-b

18.5% passing the #200 sieve based on the portion the #4 sieve.

Specification requires 0-12%.

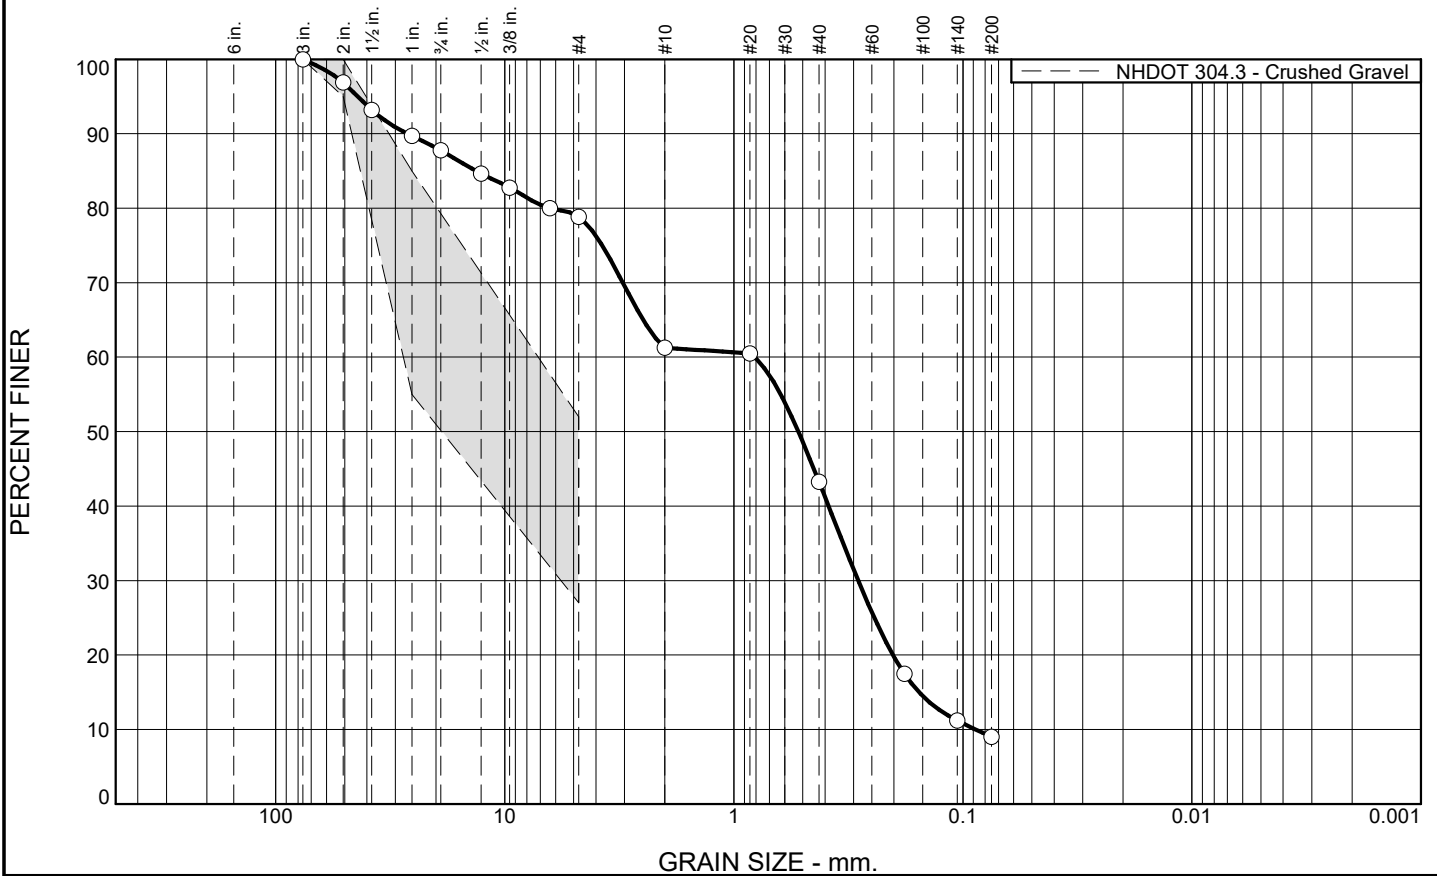
% +3"	% Gravel		% Sand			% Fines	
	Coarse	Fine	Coarse	Medium	Fine	Silt	Clay
0.0	12.2	9.0	17.5	18.0	34.3	9.0

SIEVE SIZE	PERCENT FINER	SPEC.* PERCENT	PASS? (X=NO)
3"	100.0	100.0	
2"	96.9	95.0 - 100.0	
1 1/2"	93.2		
1"	89.7	55.0 - 85.0	X
3/4"	87.8		
1/2"	84.6		
3/8"	82.8		
1/4"	80.0		
#4	78.8	27.0 - 52.0	X
#10	61.3		
#20	60.5		
#40	43.3		
#80	17.5		
#140	11.2		
#200	9.0

Remarks
 Natural Moisture Content: 14.8%
 11.4% passing the #200 sieve based on the portion the #4 sieve.
 Specification requires 0-12%.

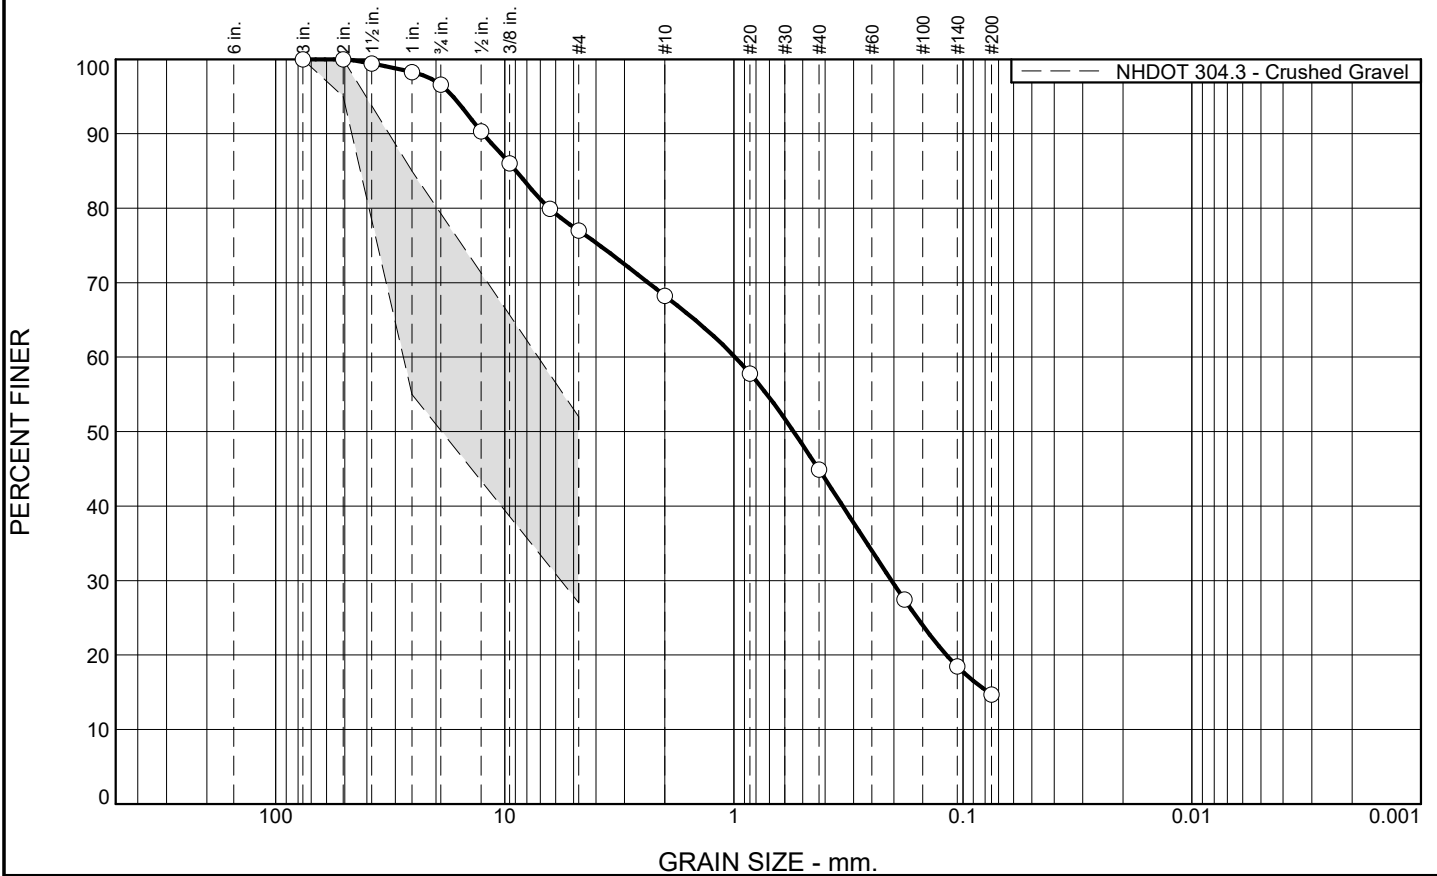
% +3"	% Gravel		% Sand			% Fines	
	Coarse	Fine	Coarse	Medium	Fine	Silt	Clay
0.0	3.4	19.6	8.8	23.3	30.2	14.7

SIEVE SIZE	PERCENT FINER	SPEC.* PERCENT	PASS? (X=NO)
3"	100.0	100.0	
2"	100.0	95.0 - 100.0	
1 1/2"	99.4		
1"	98.3	55.0 - 85.0	X
3/4"	96.6		
1/2"	90.3		
3/8"	86.0		
1/4"	79.9		
#4	77.0	27.0 - 52.0	X
#10	68.2		
#20	57.8		
#40	44.9		
#80	27.5		
#140	18.5		
#200	14.7

Natural Moisture Content: 6.9%

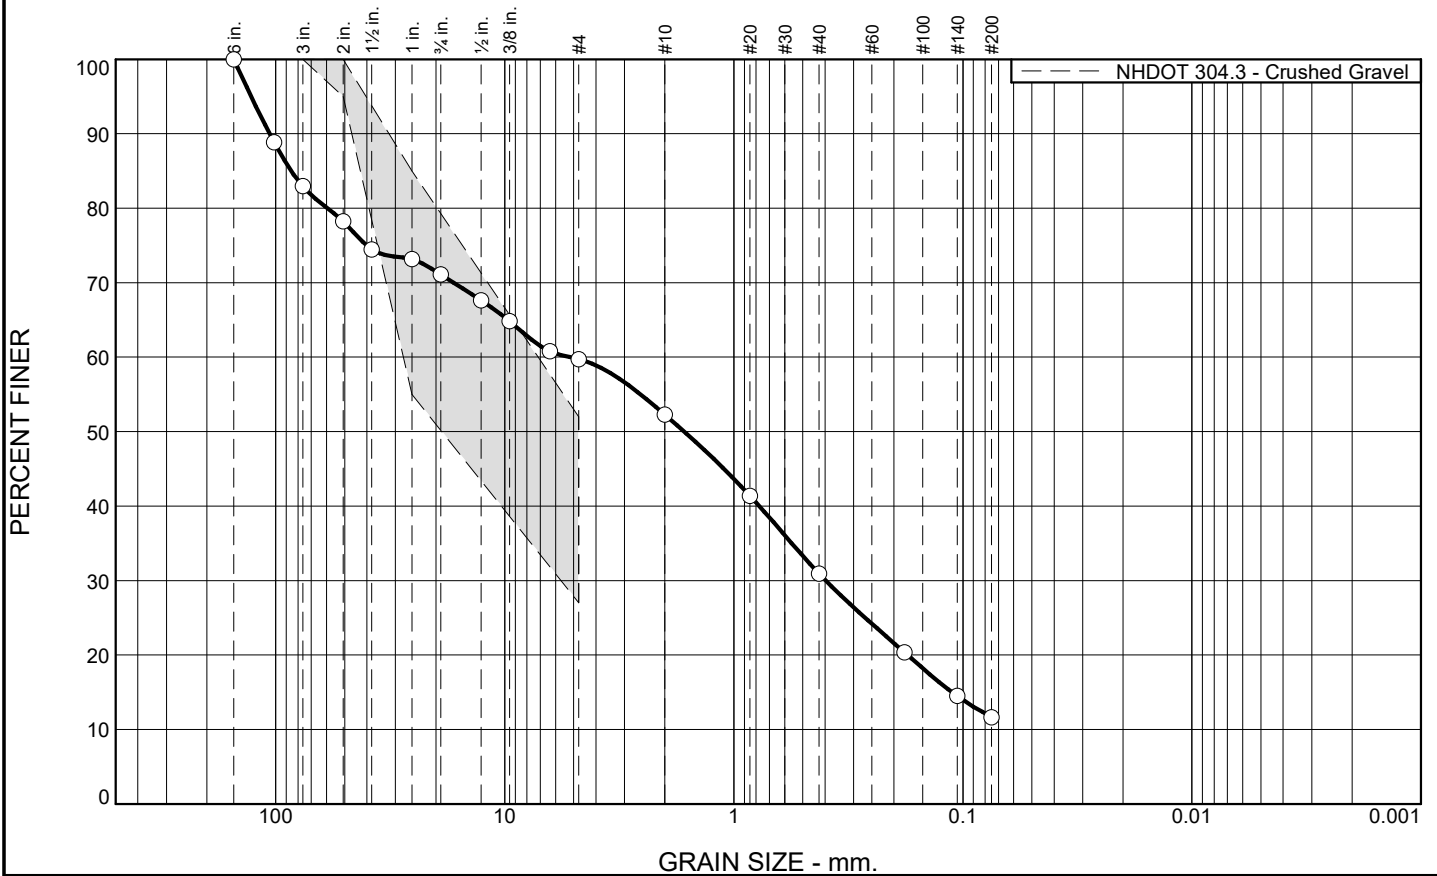
% +3"	% Gravel		% Sand			% Fines	
	Coarse	Fine	Coarse	Medium	Fine	Silt	Clay
17.1	11.8	11.4	7.4	21.3	19.4	11.6

SIEVE SIZE	PERCENT FINER	SPEC.* PERCENT	PASS? (X=NO)
6"	100.0		
4"	88.9		
3"	82.9	100.0	X
2"	78.3	95.0 - 100.0	X
1 1/2"	74.5		
1"	73.2	55.0 - 85.0	
3/4"	71.1		
1/2"	67.6		
3/8"	64.8		
1/4"	60.8		
#4	59.7	27.0 - 52.0	X
#10	52.3		
#20	41.4		
#40	31.0		
#80	20.4		
#140	14.5		
#200	11.6

Natural Moisture Content: 8.1%

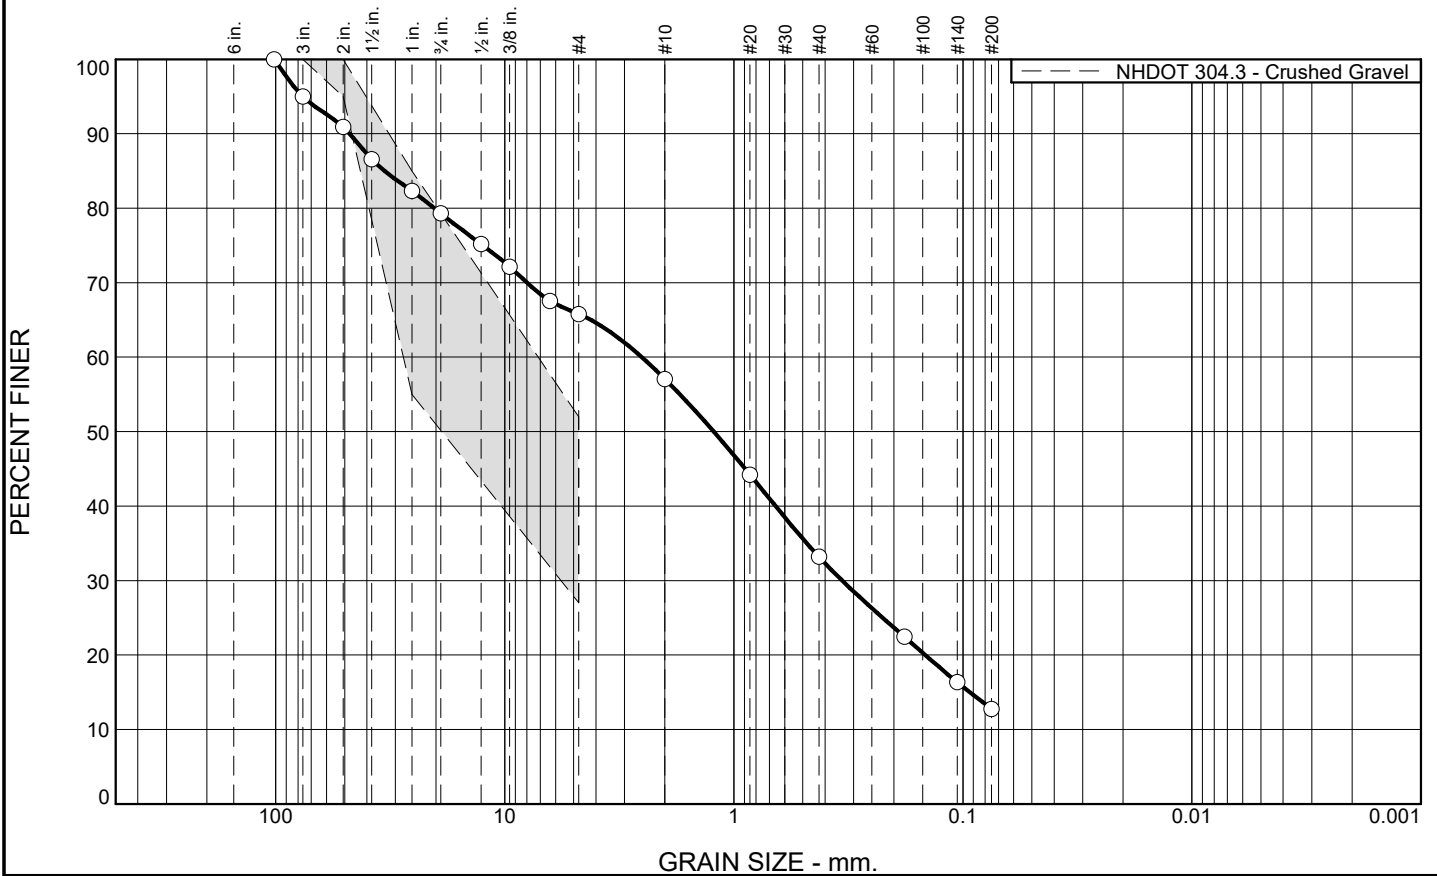
% +3"	% Gravel		% Sand			% Fines	
	Coarse	Fine	Coarse	Medium	Fine	Silt	Clay
5.0	15.7	13.5	8.7	23.9	20.5	12.7

SIEVE SIZE	PERCENT FINER	SPEC.* PERCENT	PASS? (X=NO)
4"	100.0		
3"	95.0	100.0	X
2"	90.9	95.0 - 100.0	X
1 1/2"	86.6		
1"	82.3	55.0 - 85.0	
3/4"	79.3		
1/2"	75.2		
3/8"	72.1		
1/4"	67.6		
#4	65.8	27.0 - 52.0	X
#10	57.1		
#20	44.2		
#40	33.2		
#80	22.4		
#140	16.4		
#200	12.7

Natural Moisture Content: 10.0%

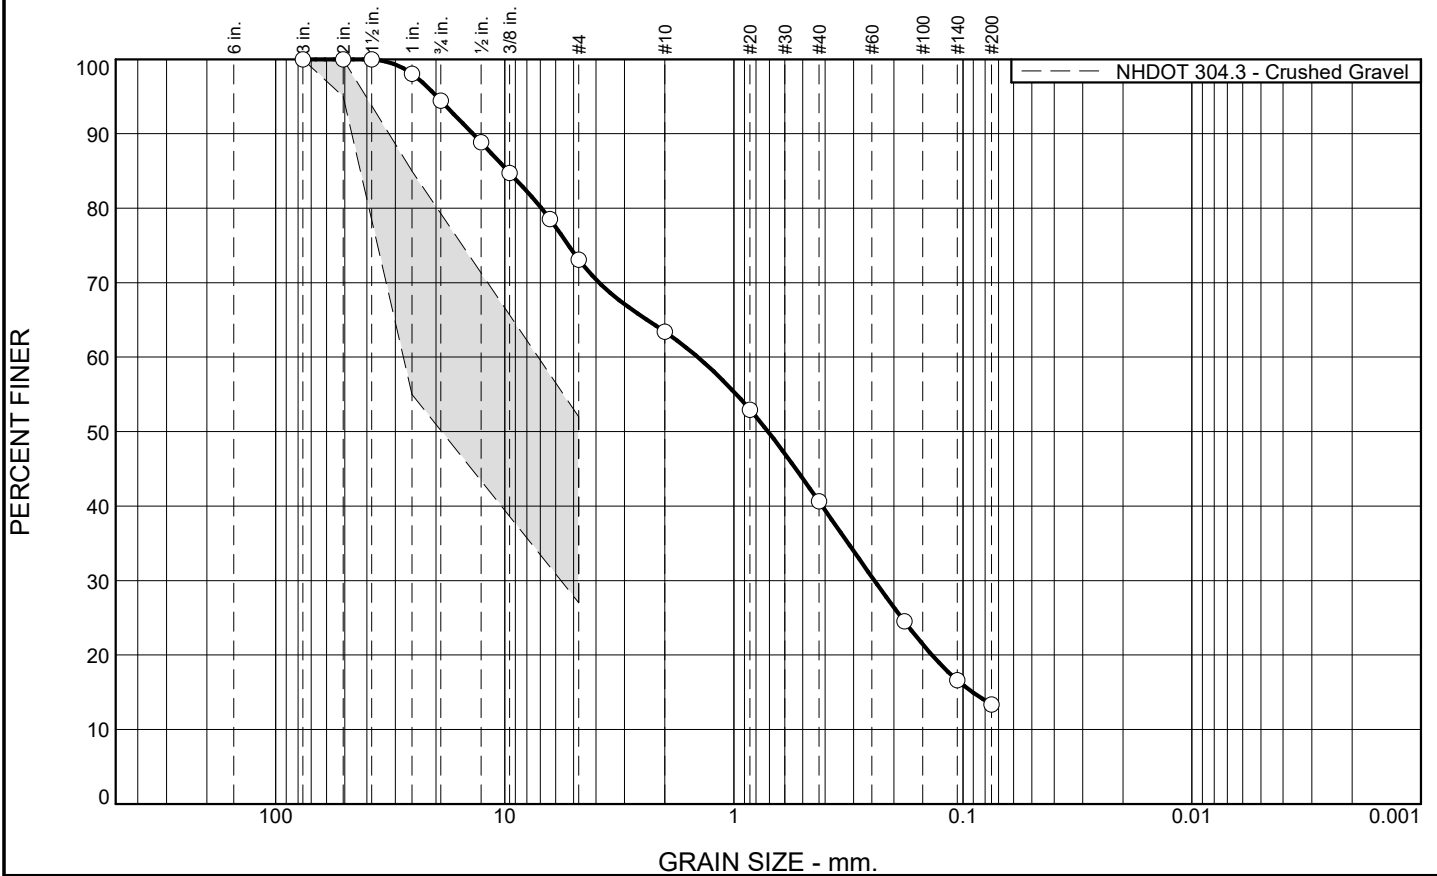
% +3"	% Gravel		% Sand			% Fines	
	Coarse	Fine	Coarse	Medium	Fine	Silt	Clay
0.0	5.6	21.3	9.7	22.8	27.2	13.4

SIEVE SIZE	PERCENT FINER	SPEC.* PERCENT	PASS? (X=NO)
3"	100.0	100.0	
2"	100.0	95.0 - 100.0	
1 1/2"	100.0		
1"	98.1	55.0 - 85.0	X
3/4"	94.4		
1/2"	88.9		
3/8"	84.7		
1/4"	78.5		
#4	73.1	27.0 - 52.0	X
#10	63.4		
#20	52.9		
#40	40.6		
#80	24.5		
#140	16.6		
#200	13.4

Remarks
 Natural Moisture Content: 7.8%
 18.3% passing the #200 sieve based on the portion the #4 sieve.
 Specification requires 0-12%.

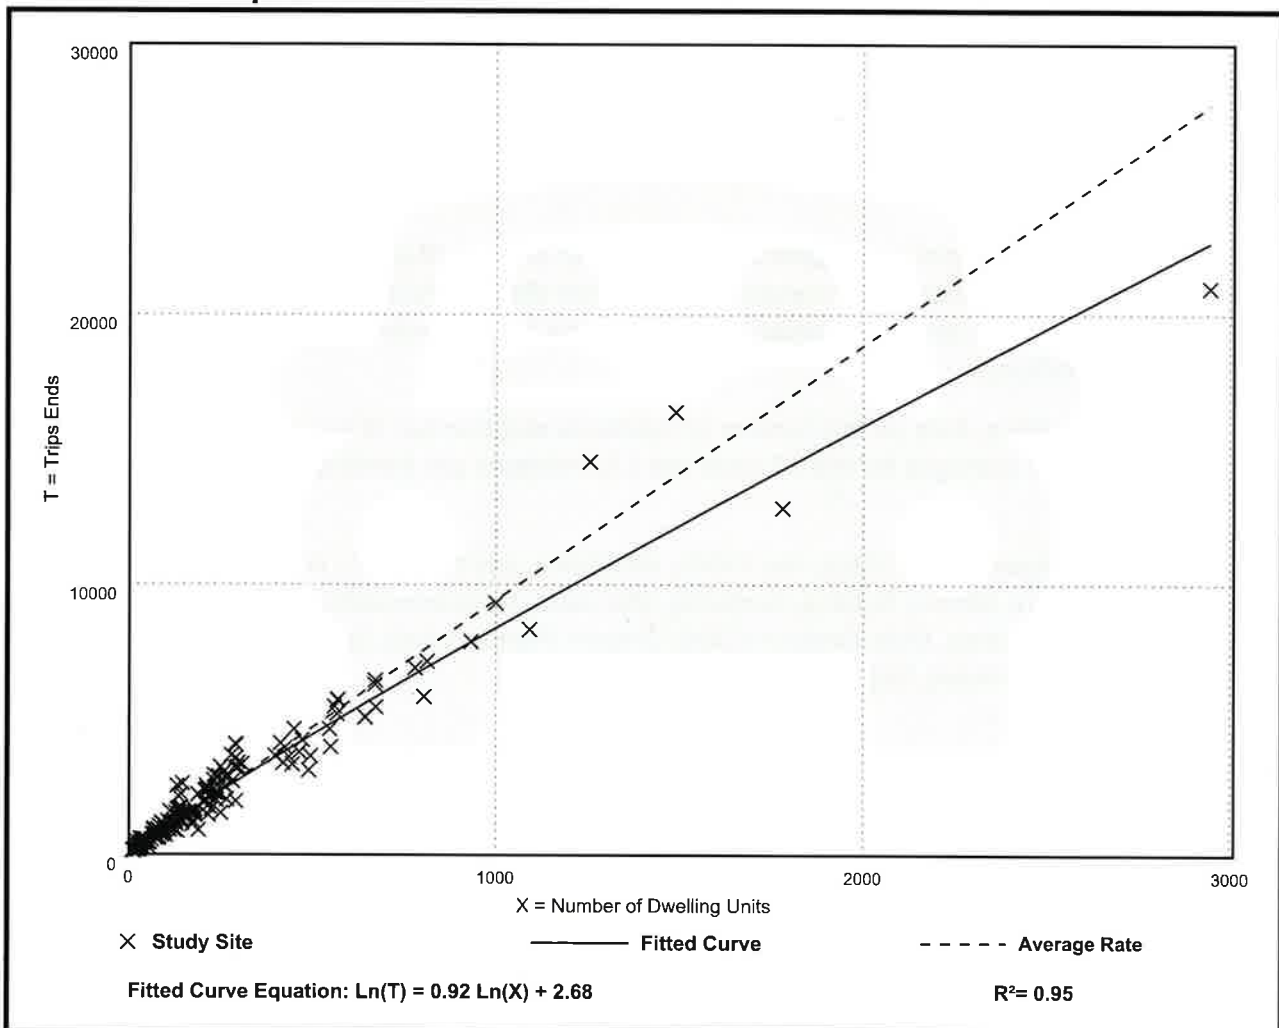
Data Plot and Equation

70 PARCELS x 9.43 = 660

Gale utilized traffic data from the Institute of Transportation Engineers (ITE) [Trip Generation Manual, 11th Edition](#) for Land Use: 210 – Single-Family Detached Housing. Based on the ITE data, Gale calculated the Average Daily Traffic (ADT) count expected to be experienced along Dr. True Road, which included the residential parcels located along Maple Circle. According to the Town's 2022 Tax Map 10, 11, and 12, there are forty-nine (49) residential parcels along Dr. True Road and twenty-one (21) residential parcels along Maple Circle; totaling 70 residential parcels. The total parcel count did not include land owned by the Town. The calculated ADT count for Dr. True Road is 660.
