# FINAL REPORT

## EVALUATION AND ASSESSMENT SANBORNTON TOWN OFFICE & PUBLIC SAFETY BUILDINGS SANBORNTON, NEW HAMPSHIRE

FEBRUARY 1, 2017

The H.L. Turner Group Inc.

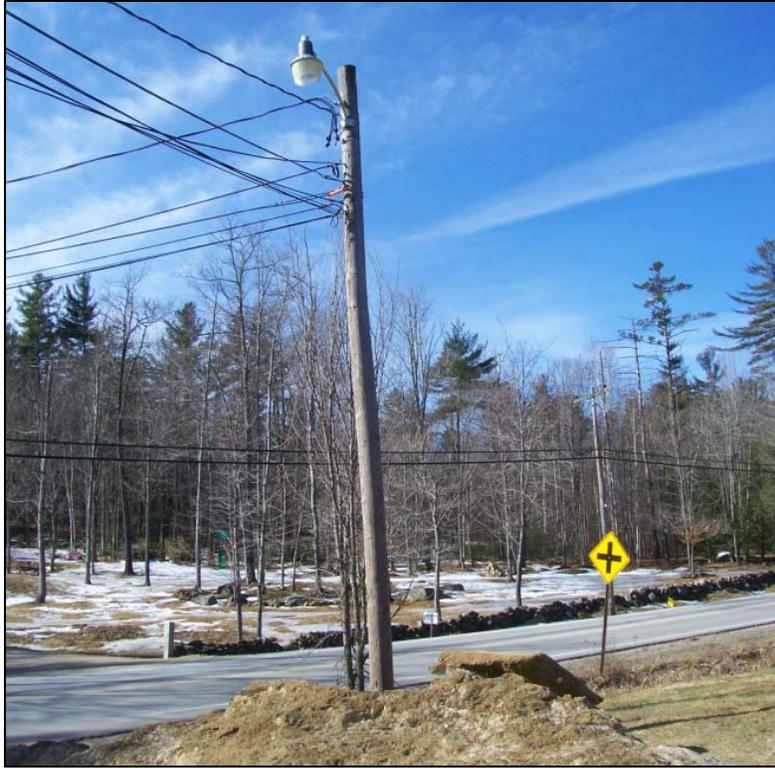
There is very little direct site lighting. Aside from a fixture mounted to the utility pole at the southwest corner of the building all external lighting is provided by building-mounted wall packs. These lights probably illuminate the spaces immediately adjacent to the building but fail to provide adequate lighting for the entire lot.

Site light at southwest corner.

- Review adequacy of existing lighting on a dark night. If the Town decides to supplement or replace what is currently there, consult with a lighting design specialist. In addition to providing greater illuminance, the consultant can specify luminaires that consume less electricity than the current lights, such as LED's. The design should consider the site as a single entity, not two separate buildings.

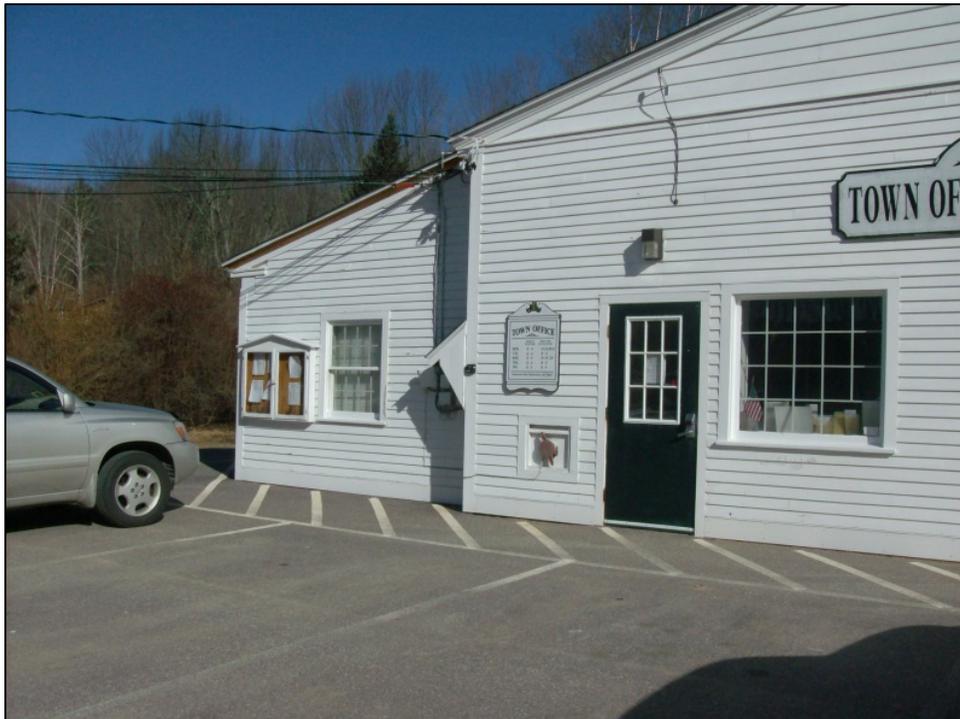
Stand pipe - left of main entrance.

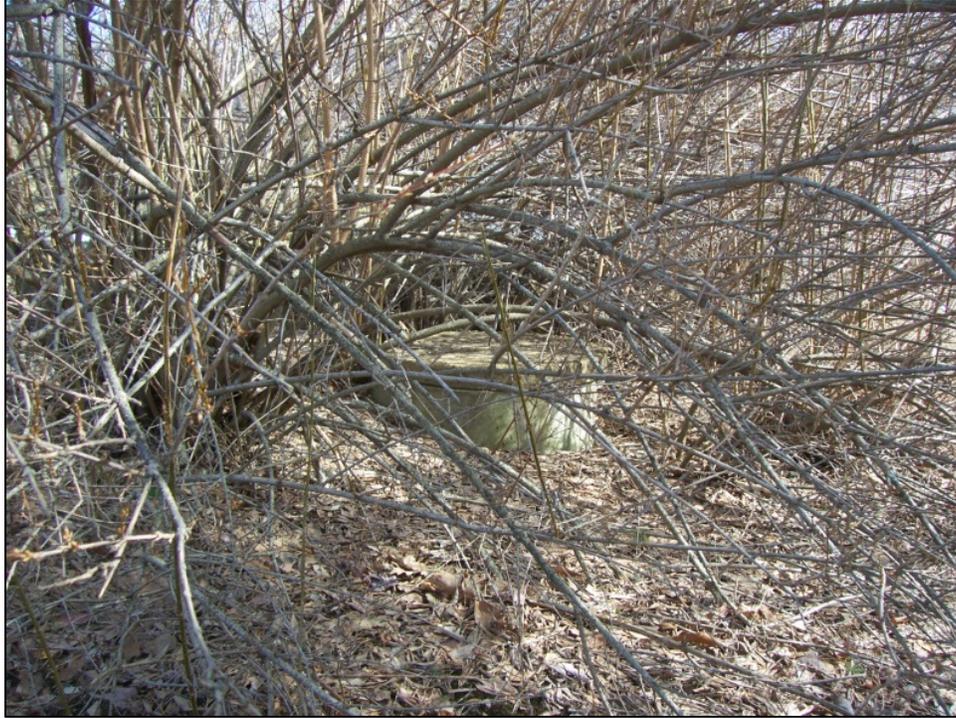
Pump station access hatch.

- Remove the vegetation from around the pump station to permit access.
- Have the septic tank and pump station inspected to determine the condition of the concrete and baffles, whether or not there is an outlet filter, possible corrosion of electrical lines, the condition of the pump, and evidence of groundwater infiltration into the structures. TTG suspects there is a stormwater culvert from a catch basin to the septic tank, which should be terminated if the connection exists. Refer to the 'Drainage' section of this report.

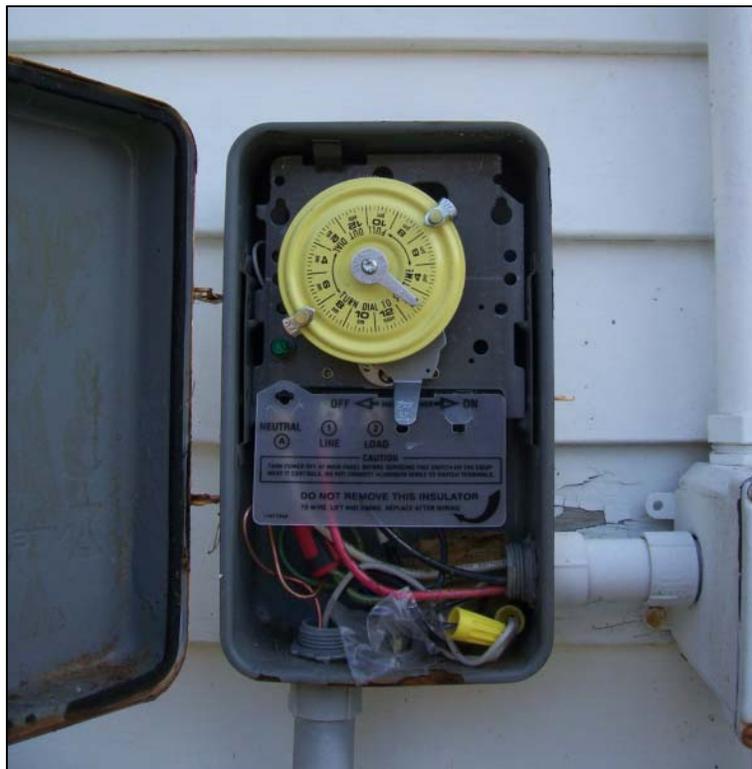
Timer on west side of building.

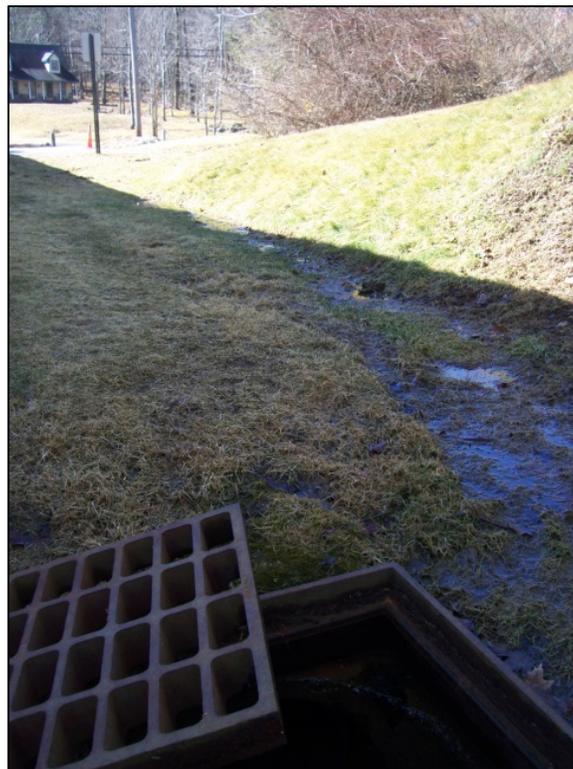
Swale along west side. Note: Elevated grate preventing water from draining.

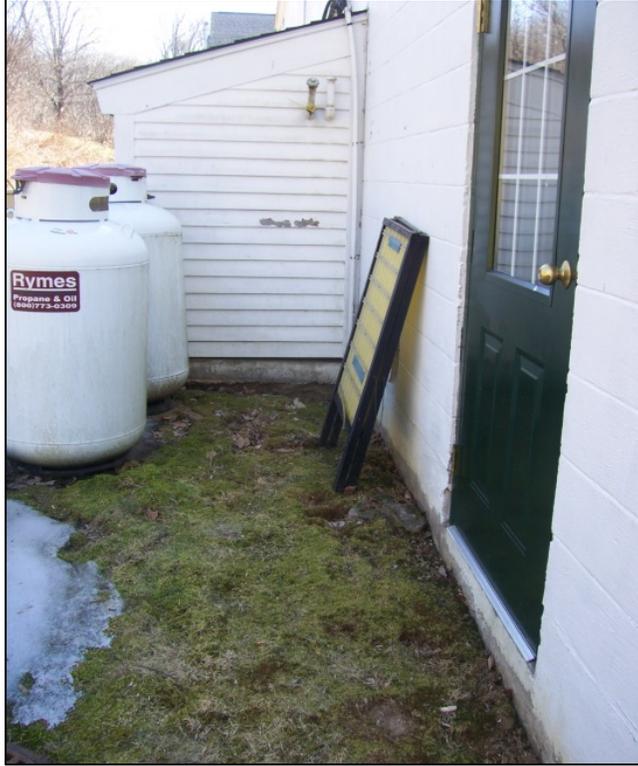
Exterior door with no concrete pad.

- Install a trench drain or similar inlet to capture runoff in front of the exterior door at the southwest corner of the building.
- Regrade the non-paved areas abutting the foundation to ensure the ground slopes away from the building. Consider installing a stone lined drip edge with a perforated pipe around the perimeter of the building where there is no pavement, to collect stormwater and snowmelt and pipe it away from the structure.

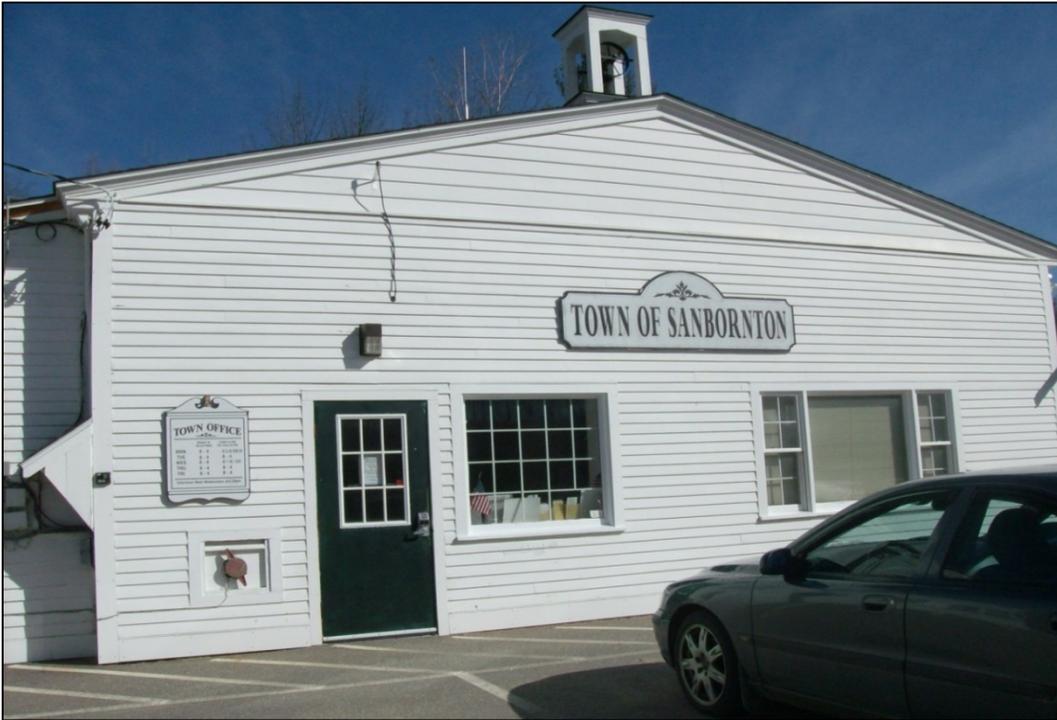
Town Office Building - Main entrance, South Side.

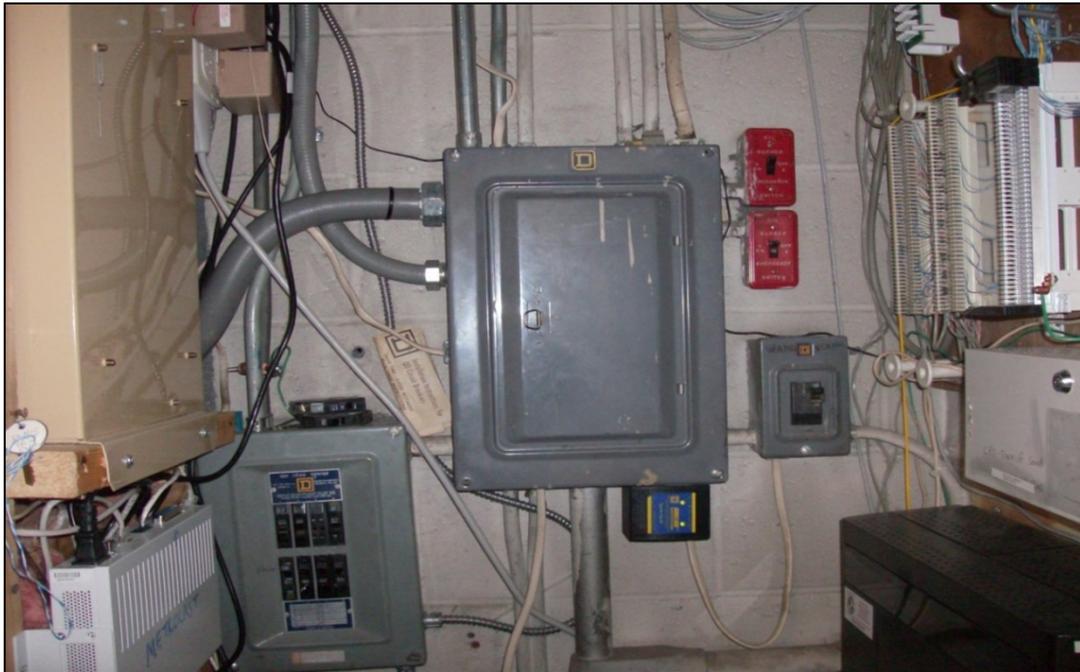
Incoming electrical panel, sub-panels, telephone and data cabling located in closet near front entrance.

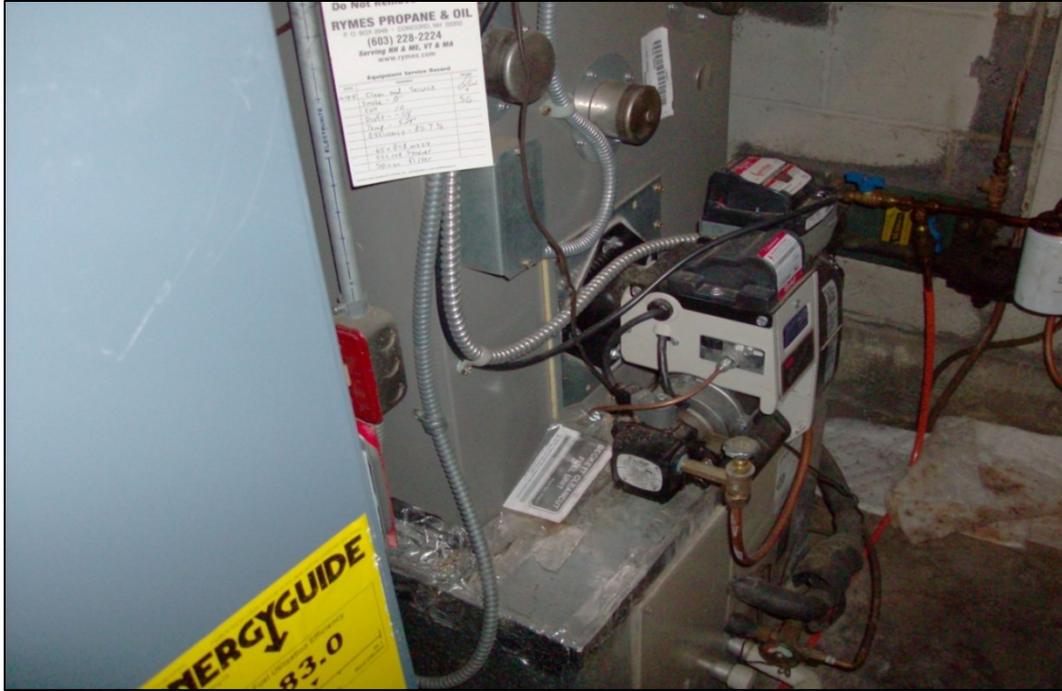
The aboveground oil tank is located within the protective radius of the well. Although the tank is enclosed within the office building, an accidental spill could conceivably seep through the intersection between the foundation and the sill plate, which could contaminate the water supply. There was no evidence of a spill kit or containment measures in close proximity to the tank.

Oil-fired hot air furnace.

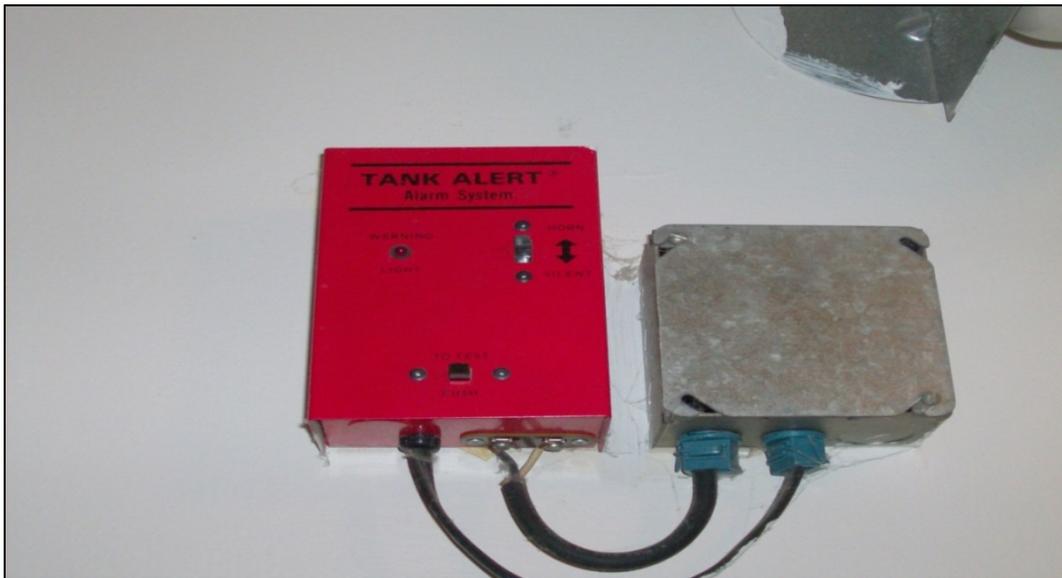
Overflow alarm for 1,000 gallon septic tank mounted on wall of bathroom.

- Ensure the septic tank is pumped yearly. Inspect the tank and pump station chamber at the same time.
- Include septic system maintenance and inspection in a site maintenance schedule recommended for this property.

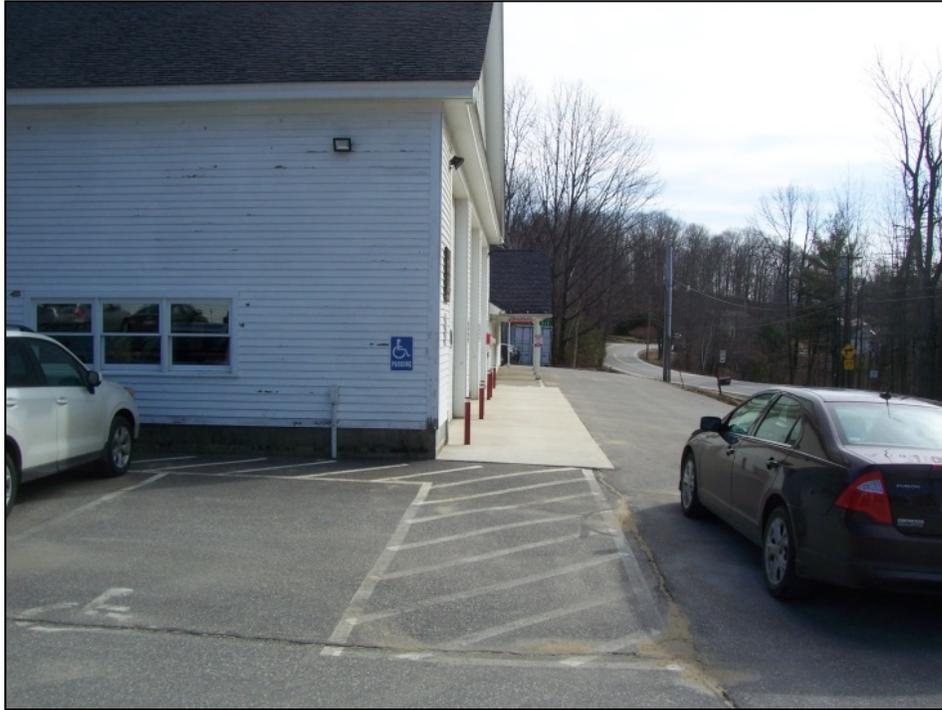
Accessible parking space and path to main entrance.

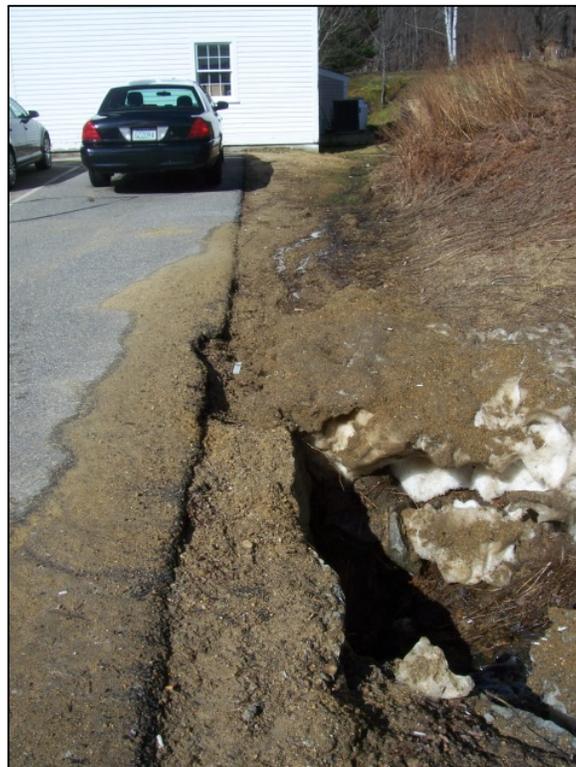
Pavement undermining at parking lot.

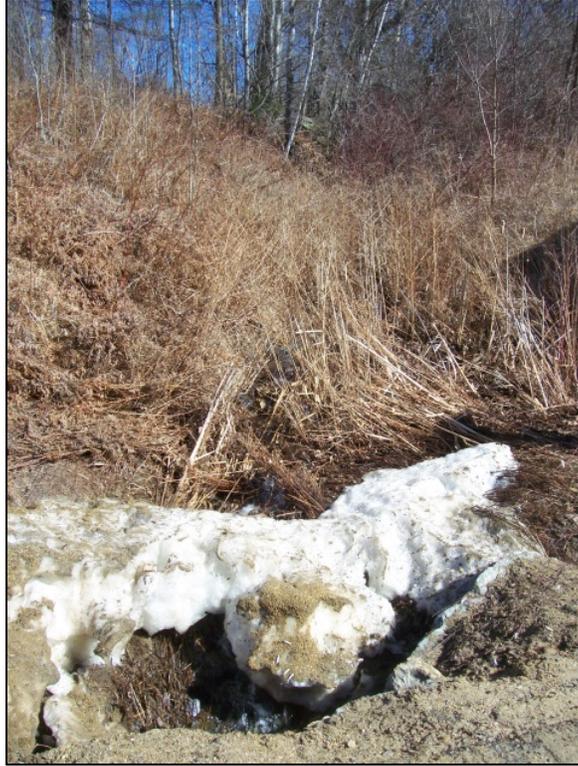
Overgrowth in swale leading to culvert beneath parking lot.

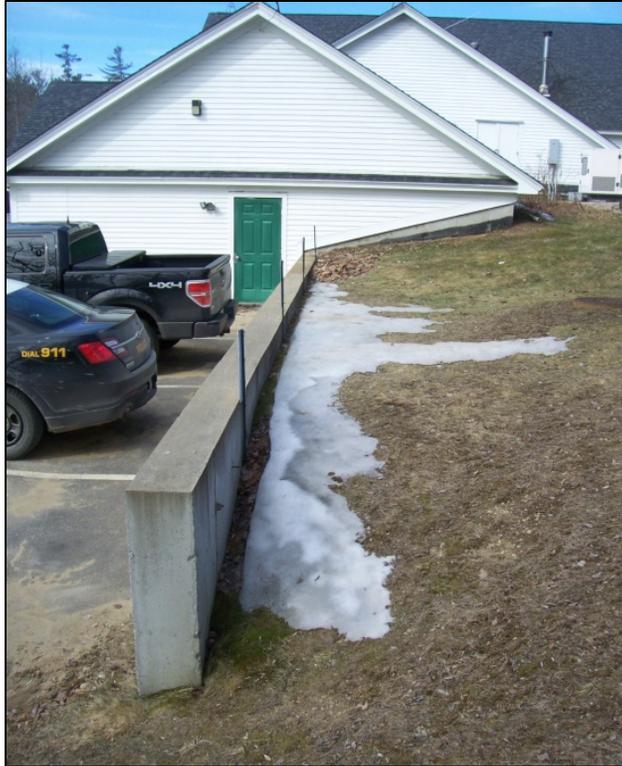
Retaining wall at east end of PSB. Note absence of fall barrier.

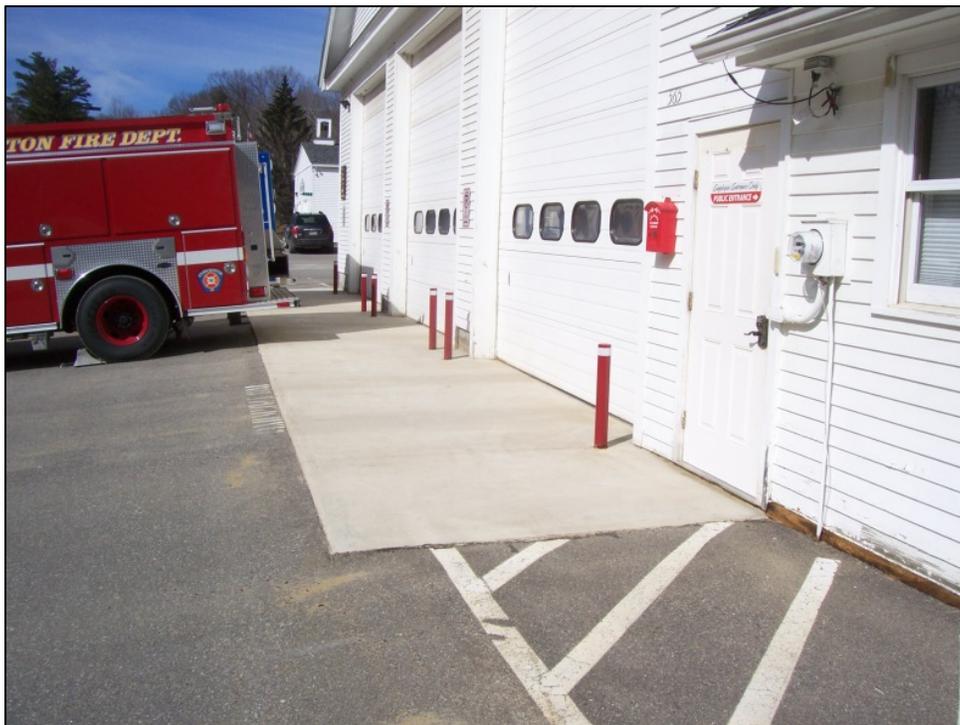
Bollards at apparatus bay and pedestrian route to main entrance.

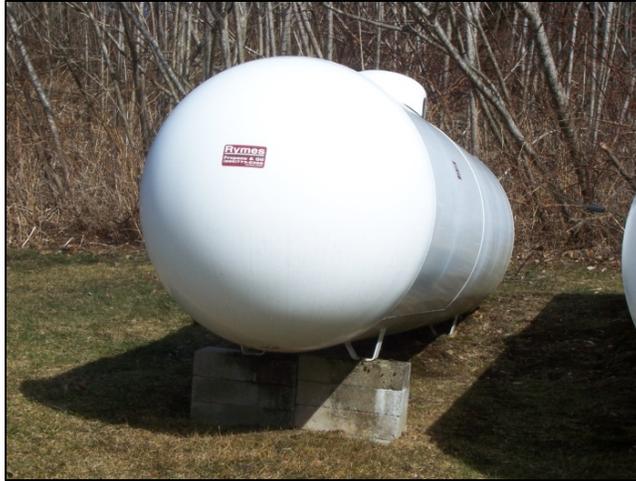
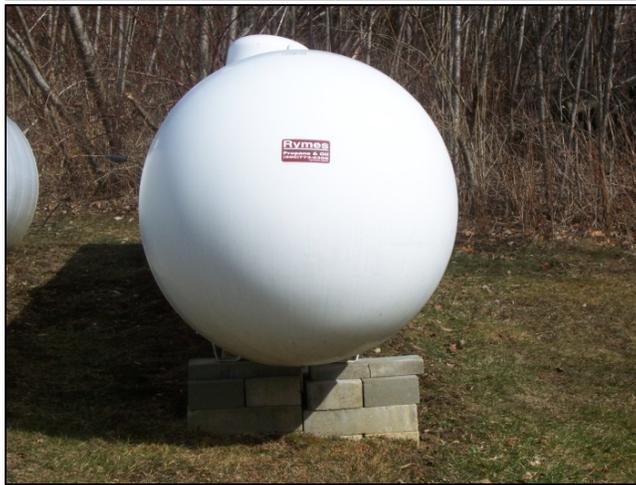
Note: Displacement of concrete blocks supporting propane tank (top photo).

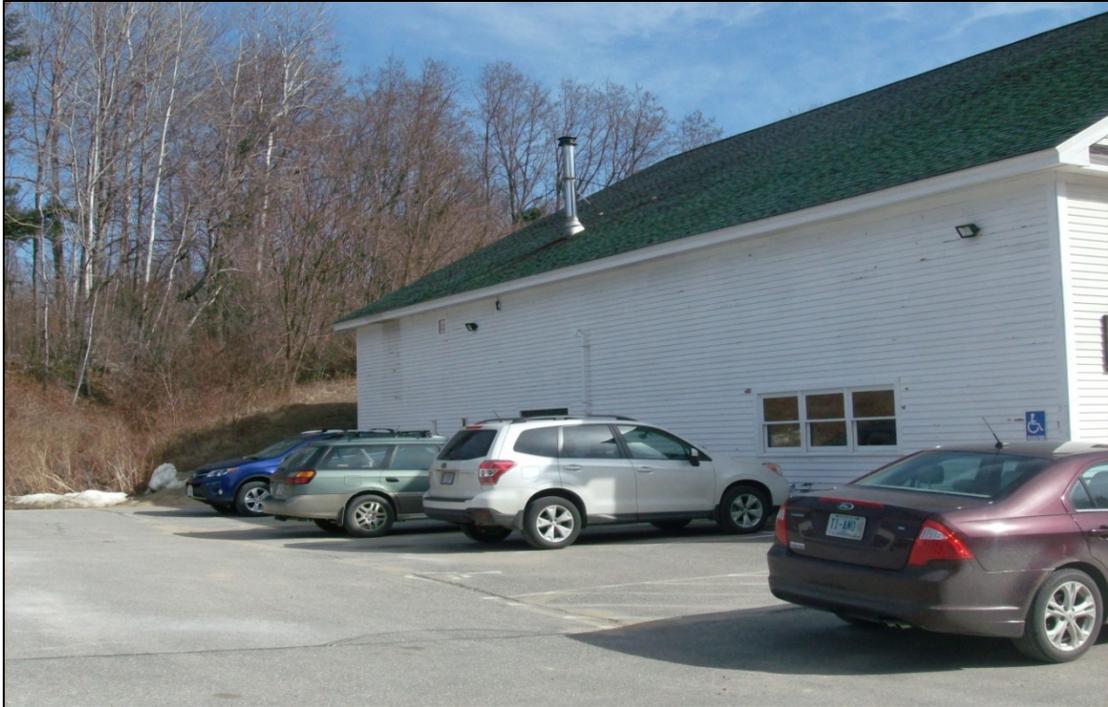
West side of Public Safety Building. Wood clapboards and asphalt shingles.

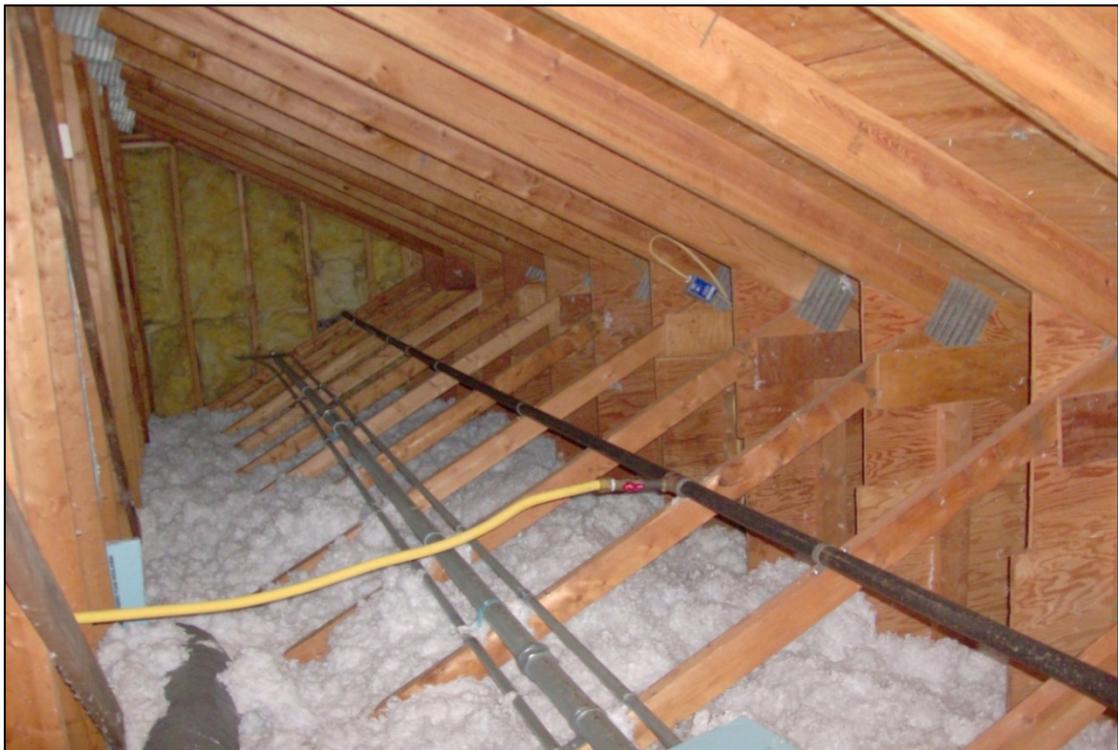
Roof trusses and insulation over administration section of building.

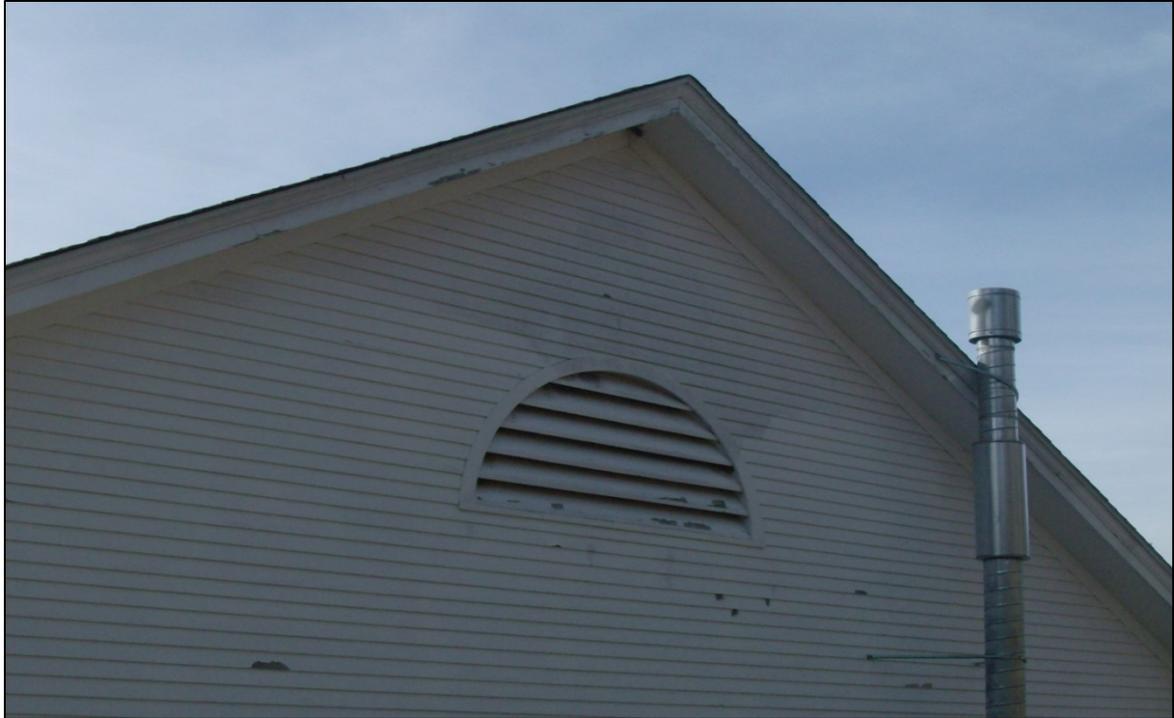
North side of Apparatus Bay. Large louver for attic ventilation.

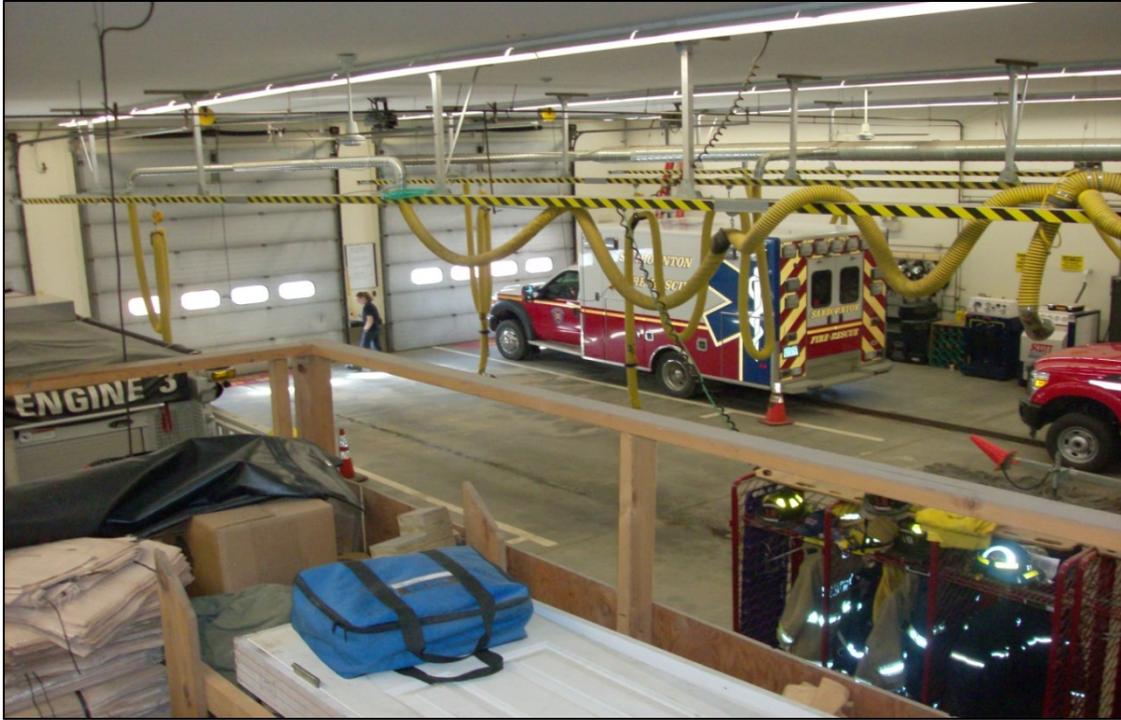
Overview of Apparatus Bay from storage mezzanine.

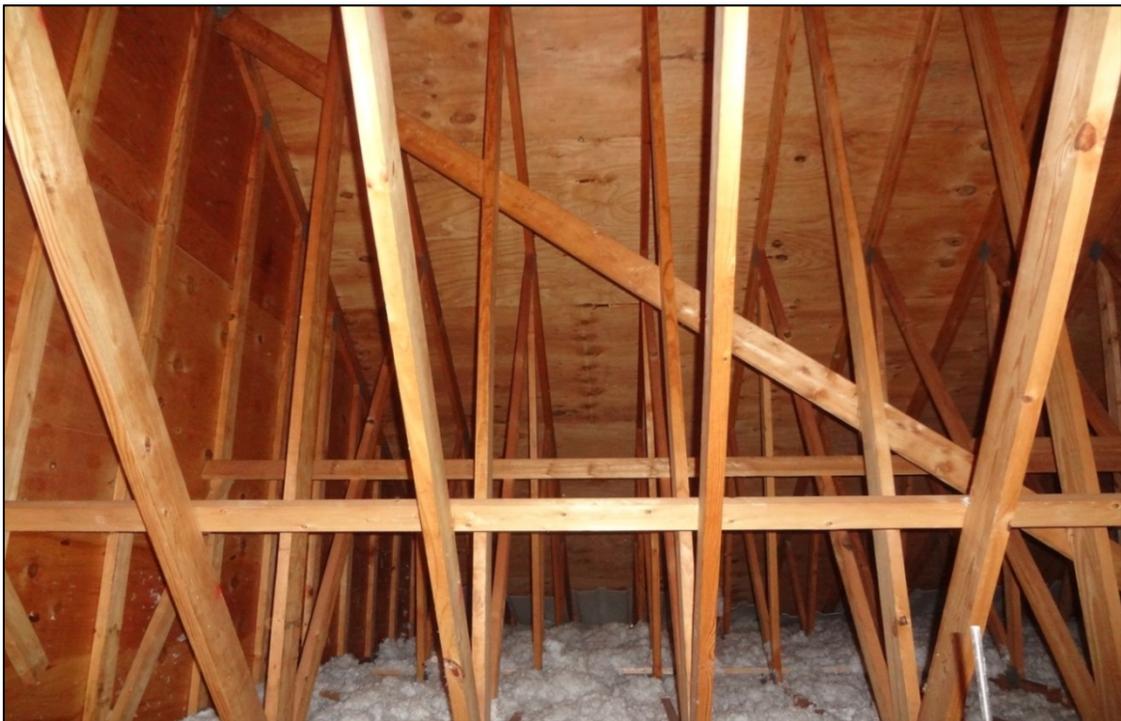
Wood trusses over the apparatus bay.

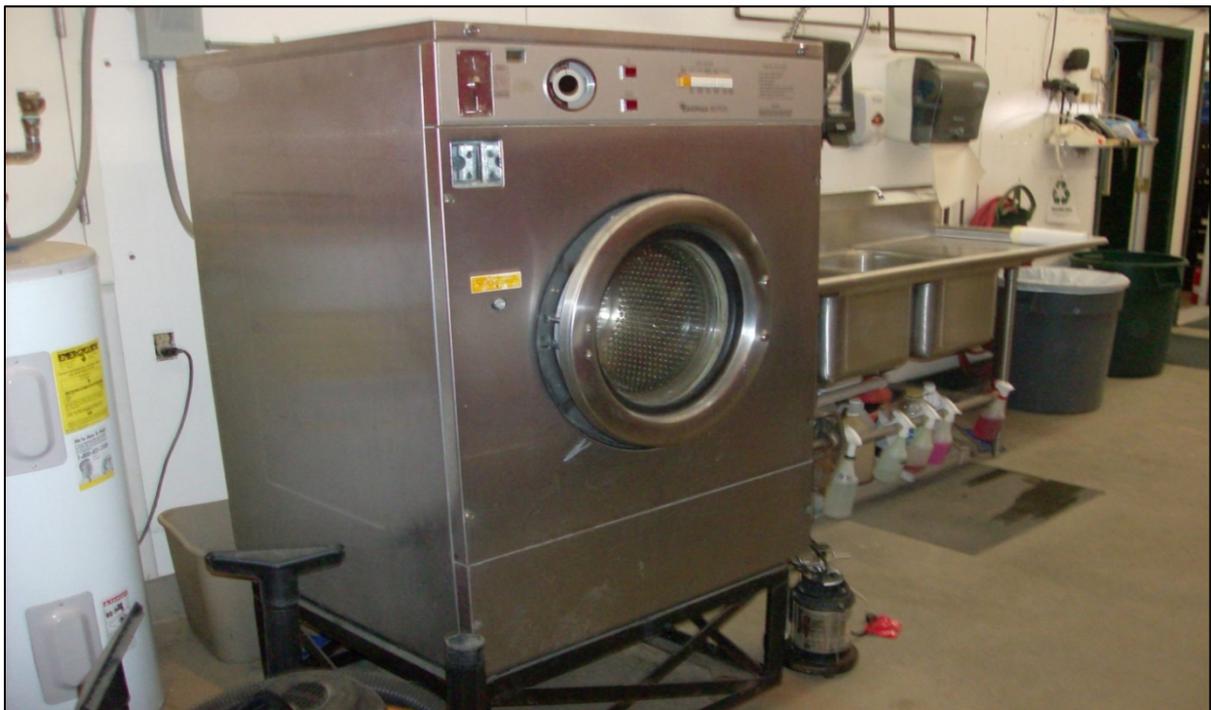
Commercial washing machine in apparatus bay.

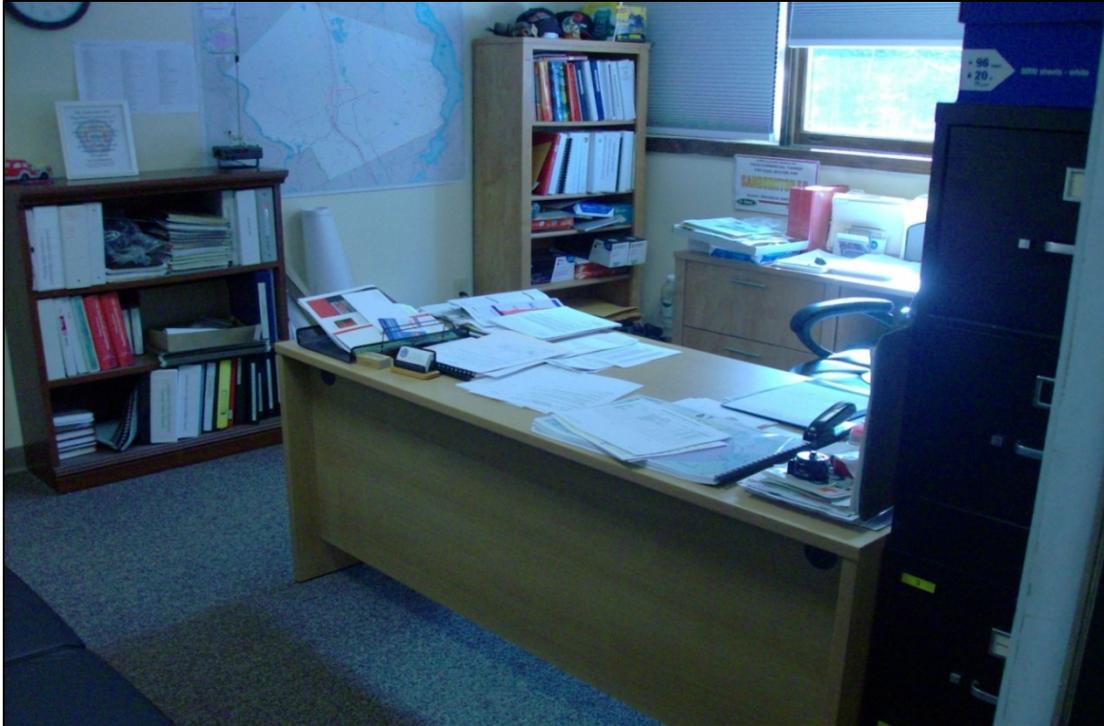
Fire Chief's Office.

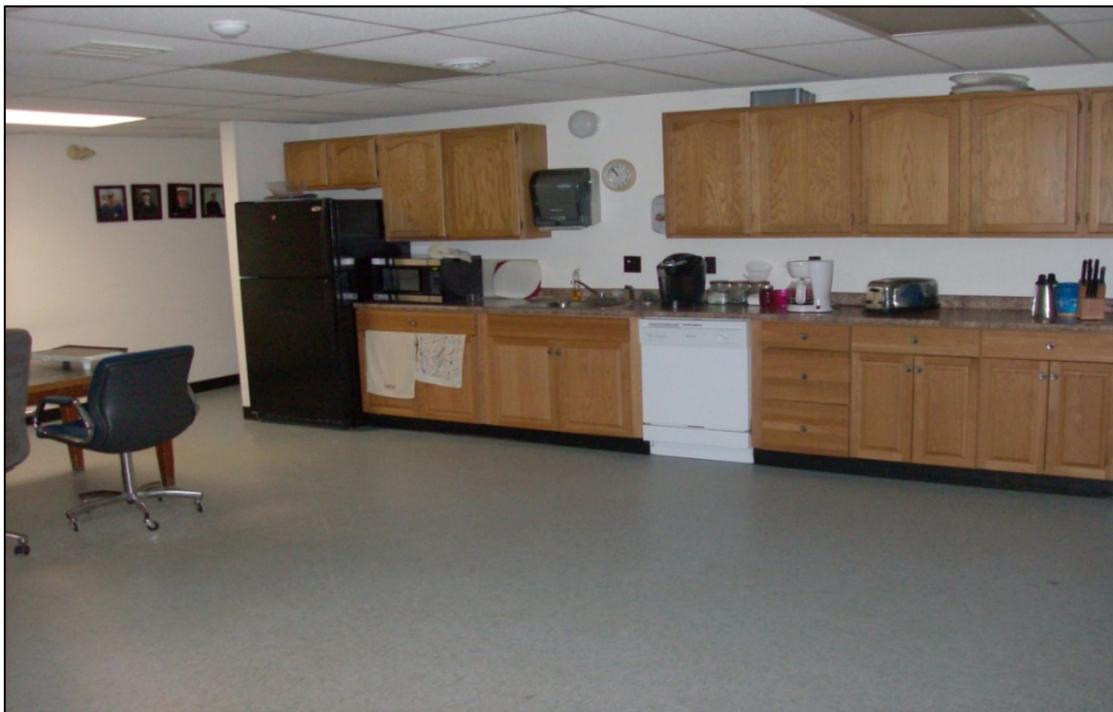
Combination Break Room, Kitchen and Training Room.

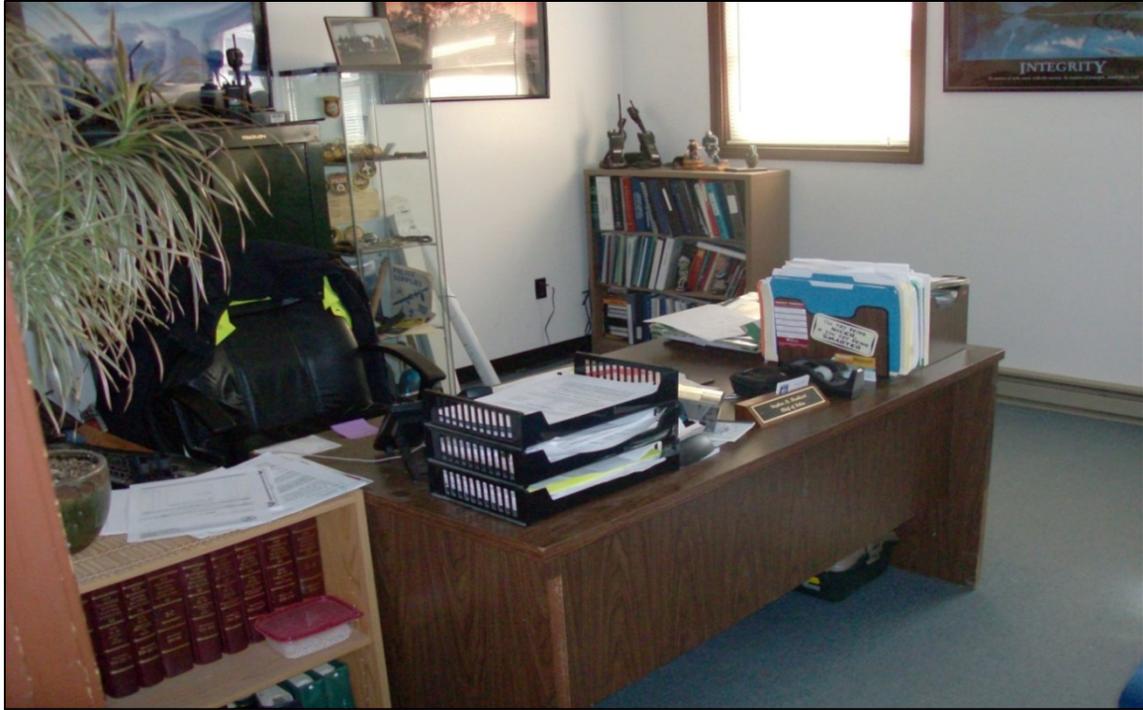
Police Chief's Office.

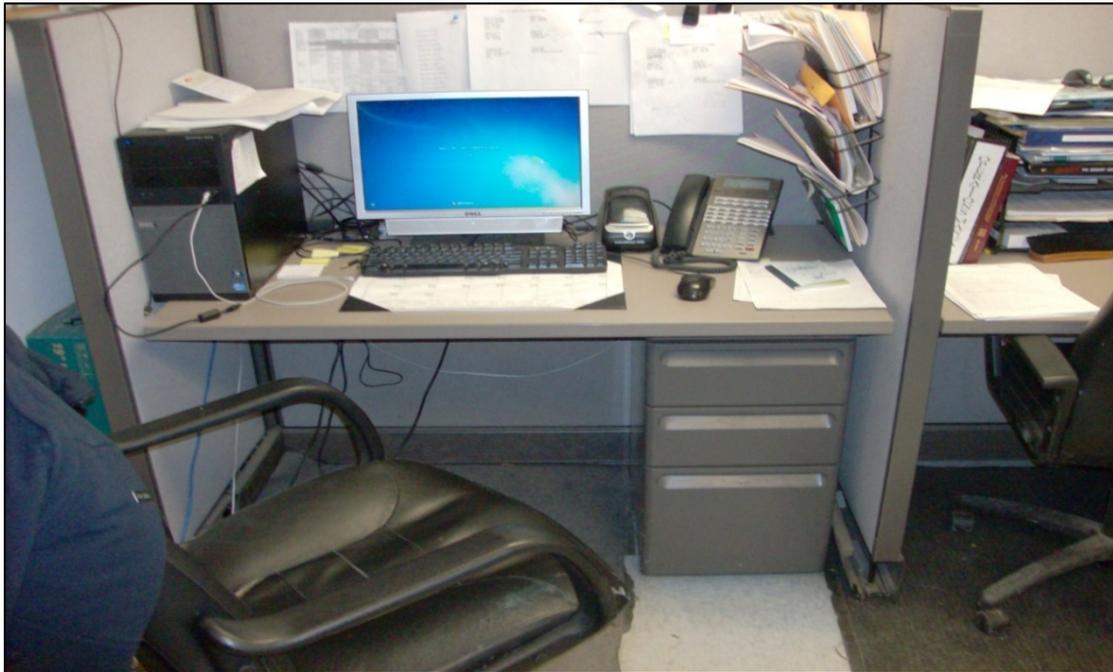
Typical work station for police officer.

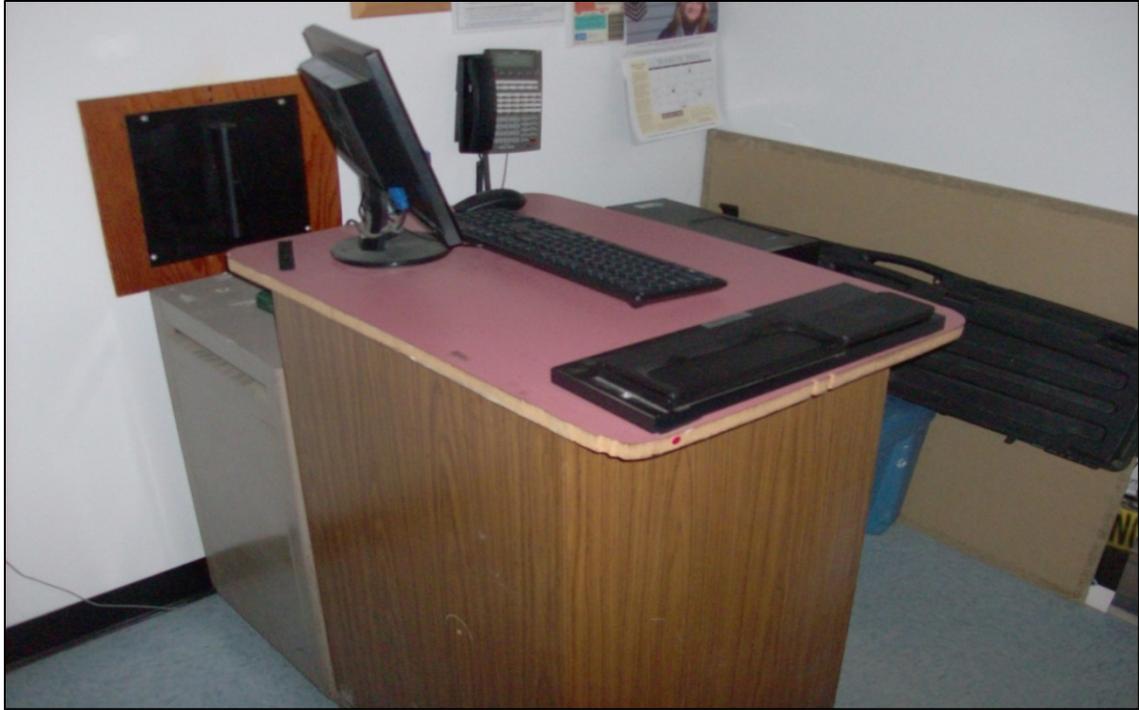
Booking station.

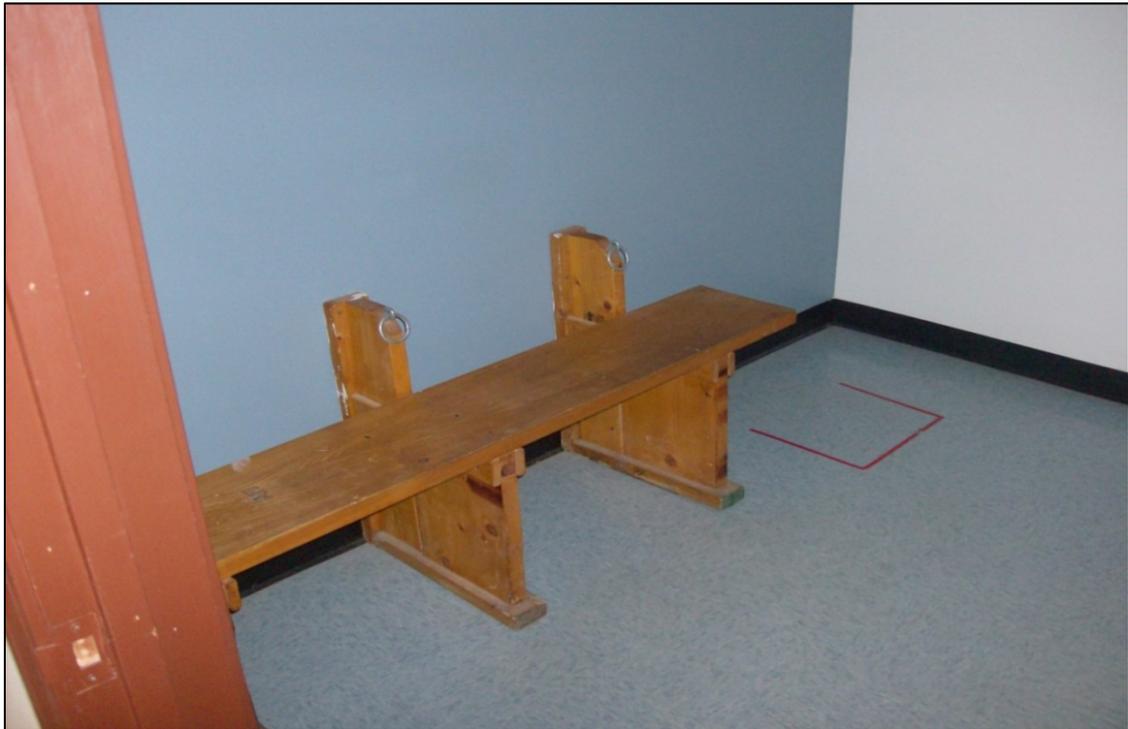
Area where prisoners are restrained until transport is arranged.
